**UNITED STATES OF AMERICA
BEFORE THE
FEDERAL ENERGY REGULATORY COMMISSION**

Docket No. RM21-17-000

**COMMENTS OF THE
NORTH AMERICAN ELECTRIC RELIABILITY CORPORATION, MIDWEST
RELIABILITY ORGANIZATION, NORTHEAST POWER COORDINATING
COUNCIL, INC., RELIABILITYFIRST CORPORATION, SERC RELIABILITY
CORPORATION, TEXAS RELIABILITY ENTITY, INC., AND WESTERN
ELECTRICITY COORDINATING COUNCIL ON
THE ADVANCE NOTICE OF PROPOSED RULEMAKING**

Attachment 1: Odessa Report, September 2021

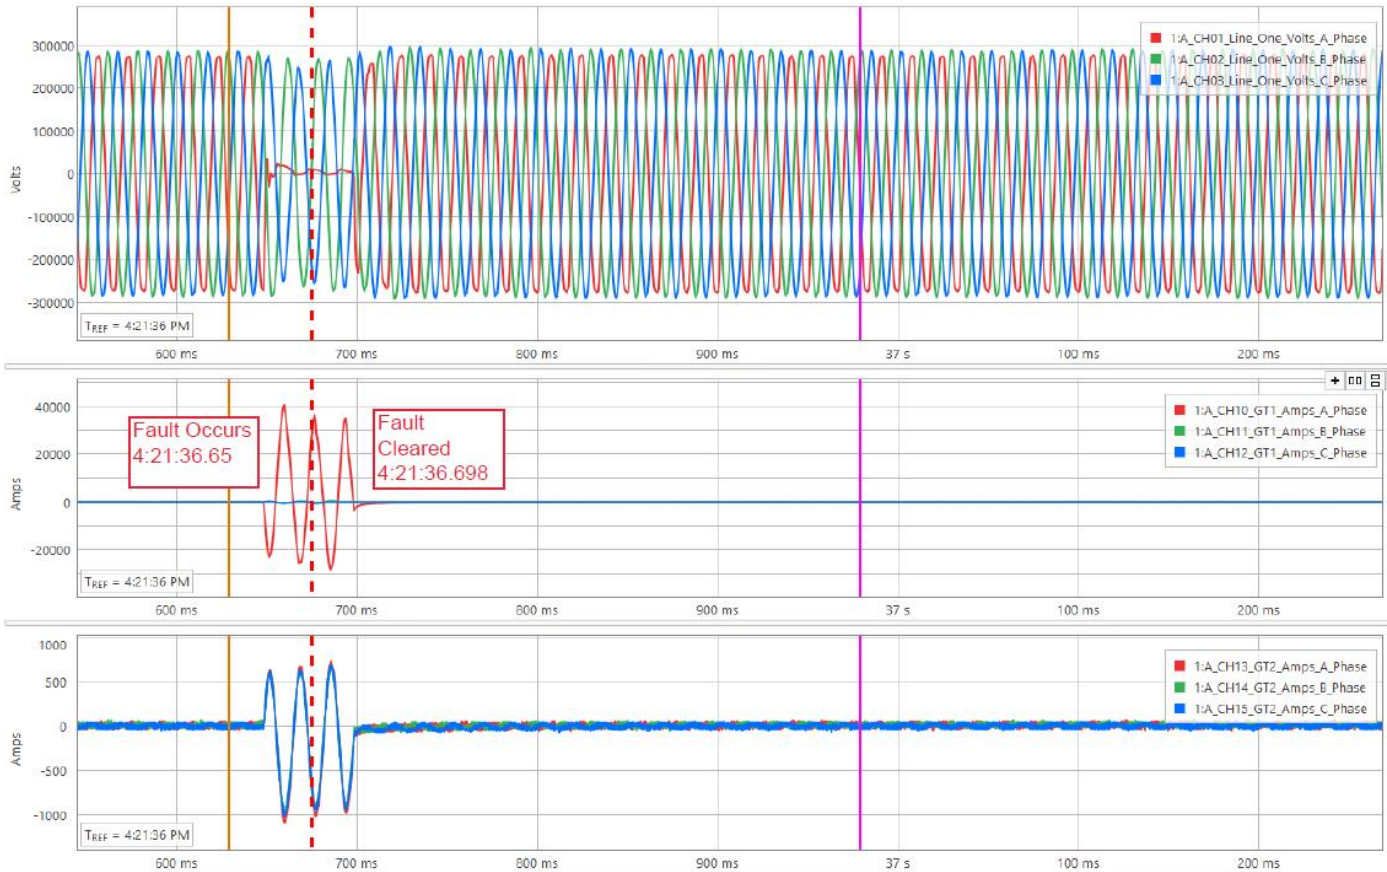
An A-phase-to-ground fault occurred on a CT GSU transformer at a combined-cycle power plant during turbine startup for testing. The fault was caused by a failed surge arrester. Protective relaying cleared the fault on the 18/345 kV GSU in three cycles (see **Figure I.3**). At the combined cycle plant where the fault occurred, the faulted CT was tripped off-line, consequentially, by protective relay operation. In addition, the neighboring unit at the facility experienced a natural gas turbine runback and consequent steam turbine power reduction. The total loss of generation at the plant was 192 MW.

Figure I.3: A-Phase-to-Ground Fault on Combined Cycle Combustion Turbine GSU

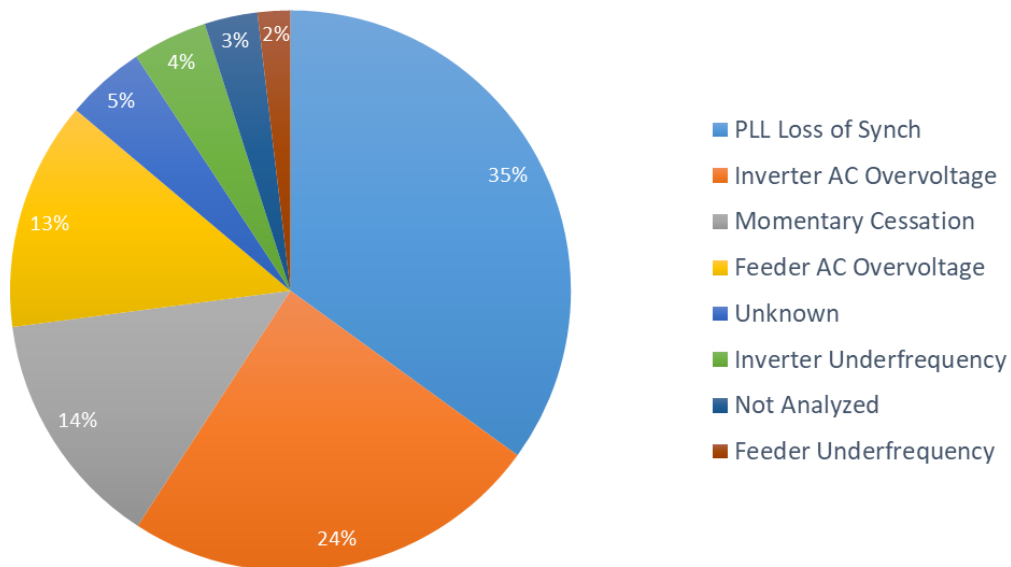
Figure 1.1: Causes of Solar PV Reduction

- **Not Analyzed (34 MW):** A total of 34 MW of solar PV facilities reduced power output yet were below the threshold for a detailed review by NERC and Texas RE.
- **Feeder Underfrequency (21 MW):** One plant had one feeder-level relay operate on underfrequency, tripping 21 MW of inverters. The relay manufacturer indicated that the relay performs the frequency measurement over a 3 cycle window. Analyzing the waveforms during the disturbance from the relay, it was determined that the relay measured the frequency correctly over the 3 cycle window. However, the manufacturer recommends a minimum time delay for frequency tripping to be 5 cycles. The relay was set for zero delay. This reinforces previous disturbance reports recommendations to not use an instantaneous trip setting for frequency protection.

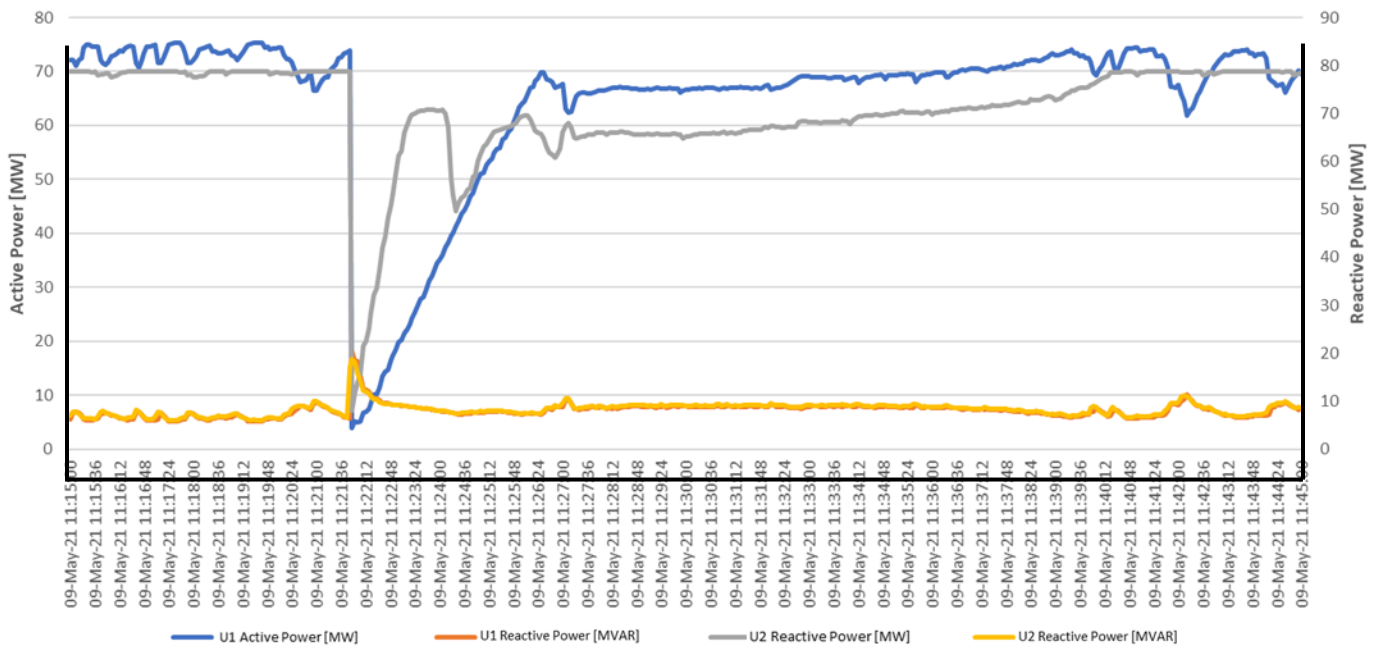
As experienced in the past NERC analyses of disturbances involving solar PV resources, one facility had legacy inverters programmed to enter momentary cessation when voltage falls below 0.9 pu. After fault clearing, voltage recovered to normal operating ranges quickly (within a few cycles) and the inverter attempted to return to pre-disturbance levels. The inverter manufacturer for this facility stated that there are no inverter-level controls that would slow the inverter response to the levels seen in [Figure 1.3](#). Rather, once voltage recovers, the inverters return to responding to plant-level set point values. The plant-level controller has ramp rate limits that limit how quickly inverters can change active power output to support BA balancing activities. However, these limits should not interfere with the inverters' ability to recover to pre-disturbance output levels within under about one second. This is documented in NERC reliability guidelines.²¹

Figure 1.3: Momentary Cessation with Ramp Rate Interaction

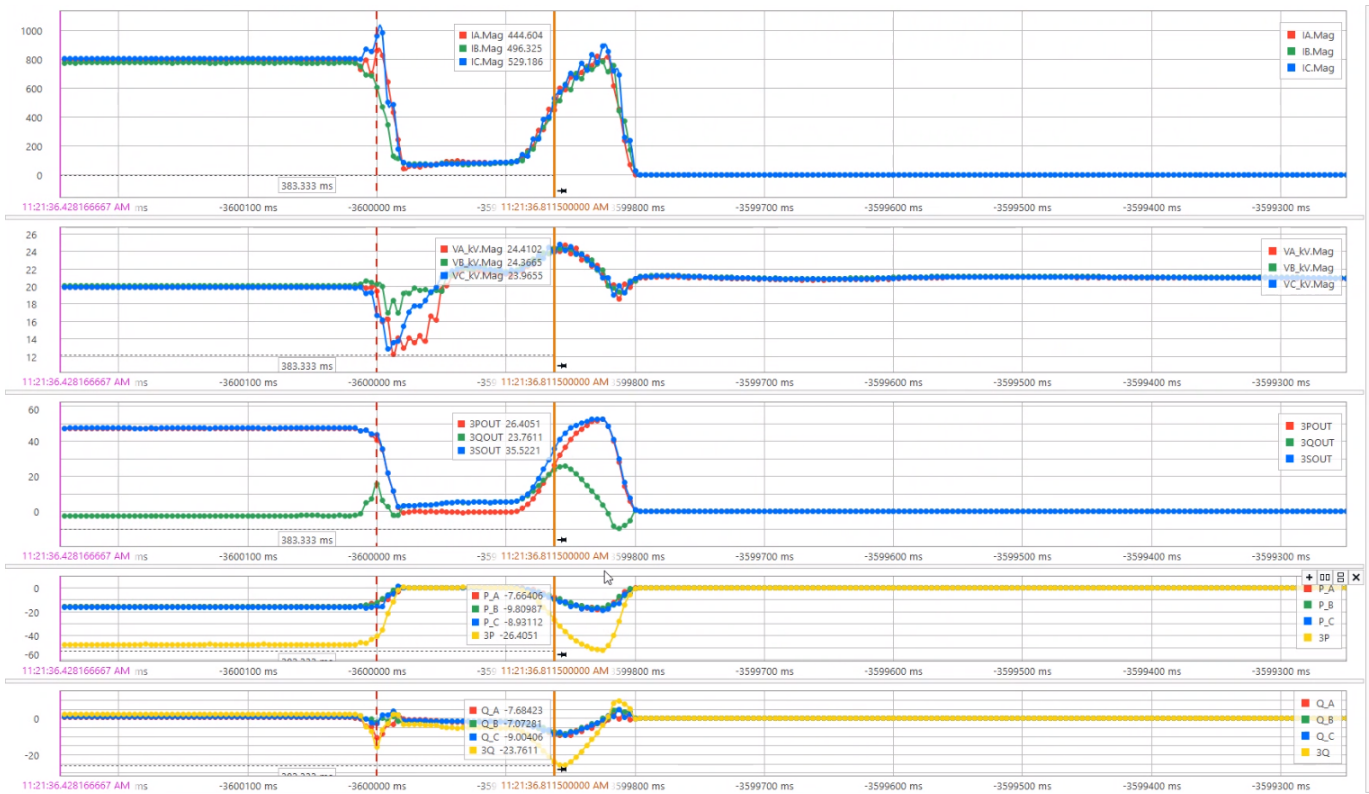
²² Current near zero is attributed to the inverter gate blocking the electronics, prohibiting it from injecting current, while the inverter output capacitors remain on-line and connected to the ac network.

Figure 1.4: Current Injection at Time of Trip

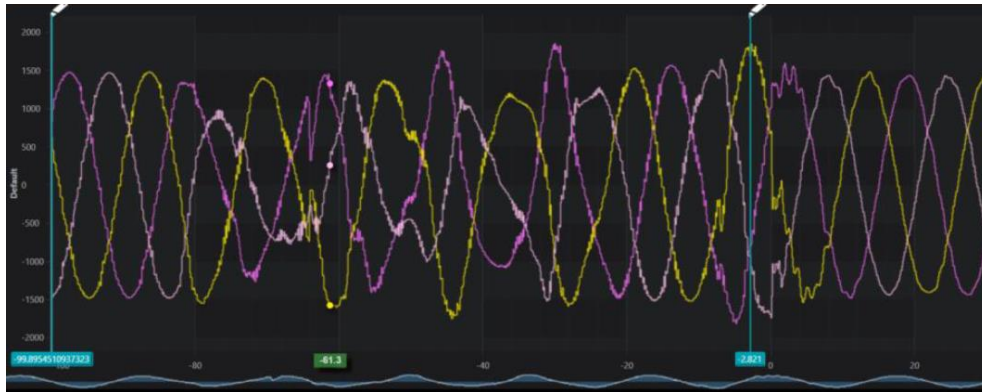
used to meet PRC-024-3 requirements. This hard-coded voltage trip threshold is based on instantaneous peak measurements, not RMS measurements of voltage. Therefore, these settings cannot be modified for any existing facilities and likely will continue to invoke tripping for normal grid fault events unless plants are tuned accordingly to appropriately ride through these types of events.

Figure 1.5: Inverter Oscillography of Transient AC Overvoltage Tripping

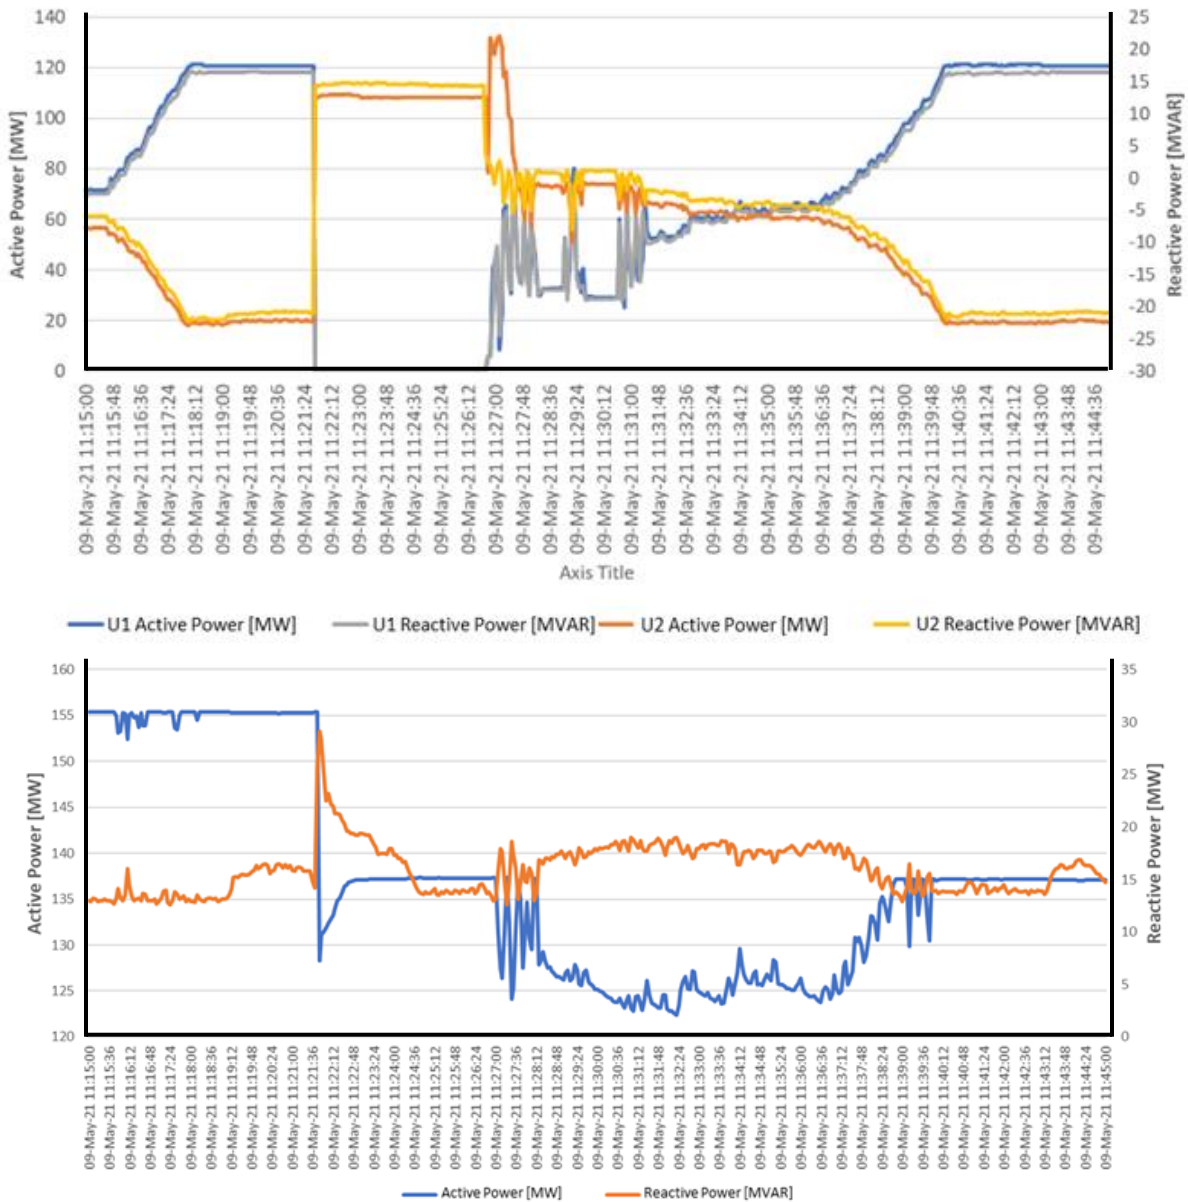
For example, in this event, frequency reached 60.028 Hz momentarily, which is 0.011 Hz outside the upper deadband threshold. On a 5% droop characteristic based on nameplate rating, this equates to a reduction in plant output by only 0.37% (i.e., 0.37 MW for a 100 MW facility). However, as illustrated in [Figure 1.7](#), facilities began reducing power output significantly for these minor frequency deviations. The plot on the left shows a plant with interactions between the ramping controls and the PFR controls; the plot on the right shows a plant where the PFR controls are reducing power abnormally. Such large swings in active power output from inverter-based resources will actually degrade the ability of the BA (i.e., ERCOT) to control frequency in a smooth and stable manner.

Figure 1.7: Examples of Poorly Coordinated Primary Frequency Response Controls

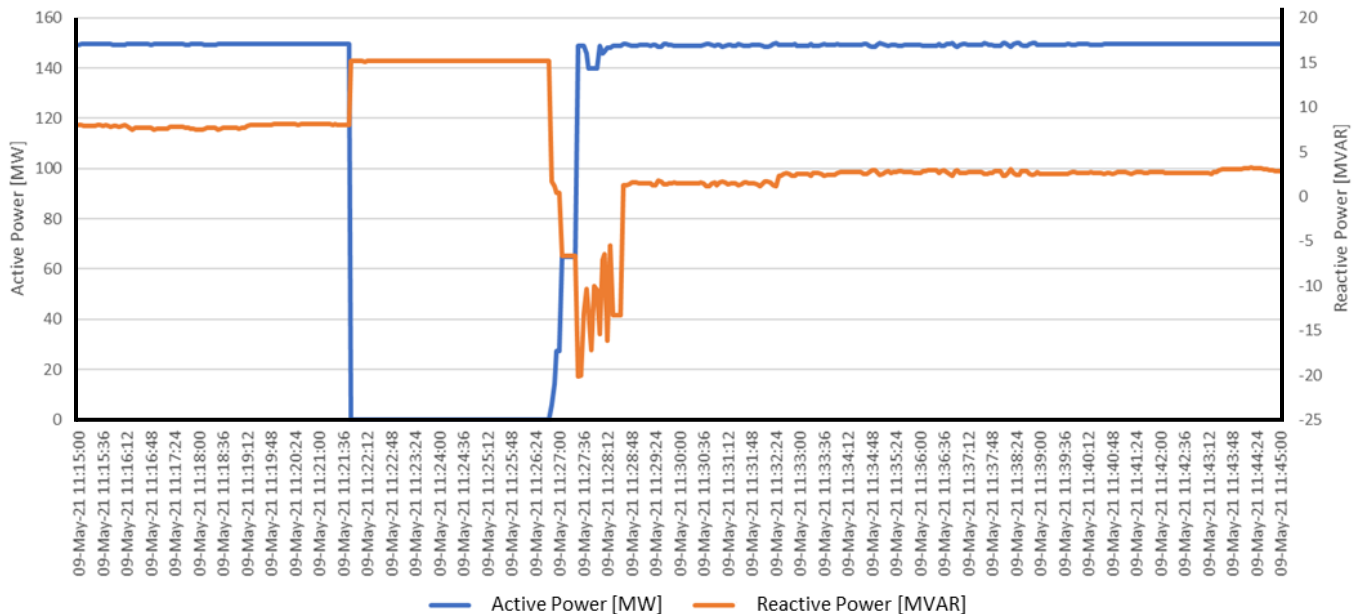
During the analysis of multiple facilities for this event, the review team noticed abnormal reactive power response upon inverter tripping. [Figure 1.8](#) provides an example of the performance at a plant that tripped on PLL loss of synchronism. Before the disturbance, the plant is on automatic voltage control and injecting around 9 MVAR to the system at the POI. At the time of the fault, all inverters at the facility trip off-line, plant reactive power injection increases to 16 MVAR, and the POI voltage rises slightly due to this increase in reactive power production from the facility. Immediately upon inverter re-start, the plant pulls its reactive power injection down to about 4 MVAR after a ramping period where it appears that voltage control may be disabled.

Figure 1.8: Example of Reactive Power Injection during Inverter Gate Blocking

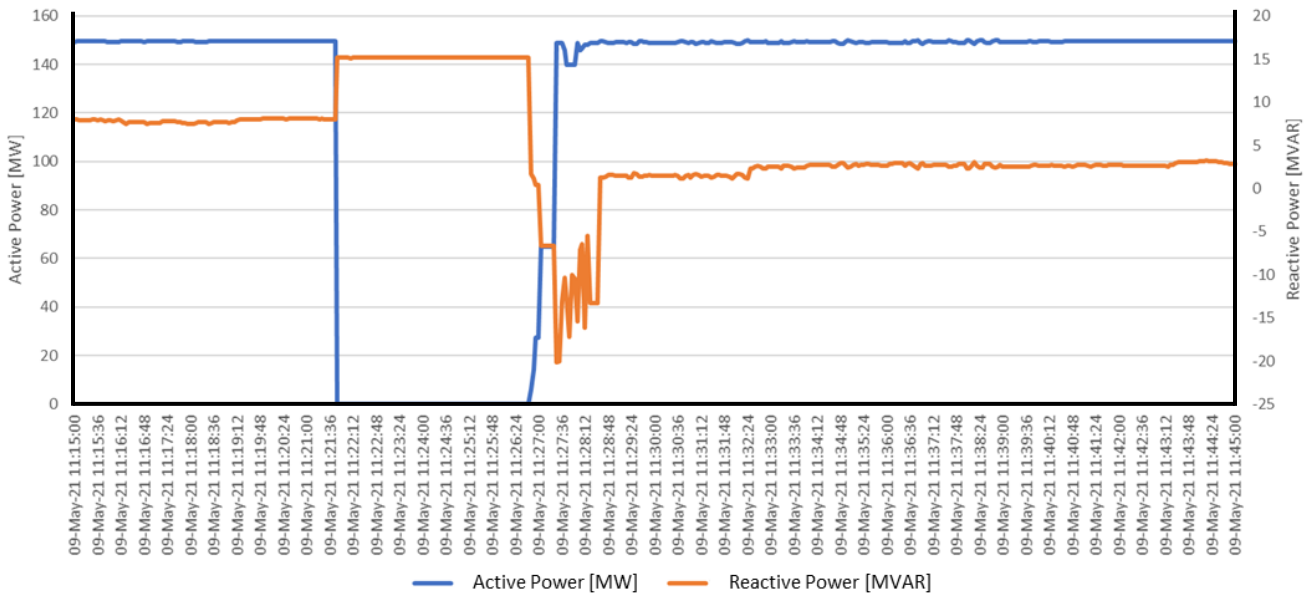
NERC identified anomalous behavior in reactive power output when the inverters shut down due to loss of synchronism. Reactive power increases during this time to about 15.5 MVAR while the inverters were in an “idle” mode. NERC raised this issue with the inverter manufacturer, and they stated that the inverters will “gate block” the power electronics (same mechanism as momentary cessation) and power output will go to zero. However, the inverter ac circuit breaker did not operate and the inverter output capacitors remained connected to the system. This results in an unexpected injection of reactive power while the inverters sat idle connected to the system but blocked from supporting the grid. Upon recovery of active power after the auto-restart, the resource experiences abnormal reactive power injection during inverter restoration before reaching a new steady-state condition.

Figure B.2: Plant Active and Reactive Power Output

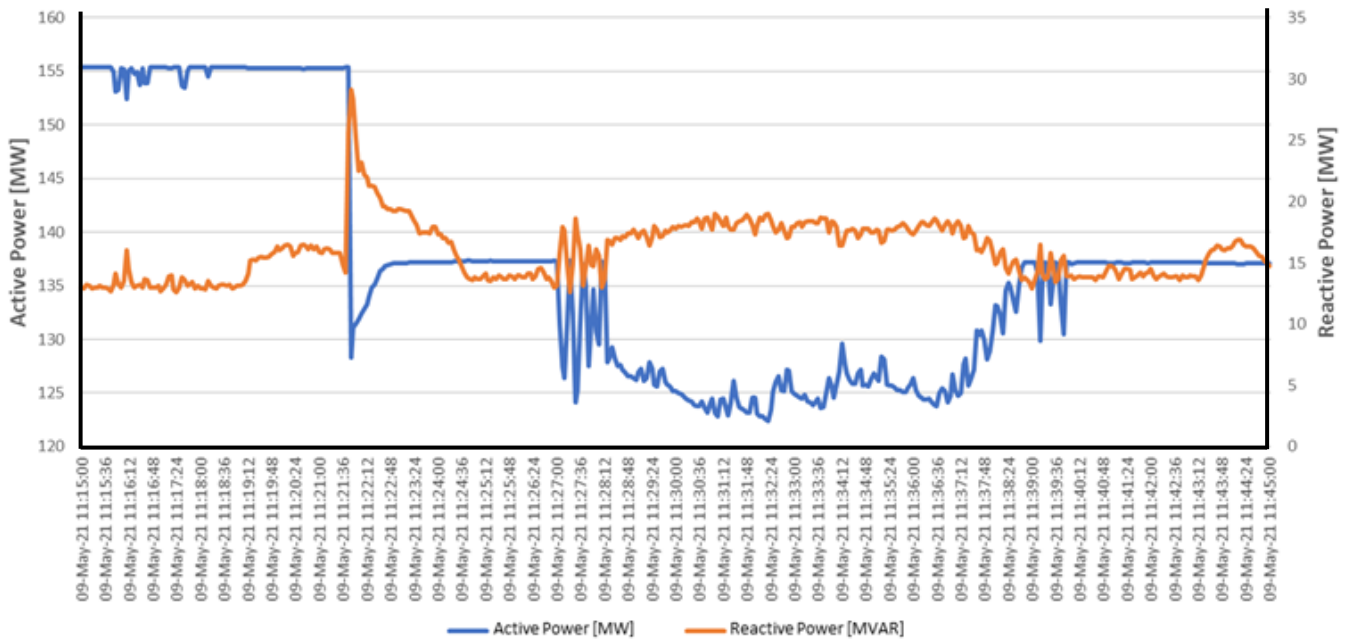
Plant E is a 162 MW facility connected to the 138 kV network that went into commercial operation in May 2021. During the event, the overall plant reduced output by about 21 MW (see [Figure B.6](#)). A total of 25 inverters disconnected when a medium voltage feeder breaker tripped on measured underfrequency conditions. Frequency protective relaying was set to trip at 57.5 Hz instantaneously, and settings were programmed to match the PRC-024-3 curves exactly (see [Figure B.7](#)). The inverters were off-line for five days for root cause analysis.

Figure B.6: Plant Active and Reactive Power Output

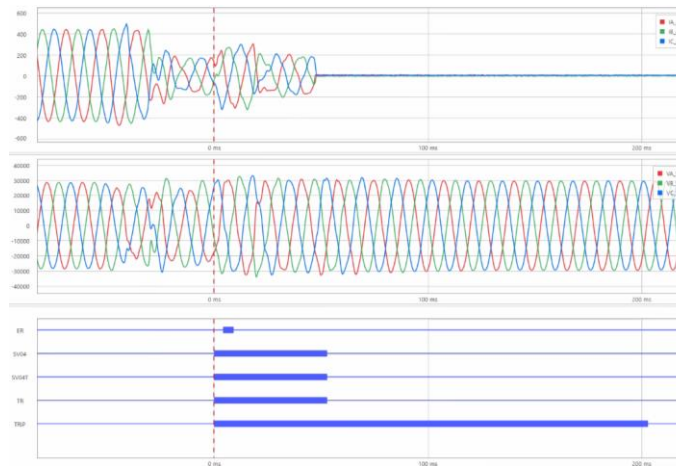
- Erroneous Relay Tripping on Measured Underfrequency:** Inverters in the Blue Cut Fire erroneously tripped on measured underfrequency, and this issue was corrected fleet-wide by the equipment manufacturer. Until this event, no inverter-based resources had tripped on underfrequency protection captured by a protective relay, so this event was anomalous in that this was unexpected since frequency only fell to 59.8 Hz (nowhere near the 57.5 Hz protection setting). However, frequency was measured by the protective relay at 56.9 Hz and caused a trip. **Figure B.9** shows the waveforms captured by the relay for this event. The relay manufacturer indicated that the relay performs the frequency measurement over a 3 cycle window. Analyzing the waveforms during the disturbance from the relay, it was determined that the relay measured the frequency correctly over the 3 cycle window. However, the manufacturer recommends a minimum time delay for frequency tripping to be 5 cycles. The relay was set for zero delay. This reinforces previous disturbance reports recommendations to not use an instantaneous trip setting for frequency protection.

Figure B.9: Raw Unfiltered Waveforms at Feeder that Tripped

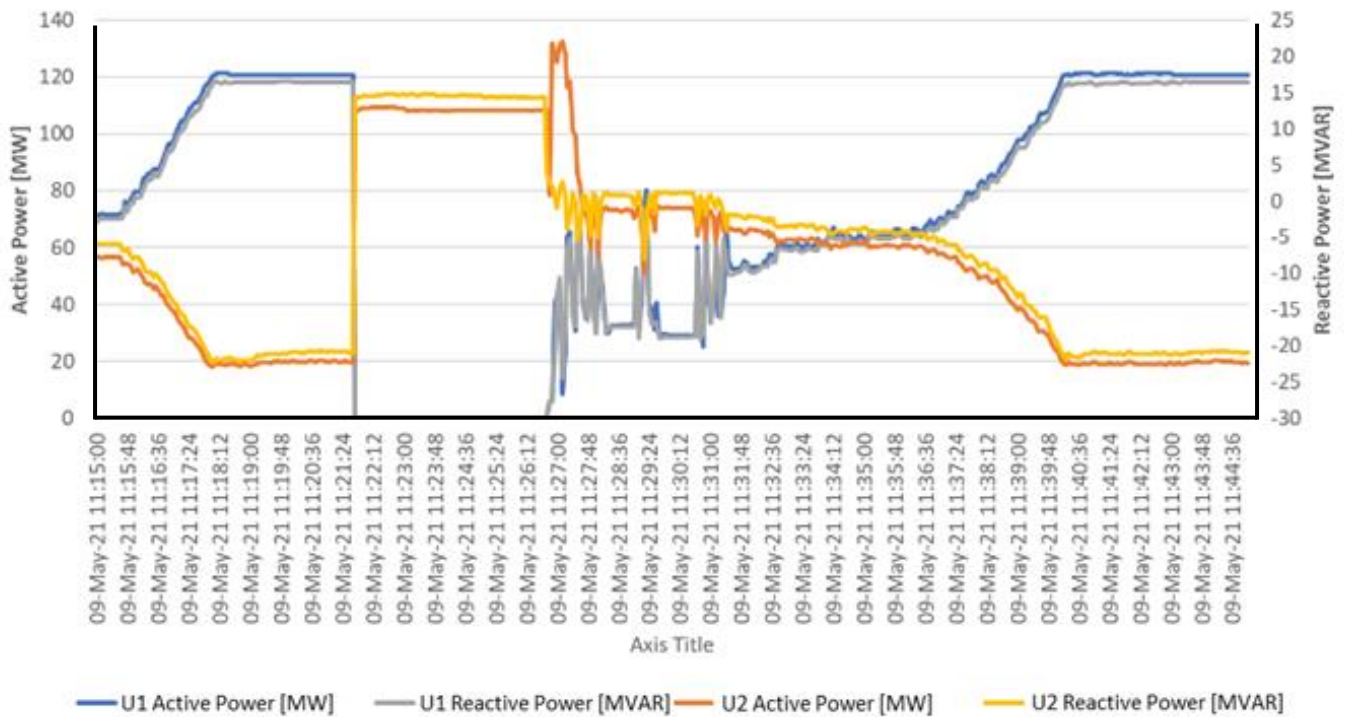
Lastly, the plant appears to have exhibited abnormal oscillatory behavior during inverter reconnection and ramping upon returning to service after the fault. This was identified as an interaction between the ramping and the primary frequency response logic in the plant-level controller. The ramping logic did not register the zero-output of the inverters and expected them to stay at 240 MW. The inverters therefore followed their internal ramping limit. The large difference between the PFR logic reference and the ramping reference set points created a logic loop that caused an over-response to the frequency deviation. When the frequency returned within the dead band, the ramping logic set point was still above the plant output allowing the inverters to ramp per their internal ramp rate, trigger the cycle again. This continued until the ramping set point and PFR set points were within a range that allow the logic loop to collapse and the inverters to follow the ramping logic.

Figure B.11: Plant Active and Reactive Power Output

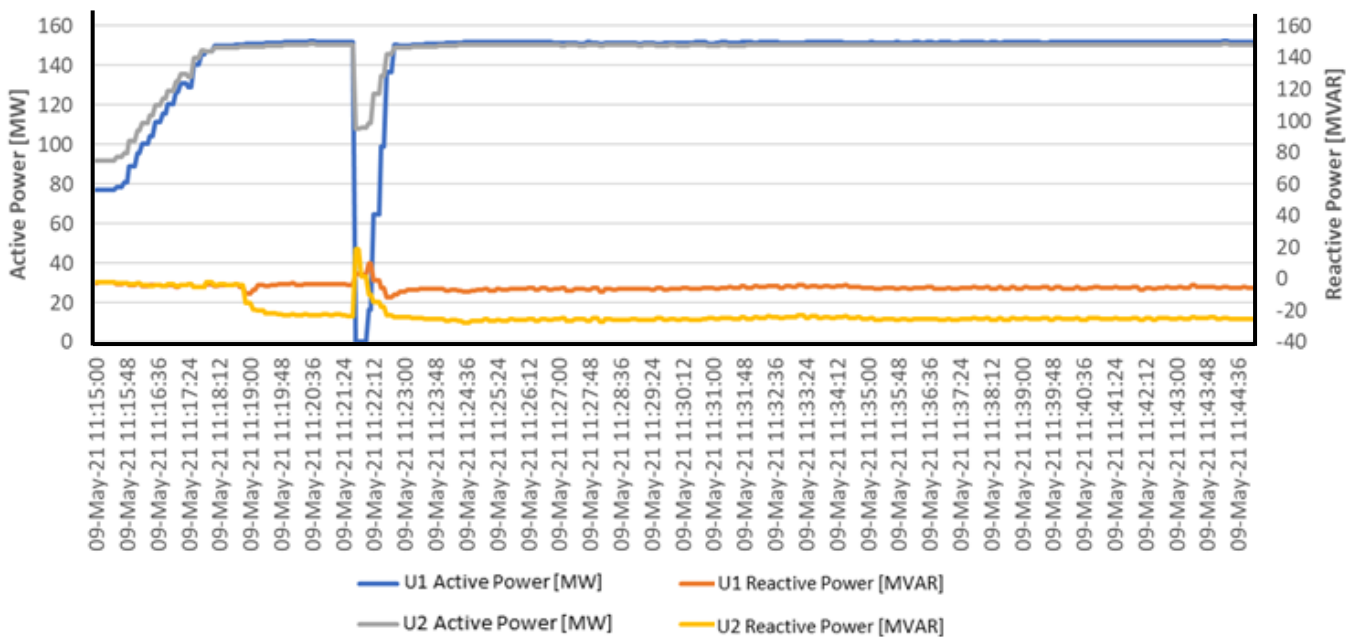
Figure B.12: Plant Active and Reactive Power Output

A coordination analysis between the reactive current injection controls at the inverters and the overvoltage protection settings needs to be conducted by this facility to ensure it remains connected to the BPS for POI voltages within the PRC-024-2 curves. This facility did not meet the performance requirements laid out in PRC-024-2 and may have equipment limitations that may hinder its ability to do so.

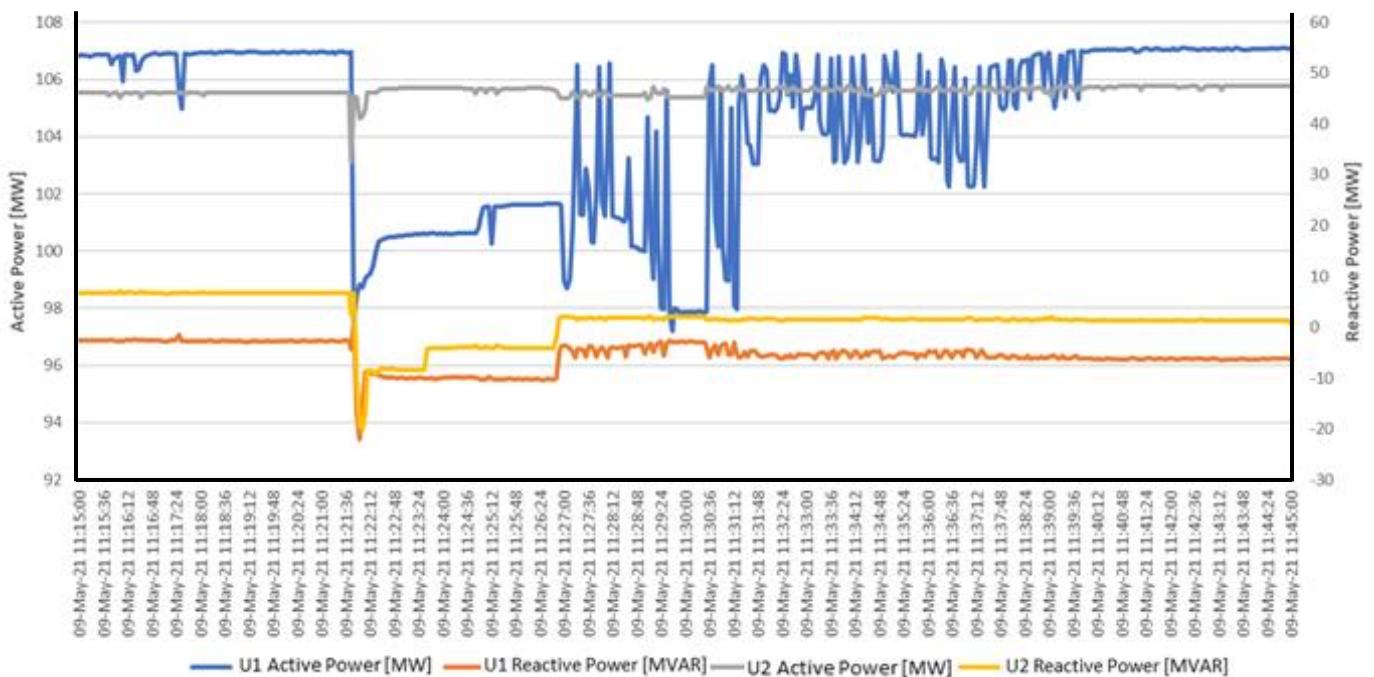
Figure B.16: Plant Active and Reactive Power Output

The occurrence of this level of oscillatory behavior warrants immediate detailed analysis by ERCOT and the affected facilities. This should include a detailed EMT study of this facility, the local interconnecting transmission system, and all neighboring facilities (as deemed necessary by ERCOT).

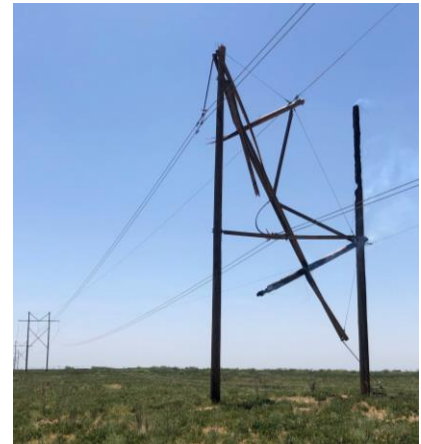
At approximately 11:14:27 on June 26, 2021, an A-phase-to-ground fault occurred on a 345 kV circuit about 40 miles north of Odessa, Texas. The H-frame structure experienced a failure (see [Figure C.1](#)). Line differential protection cleared the fault normally in about three cycles. This fault caused several solar PV resources to have reduced active power output for a loss of approximately 518 MW. Frequency dropped to 59.927 Hz and began to recover. About one second later, one end of the faulted line attempted a reclose and experienced an A-C-ground fault and cleared in about 3.5 to 4 cycles. Then about 30 seconds later, the other end of the line attempted a reclose and experienced a three-phase-to-ground fault that cleared in 4.5 cycles. This fault resulted in the loss of around 179 MW of solar PV resources. Frequency then dropped to 59.935 Hz and recovered to 60 Hz within 1 minute and 15 seconds. [Figure C.2](#) shows the ERCOT solar PV output during the faults and [Figure C.3](#) shows system frequency. [Table C.1](#) shows the predisturbance operating conditions at the time the events occurred.

Figure C.1: Failed H-Frame

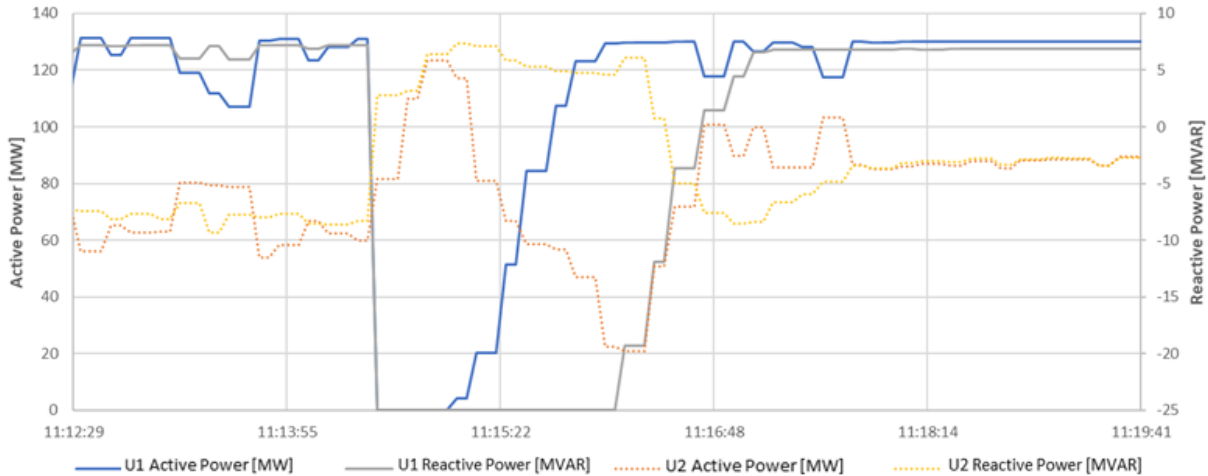
In the June 26 event, this facility tripped on inverter-level ac overcurrent and ac undervoltage protection. The combined facility (Plants I and J) output decreased by 260 MW (see [Figure C.4](#)). [Figure C.5](#) shows high-resolution point-on-wave oscillography data at the POI during the fault event. POI voltage is within the PRC-024-3 voltage boundaries.

Figure C.4: Plant I and Plant J Active and Reactive Power Output

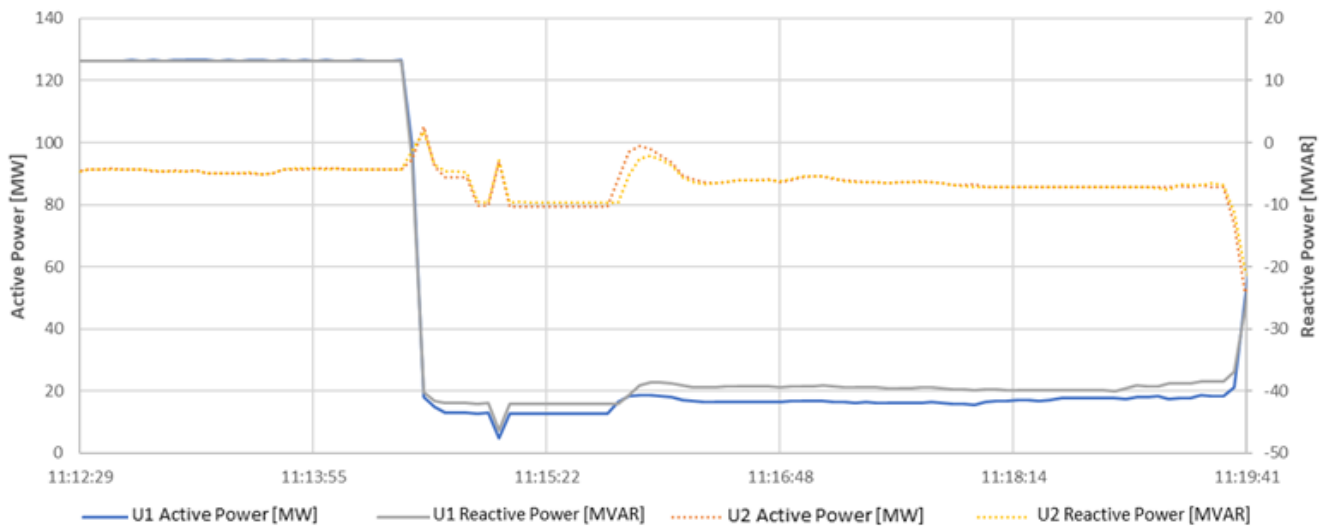
In the June 26 event, this facility was in the commissioning process. The facility tripped on an unknown fault code of “no modules.” No further information was available from the plant or inverter manufacturer. The combined facility (New Plant 1 and New Plant 2) output decreased by 223 MW (see [Figure C.6](#)).

Figure C.6: New Plant 1 and New Plant 2 Active and Reactive Power Output

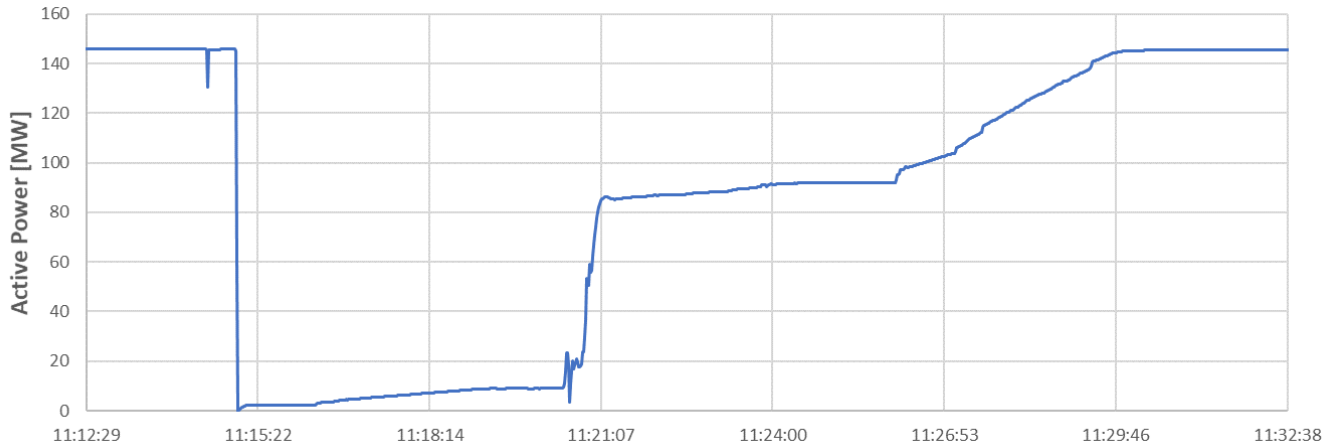
In the June 26 event, this facility tripped on inverter-level instantaneous ac overvoltage protection. [Figure C.7](#) shows the trip and reconnection that occurred five minutes later. For the May 9 event, the facility tripped on ac overvoltage protection that operated the feeder breakers rather than the individual inverters.

Figure C.7: Plant Active Power Output
