NORTH AMERICAN ELECTRIC RELIABILITY COUNCIL

NERC Response

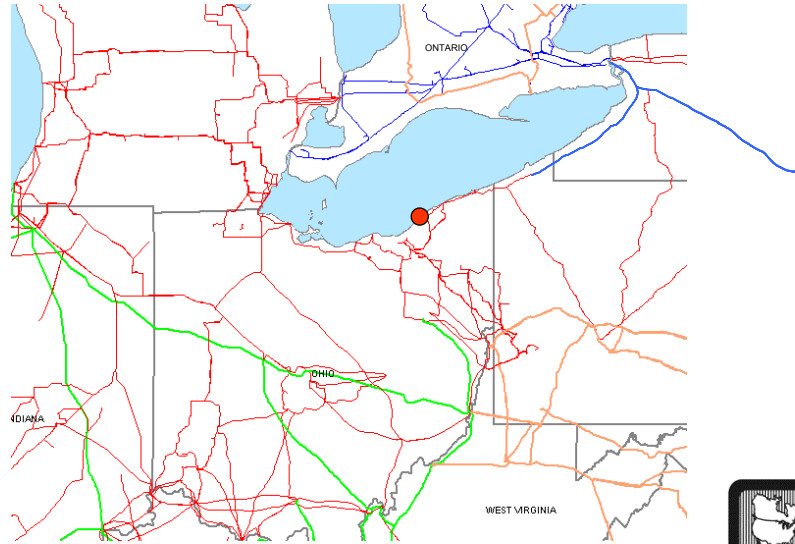
East Lake 5 Trip: 1:31:34 PM

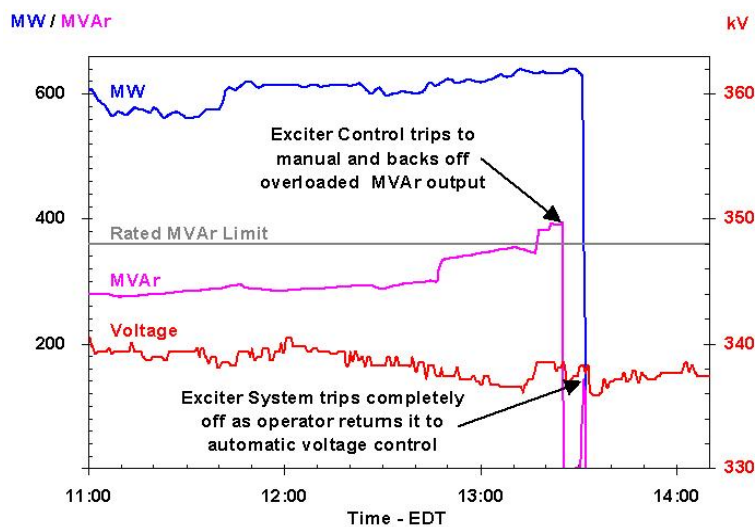
East Lake 5 Exciter Failure Causes Trip

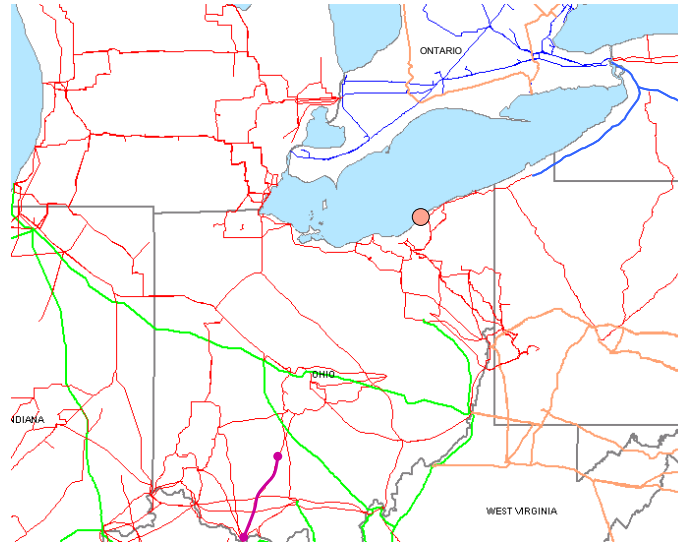
Stuart Atlanta Trip: 2:02 PM

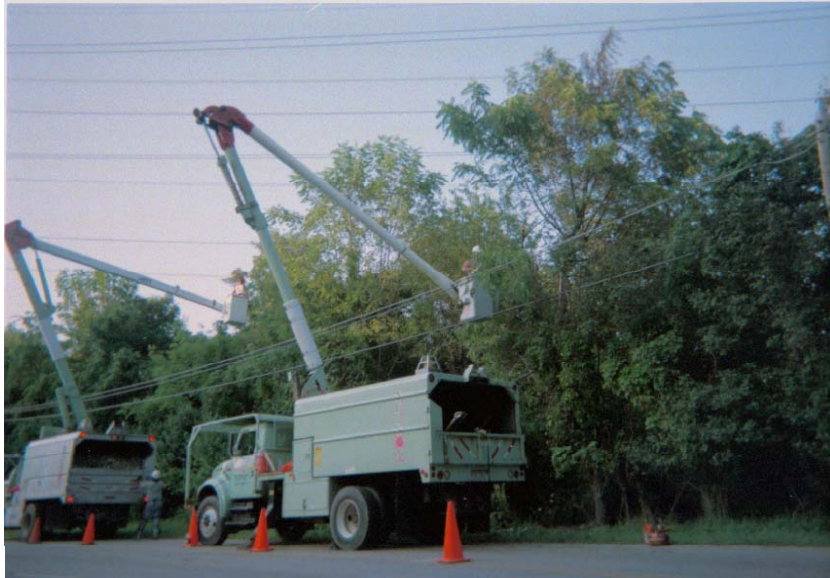
Hanna - Juniper Tree Contact Insufficient Clearance with Trees

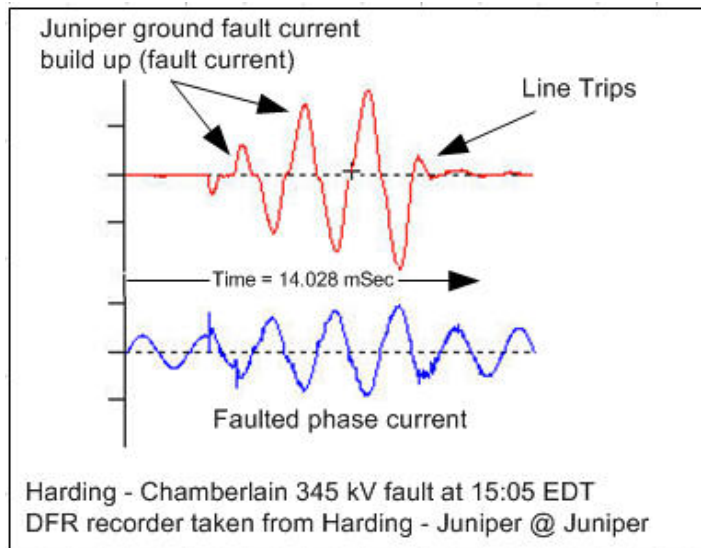
Chamberlin-Harding Indication of Ground Fault Due to Tree Contact as Measured by DFR at Juniper

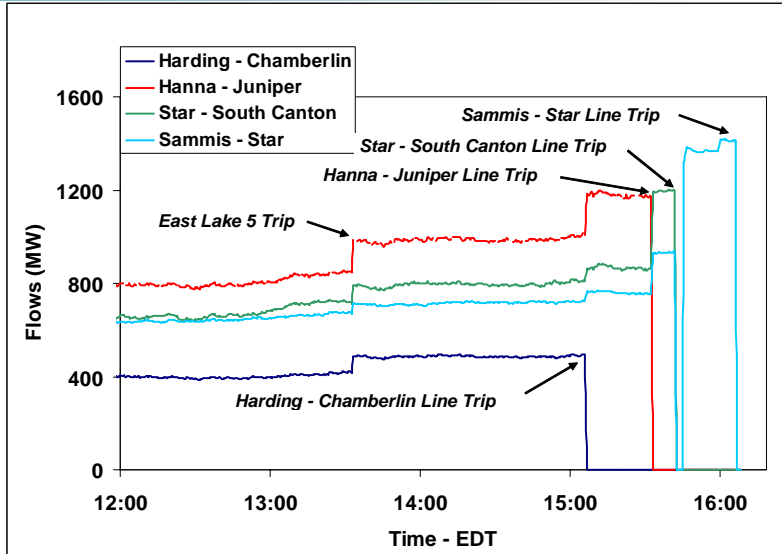
Actual Loading on Critical Lines

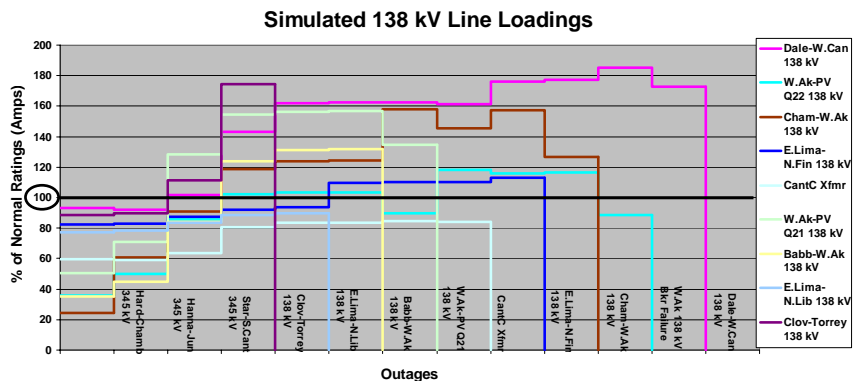
138 kV Lines Overload and Cascade Near Akron

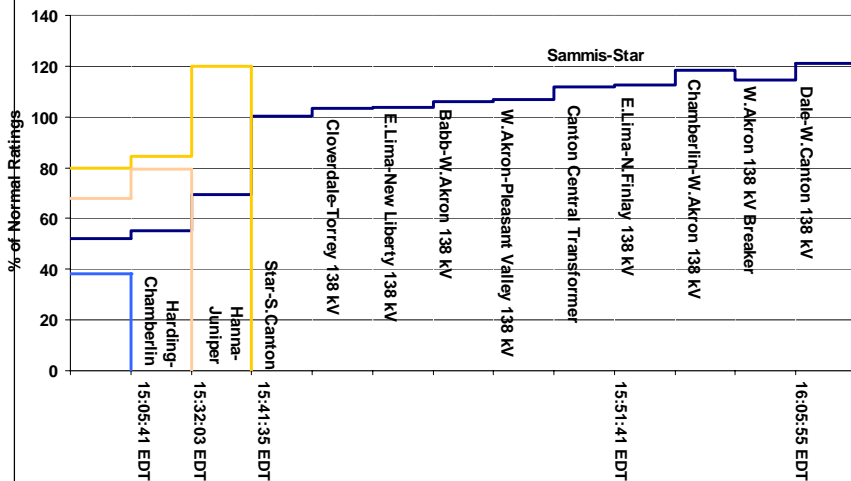
138 kV Cascade Contributes Further to Overload of Sammis-Star

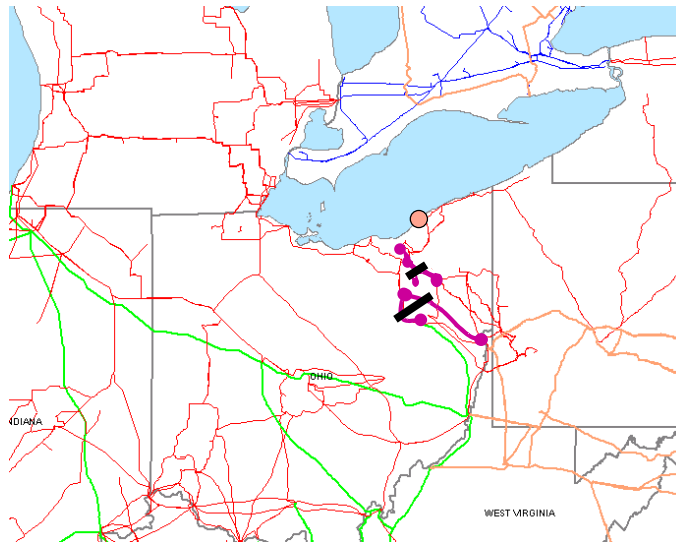
Last Major Path to Cleveland Blocked after Loss of Sammis-Star 4:05:57.5 PM

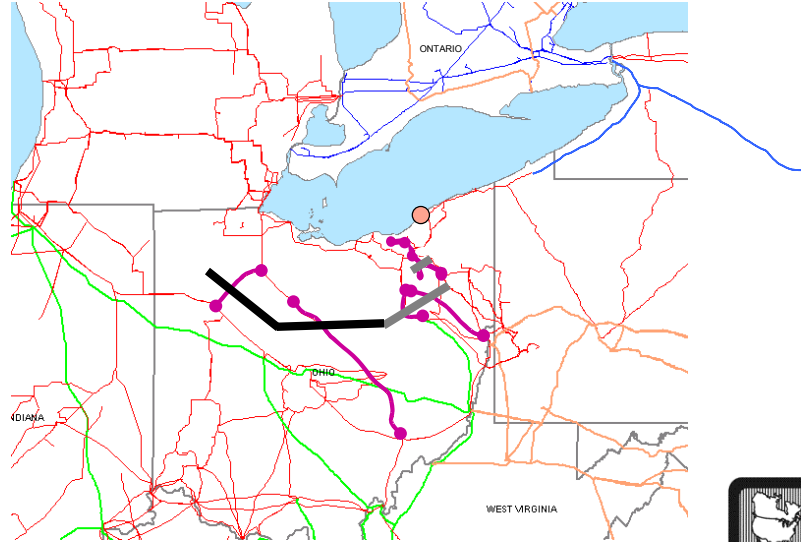
345 kV Lines Trip Across Ohio to West 4:08:59 - 4:09:07 PM

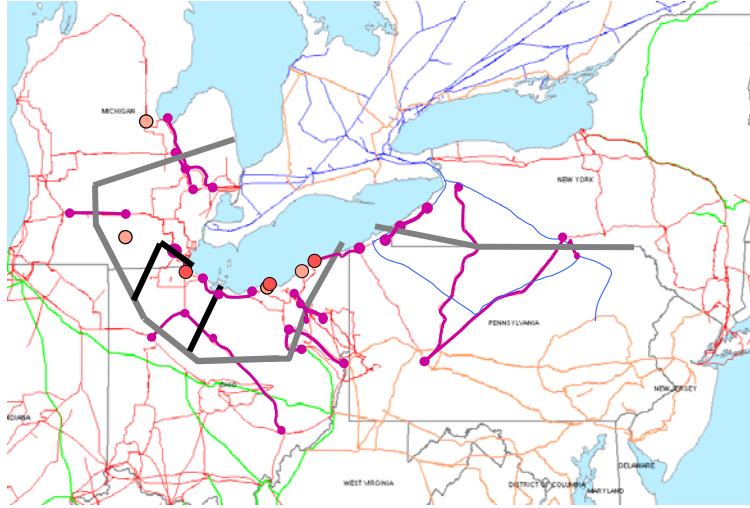
Cleveland – Toledo Island 4:10:39 - 4:10:46 PM Cleveland Blacks Out

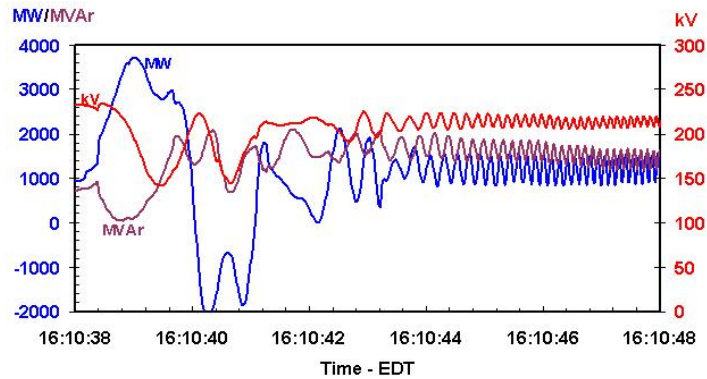
Eastern Eastern Michigan (Detroit) Unstable Voltage and Frequency Collapse and Pole Slipping

Ontario – Michigan Interface Flow and Voltages Beginning 16:10:38
