Odessa Disturbance

Texas Events: May 9, 2021 and June 26, 2021
Joint NERC and Texas RE Staff Report

September 2021

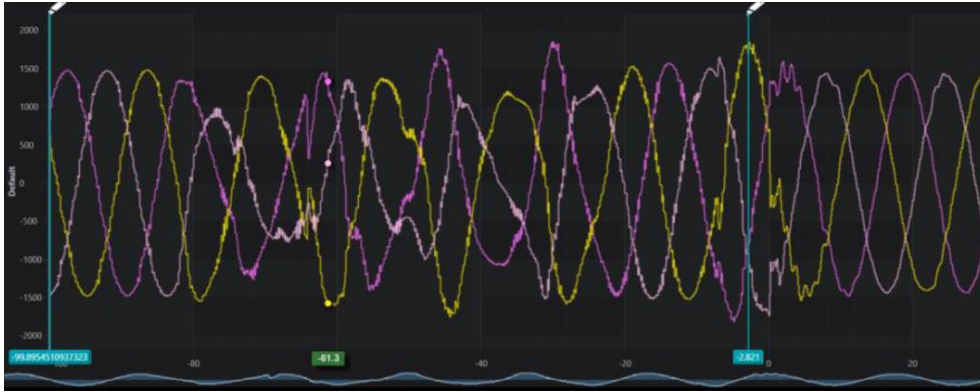
Figure 1.5: Inverter Oscillography of Transient AC Overvoltage Tripping

used to meet PRC-024-3 requirements. This hard-coded voltage trip threshold is based on instantaneous peak measurements, not RMS measurements of voltage. Therefore, these settings cannot be modified for any existing facilities and likely will continue to invoke tripping for normal grid fault events unless plants are tuned accordingly to appropriately ride through these types of events.

Note that PRC-024-2 was modified and updated to PRC-024-3, and one of the main clarifications added to this standard was that the “voltages in the boundaries assume RMS fundamental frequency phase-to-ground or phase-to-phase per unit voltage.”²³ However, inverters are being installed on the system with trip setting that use instantaneous rather than RMS fundamental frequency measurements and will likely continue to result in plants tripping on ac overvoltage conditions. The modifications made to PRC-024-3 will not address this growing and persistent issue with solar PV resources, particularly from this one manufacturer.

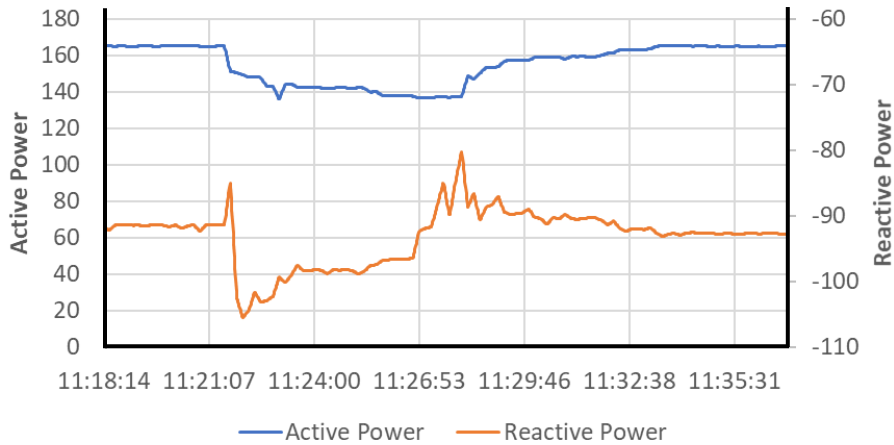
Figure B.1: Plant Active and Reactive Power Output

The plant had a PMU located at the interconnection point and measured POI voltage of around 0.63 pu followed by a slight voltage overshoot upon fault clearing—well within the PRC-024-2 curve. The plant was operating near maximum active power output and also consuming a significant amount of reactive power prior to the fault event.

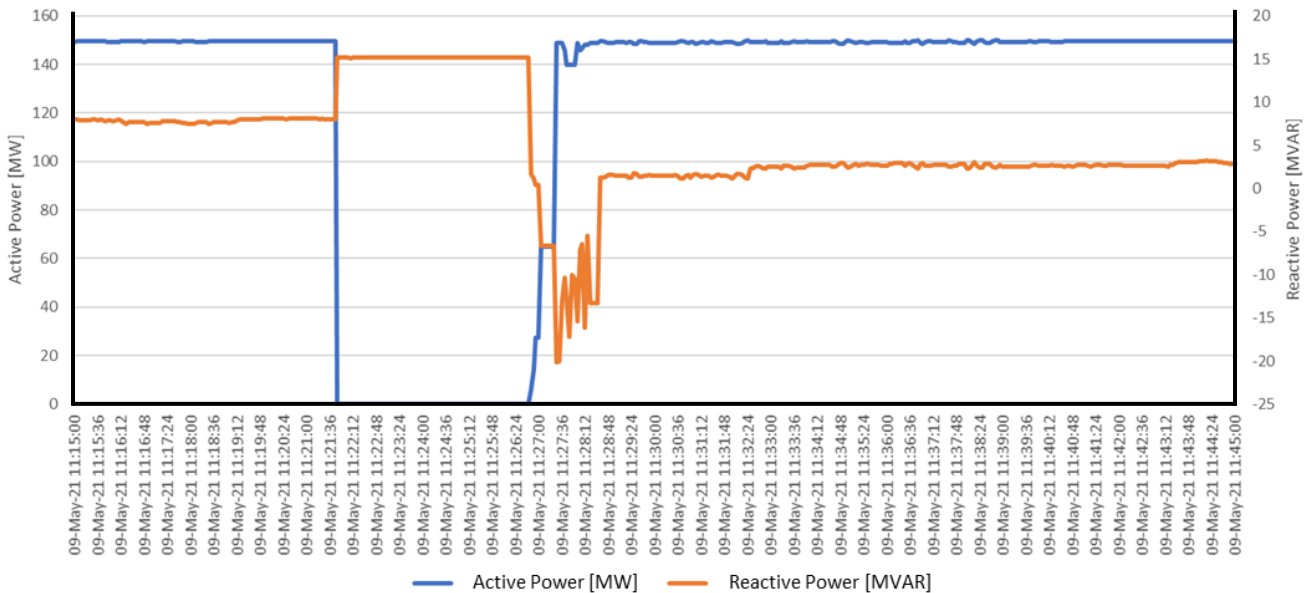
Figure B.2: Plant Active and Reactive Power Output

NERC identified anomalous behavior in reactive power output when the inverters shut down due to loss of synchronism. Reactive power increases during this time to about 15.5 MVAR while the inverters were in an “idle” mode. NERC raised this issue with the inverter manufacturer, and they stated that the inverters will “gate block” the power electronics (same mechanism as momentary cessation) and power output will go to zero. However, the inverter ac circuit breaker did not operate and the inverter output capacitors remained connected to the system. This results in an unexpected injection of reactive power while the inverters sat idle connected to the system but blocked from supporting the grid. Upon recovery of active power after the auto-restart, the resource experiences abnormal reactive power injection during inverter restoration before reaching a new steady-state condition.

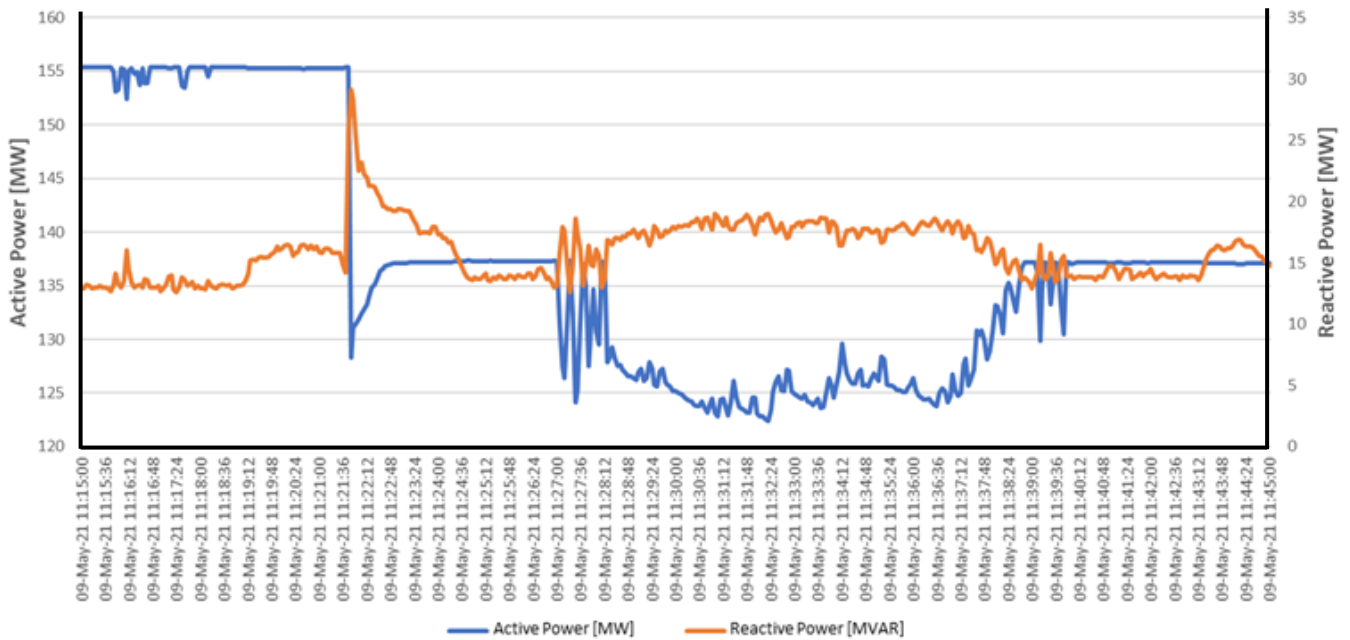
Figure B.6: Plant Active and Reactive Power Output

Plant E is a 162 MW facility connected to the 138 kV network that went into commercial operation in May 2021. During the event, the overall plant reduced output by about 21 MW (see [Figure B.6](#)). A total of 25 inverters disconnected when a medium voltage feeder breaker tripped on measured underfrequency conditions. Frequency protective relaying was set to trip at 57.5 Hz instantaneously, and settings were programmed to match the PRC-024-3 curves exactly (see [Figure B.7](#)). The inverters were off-line for five days for root cause analysis.
