NORTH AMERICAN ELECTRIC RELIABILITY COUNCIL

2002 System Disturbances

Review of Selected Electric System Disturbances in North America

August 2004

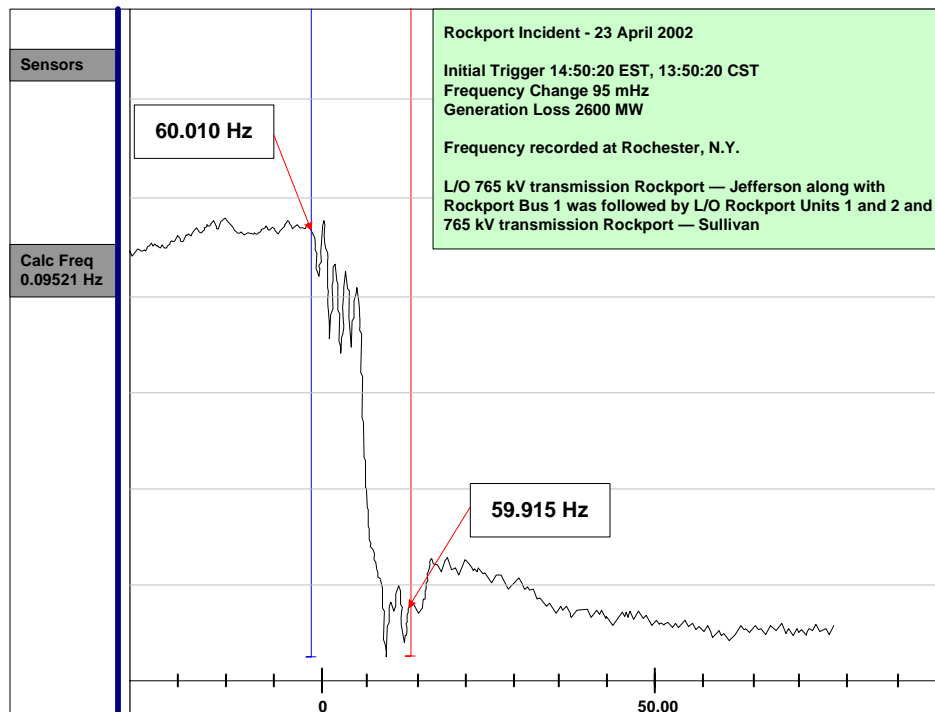
Figure 2 – Rockport Frequency Plot

The un-damped oscillations (see Figure 2) experienced by the Rockport units following the three-phase opening of the Rockport-Jefferson line were unexpected. Therefore, AEP conducted an investigation to identify potential cause(s) for these growing oscillations. Any malfunction or abnormal operation of the excitation equipment was ruled out as a cause since there were no alarms associated with the excitation system, and all the voltage regulators remained in automatic voltage control mode through the incident.

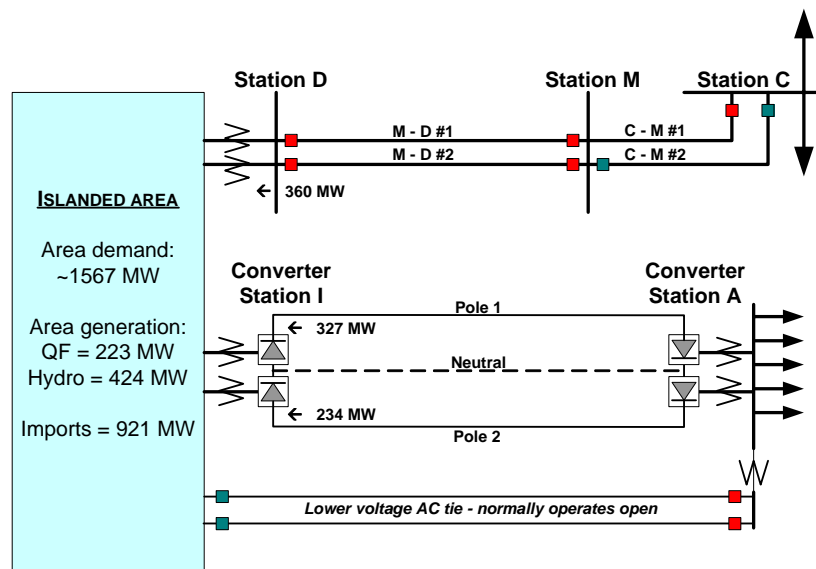
Figure 2 - Transmission connections to the islanded area

On December 26, 2002, at 12:02 PST, system protection removed from service the Station C-Station M #1 high-voltage transmission line due to conductors contacting a tree. The lack of clearance was caused by an extreme increase of conductor sag between towers due to an unequal build up of ice on the conductors in adjacent spans.
