Lesson Learned

Loss of Wind Turbines due to Transient Voltage Disturbances on the Bulk Transmission System

NERC – Lessons Learned (via email)	David Penney (via email) or (512) 583-4958
Source of Lesson Learned:	Texas Reliability Entity
Lesson Learned #:	20170701
Date Published:	July 11, 2017
Category:	Generation Facilities

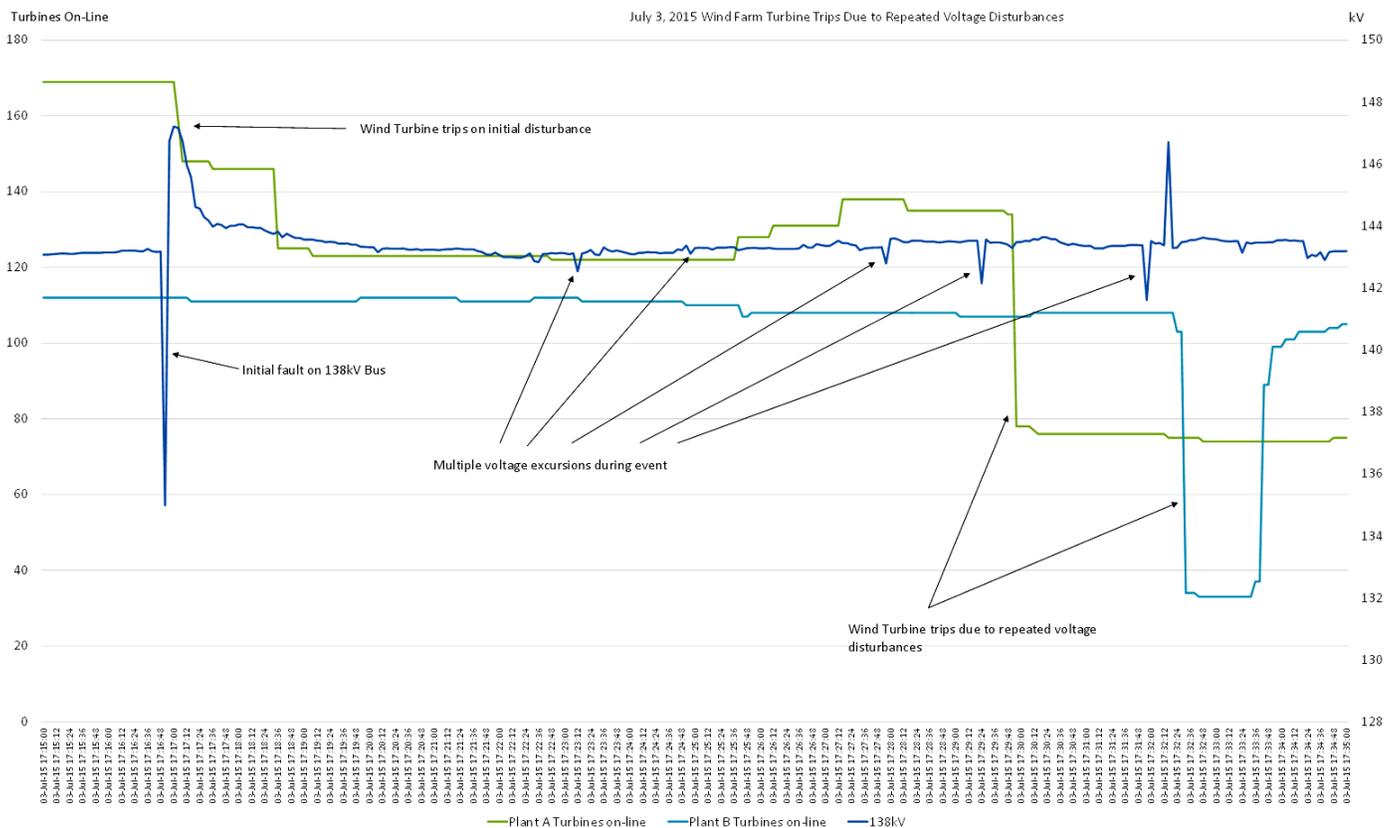
- During Event 1, wind plant owners noted that 130 turbines tripped due to the repeated voltage fluctuations during a particular event. The magnitude of the individual voltage disturbances were within the “no trip zone” of regional low-voltage ride-through requirements; however, the turbines tripped due to voltage ride-through parameters that were set to disconnect or reduce turbine output when a specified number of voltage excursions were detected within a given time frame (note that Figure 3 on the next page comes from four-second data sampling, so the actual magnitude of fluctuations may be greater than indicated). The rationale for this setting was to prevent damage to the turbine when there was insufficient recovery time between the voltage excursions. This is similar to the experiences reported by AEMO during the September 28, 2016, South Australia event.
