1996 System Disturbances

Review of Selected 1996 Electric System Disturbances in North America

North American Electric Reliability Council
Princeton Forrestal Village
116-390 Village Boulevard
Princeton, New Jersey 08540-5731

August 2002

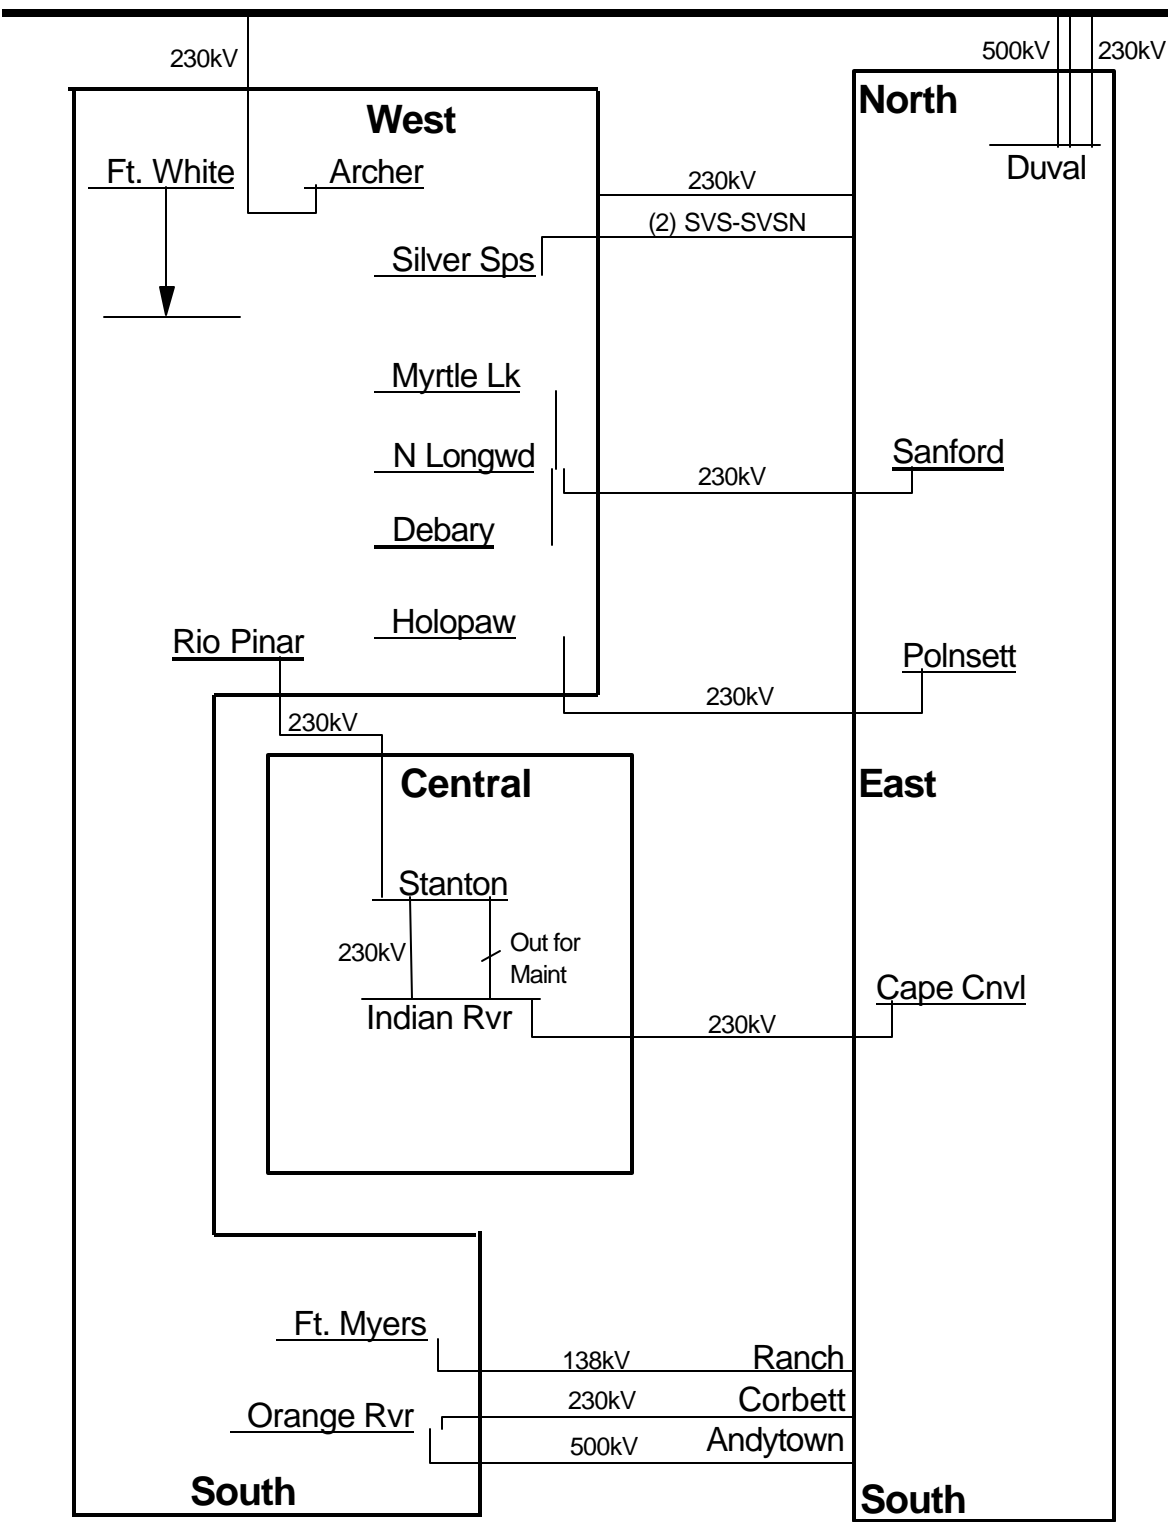
Figure 1 — Schematic Diagram for Peninsula Florida Disturbance

Following the Silver Springs bus split, the 230 kV Poinsett – Holopaw line immediately loaded to about 150% of its rated value, faulted, and system protection removed it from service. The loss of the Poinsett – Holopaw line caused the Sanford – North Longwood line to load to about 120% of its rated value. Some economy sales negatively impacting the flow on this line were cut in an attempt to lower the loading on the line. This action had a positive impact as the flows began to decrease, but was not sufficient to prevent the line from faulting. As a result of the other previous events and the Sanford – North Longwood line opening, an additional series of line overloads occurred and these lines were removed from service.

The series of events described above left west Florida and portions of central Florida as an island with about 12,588 MW of demand and 9,932 MW of generation. The Debary Plant (507 MW), which was included in the island, was removed from service due to low voltage and nine cogenerators were removed from service due to under frequency. The loss of this generation further reduced the island's generation to 9,148 MW. This generation deficiency reduced the island's frequency to about 58.65 Hz, and under frequency relays within the island operated decrease demand. A total of 3,440 MW was shed, about 27% of the total demand in the island.

Appropriate actions should be initiated to ensure that the issues related to the under frequency program are addressed including an evaluation of the islanded area's frequency decay and recovery curve shape.

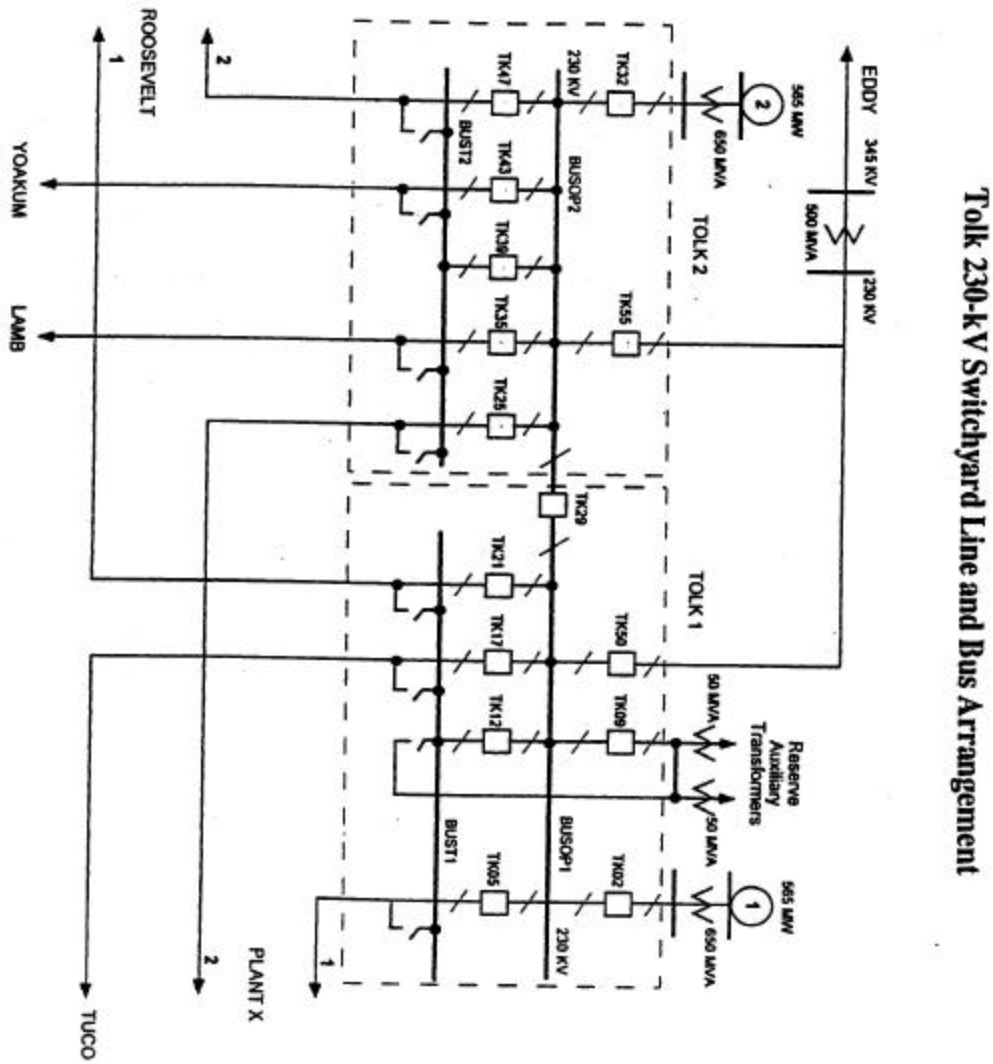
Figure 1

During the washing of 230 kV breaker TK47 at Tolk, on the Roosevelt County No.2 line, the mist from the washing operation caused an adjacent bushing to arc to ground resulting in a differential relay trip of the 230 kV No.2 bus. Circuit breakers TK25, TK29, TK32, TK35, TK47, TK55 opened to clear a single "C" phase-to-

ground fault on TK47 (See Figure 1, Tolk oneline). These breaker openings removed from service the Tolk unit No.2 at 10:20:32 EDT leaving the control area 537 MW deficient. The fault was cleared in 5 cycles.

- a.) Removing the existing 230 kV bus tie breaker TK29. This action would eliminate the single point of failure that would operate both Tolk unit No.1 and Tolk unit No.2 bus differentials. The 230 kV bus tie connection would be maintained through TK50 and TK55. This change was completed early in 1997.
- b.) Converting the Tolk Buses to a breaker and a half scheme would eliminate any common point of failure and minimize exposure to differential relay operations.
- c.) Establish a 345 kV bus at Tolk Station and move unit No.2 to this bus to provide additional isolation as well as a spare unit transformer for both Tolk units.

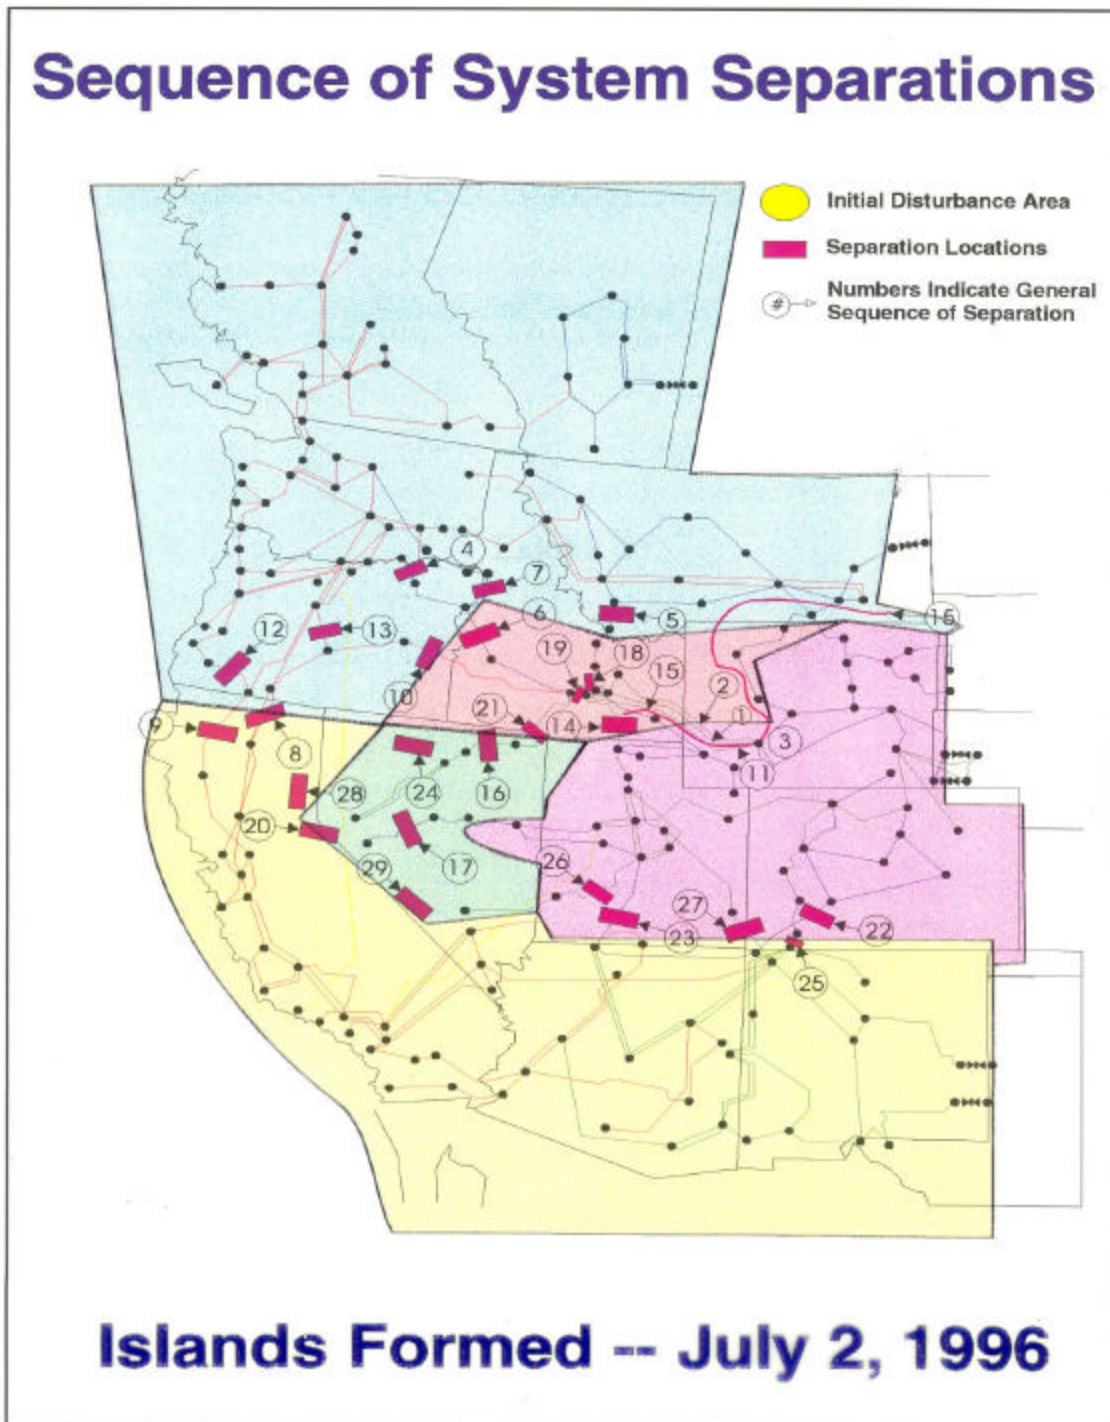
Figure 1

The first significant event was a single phase-to-ground fault at 1424:37.18 MDT on the 345 kV Jim Bridger – Kinport line (Figures 1 & 2). The fault occurred 97 miles east of Kinport and was caused by a flashover (arc) when the conductor sagged close to a tree. System protection removed the line from service clearing the fault in three cycles.

System protection opened the 345 kV Jim Bridger – Goshen line twenty milliseconds (ms) later due to misoperation of the ground element in a relay at Bridger. The relay was later removed from service. The component that failed was a local delay timer in the ground element. Redundant primary protective devices are in service to provide adequate protection.

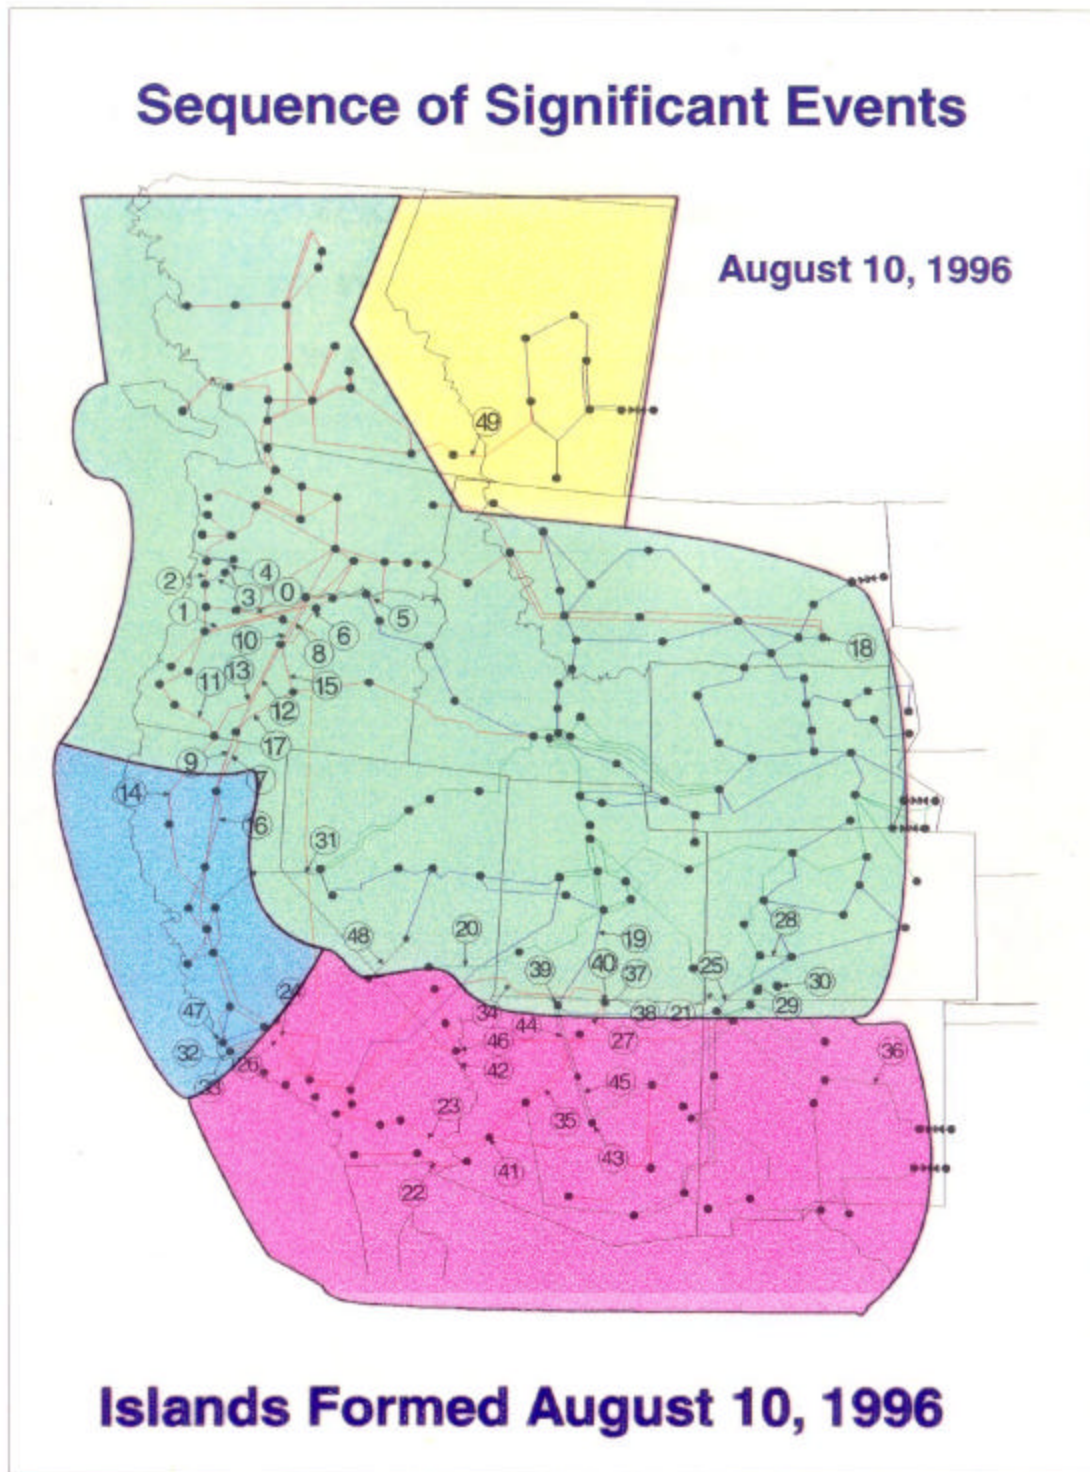
Figure 1

A major disturbance occurred in the Western Interconnection (Western Systems Coordinating Council, WSCC) at 1548 PDT, August 10, 1996 resulting in the Interconnection separating into four electrical islands (Figure 1). Conditions prior to the disturbance were marked by high summer temperatures (near or above 100 degrees Fahrenheit) in most of the Region, by heavy exports (well within known limits) from the Pacific Northwest into California and from Canada into the Pacific Northwest, and by the loss of several 500 kV lines in Oregon.

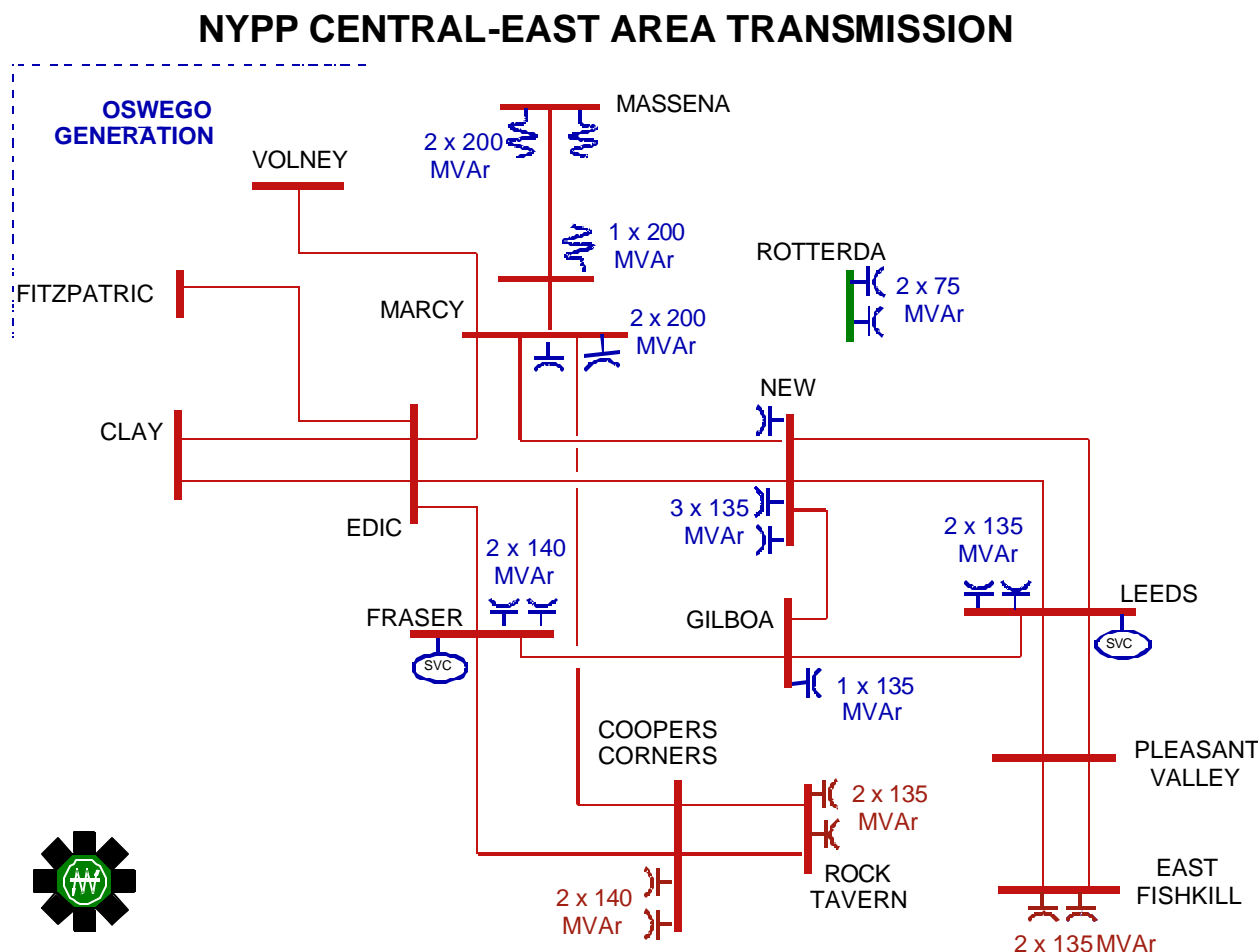
Figure 1

System protection removed the 345 kV Gilboa – Leeds line from service at 14:39 EDT. Although this contingency did not immediately result in the overload of any bulk electric system facilities, the process of returning the system to a secure state following its removal from service ultimately resulted in an order to shed firm demand in Eastern New York State. A one-line diagram of the eastern New York bulk electric system is shown as Figure 1.

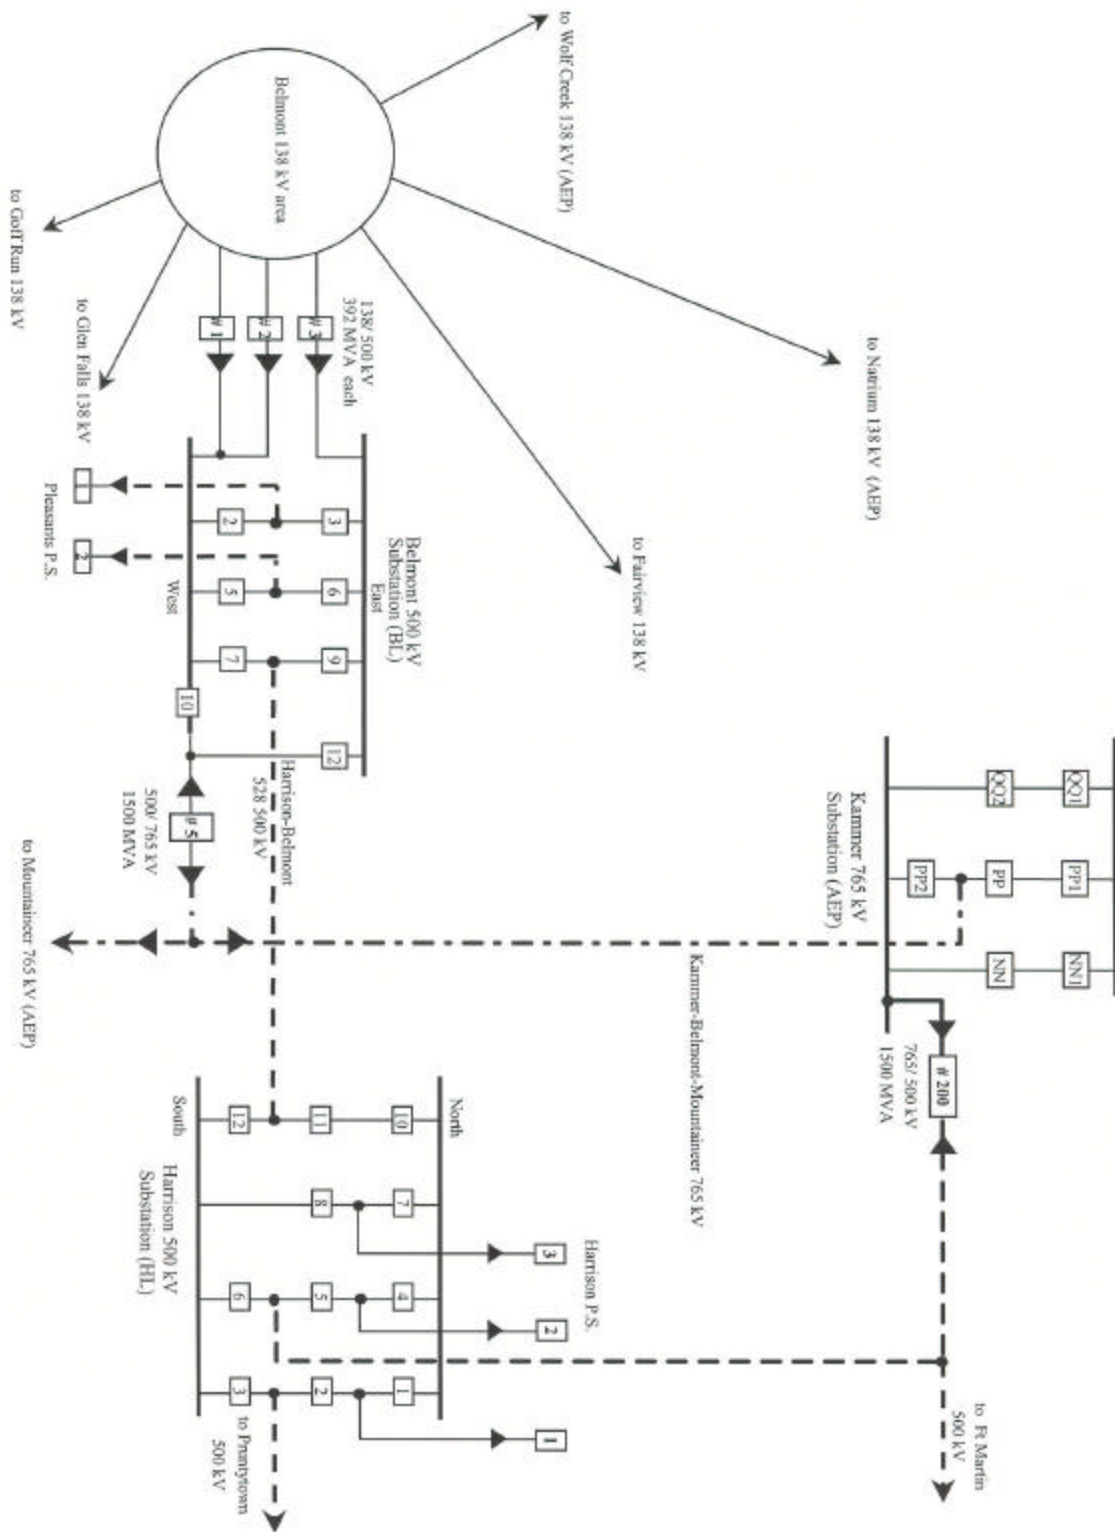
Figure 1

Both Pleasants units, which were dispatched at 550 MW and 560 MW, were immediately reduced due to overloading of the 500/138 kV Belmont Nos.1 & 2 transformers and 138 kV lines in the Belmont area. The 500 kV Belmont BL9 breaker was reported damaged, making return of the 500 kV Harrison – Belmont impossible. By 1325, the 500/138 kV Belmont No.3 transformer was returned to service, alleviating the overloading on the 500/138 kV Nos.1 & 2 transformers and restoring station service at Belmont.

The American Electric Power Columbus Operations Center (AEP) reported that the 765/500 kV Kammer No.200 transformer had a sudden pressure alarm and was leaking oil at 1349. This transformer is owned by APS but is operated and maintained by AEP. At the time of the initial line and breaker openings, the Kammer No.200 transformer increased in loading from 980 to 1,360 MW, and the 345 kV Sammis – Wylie Ridge tie line between Ohio Edison Company (OE) and APS increased from 1,090 to 1,200 MW. The transformer temperatures were being monitored, and it was decided to leave it in service because removing the Kammer No.200 bank from service would severely overload the remaining tie lines from the west to APS. A System wide Severe Condition Alert was declared and efforts were directed at curtailing west to east transfers, eliminating APS purchases from the west, and other means to reduce the 345 kV Sammis – Wylie Ridge line flow. OE redispatched about 250 MW of generation away from Sammis and began preparations with Duquesne Light Company (DL) to open the 345 kV Beaver Valley – Sammis line as requested by APS to further reduce the flow.

While switching the 765/500 kV Belmont No.5 transformer back in service, a lightning arrester on the high side of No.5 bank failed at 1418, causing the 765 kV Kammer – Belmont – Mountaineer line to open and lock out of service. In addition to the lightning arrester, one phase of the 765 kV air switch sustained damage.
