2023 Southwest Utah Disturbance

Southwestern Utah: April 10, 2023
Joint NERC and WECC Staff Report

August 2023

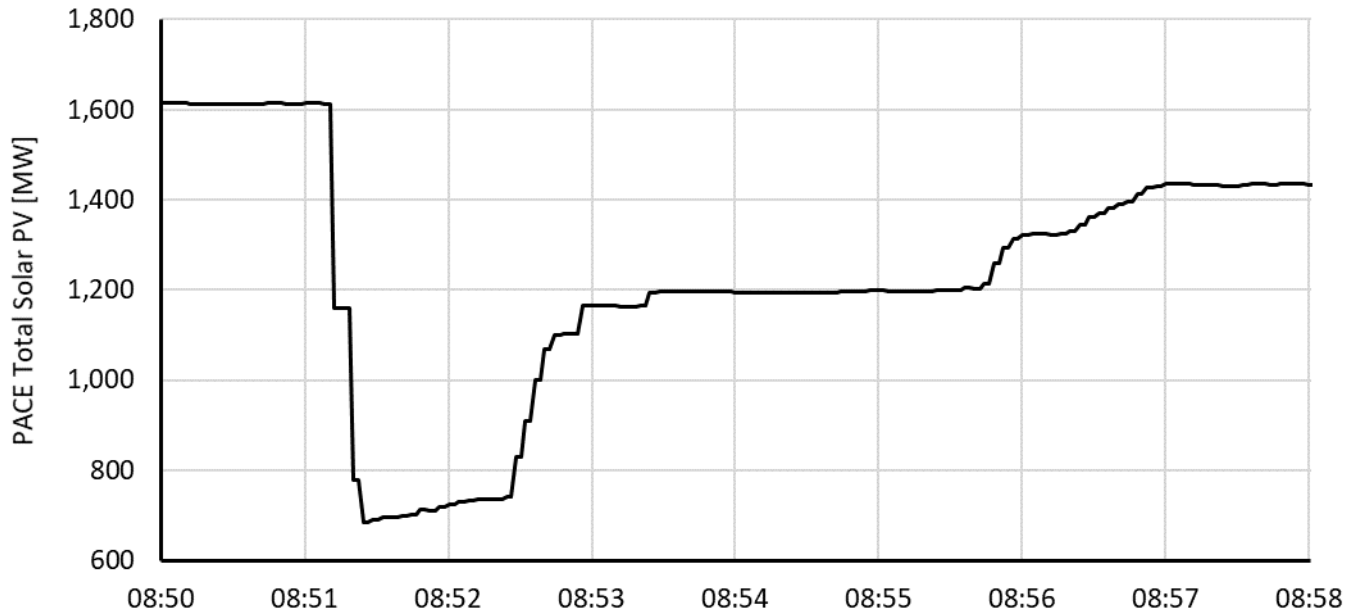
Figure I.2: PACE BPS-Connected Solar PV during Disturbance

At 08:51 Pacific time, a single-line-to-ground fault occurred on a 345 kV transmission circuit in the Southern Nevada/Southwest Utah area. Protective relaying cleared the fault normally in 3.5 cycles.⁸ While no generation tripped consequentially due to the transmission line outage, PACE supervisory control and data acquisition (SCADA) data⁹ shows that aggregate solar PV output in the PACE footprint dropped significantly (see [Figure I.2](#)). All affected solar PV facilities are located in the Southwest Utah area (see [Figure I.3](#)). The abnormal response from multiple facilities was caused by the protection and controls within each facility responding to the BPS fault in an unreliable manner. The loss of generation caused system frequency to fall from around 60.01 Hz to 59.89 Hz (see [Figure I.4](#)).

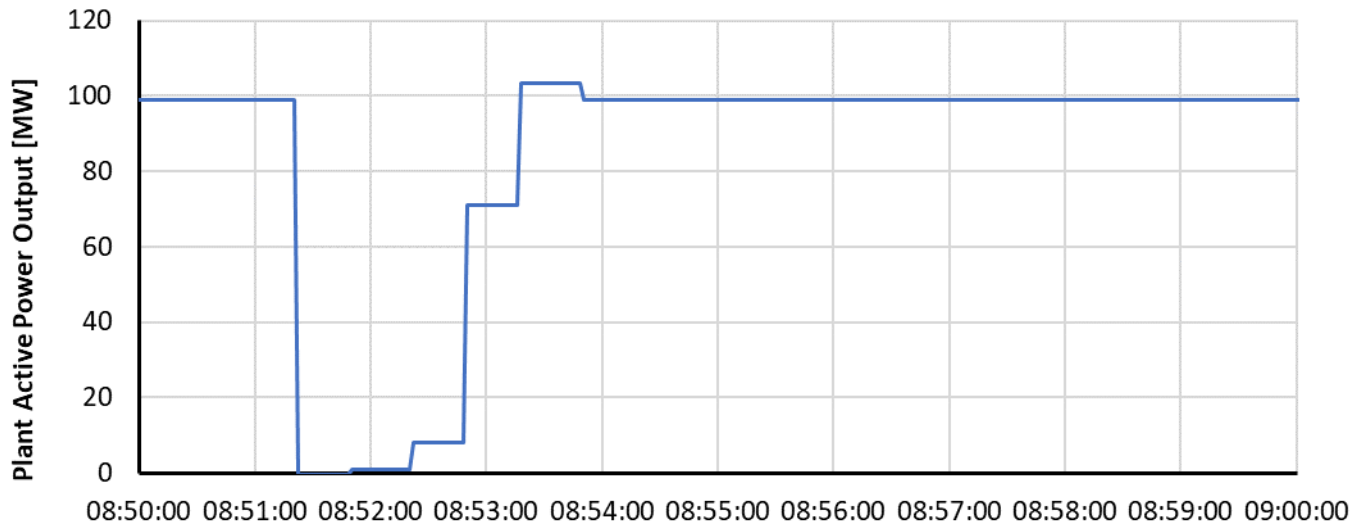
Figure A.1: Plant Active Power at POI

Plant A reduced output by 99 MW during the event (see [Figure A.1](#)). All inverters at the facility tripped on instantaneous ac overcurrent protection. The plant had no high resolution data available and did not capture any inverter-level oscillography data to analyze the tripping further.

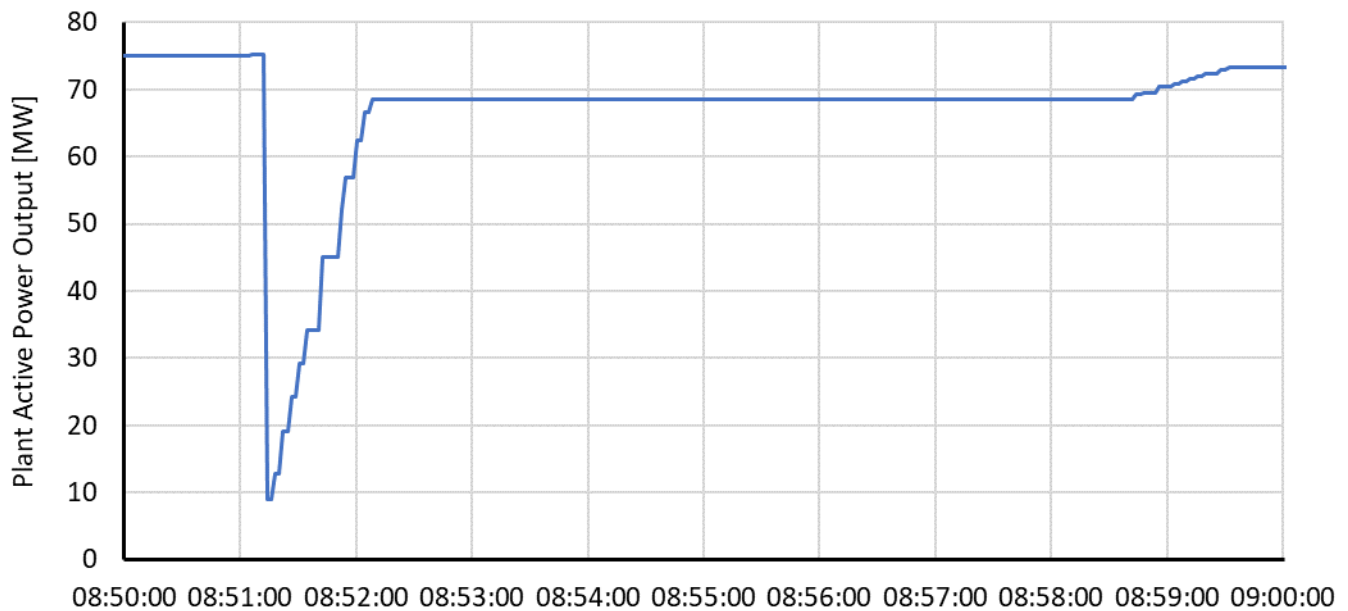
Figure A.2: Plant Active Power at POI

Plant B reduced output by 66 MW during the event (see [Figure A.2](#)). The facility owner was unable to identify the cause of reduction. The plant owner was able to identify that two inverters tripped (cause undetermined) but could not determine the cause of the other abnormal reduction and delayed recovery.

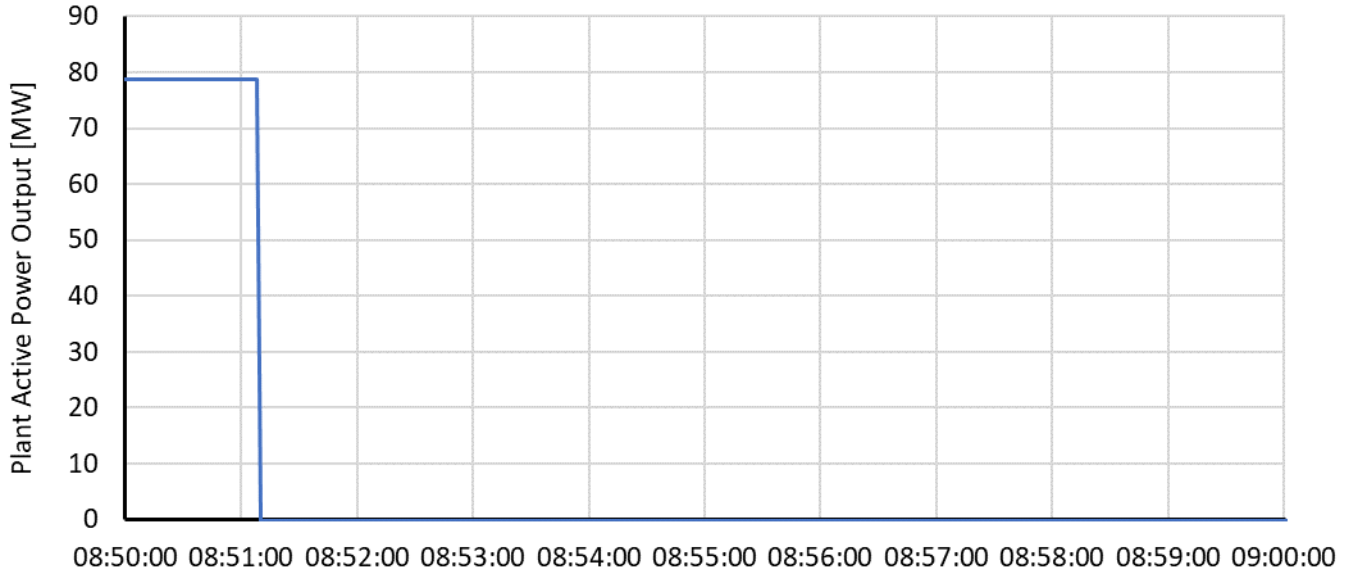
Figure A.3: Plant Active Power at POI

Plant C reduced output by 79 MW during the event (see [Figure A.3](#)). All inverters at the facility tripped. The inverters recorded fault codes involving instantaneous ac overvoltage above 125%, phase lock loop loss of synchronism, and dc reverse current tripping. The plant had no high resolution data available and did not capture any inverter-level oscillography data to analyze the tripping further.

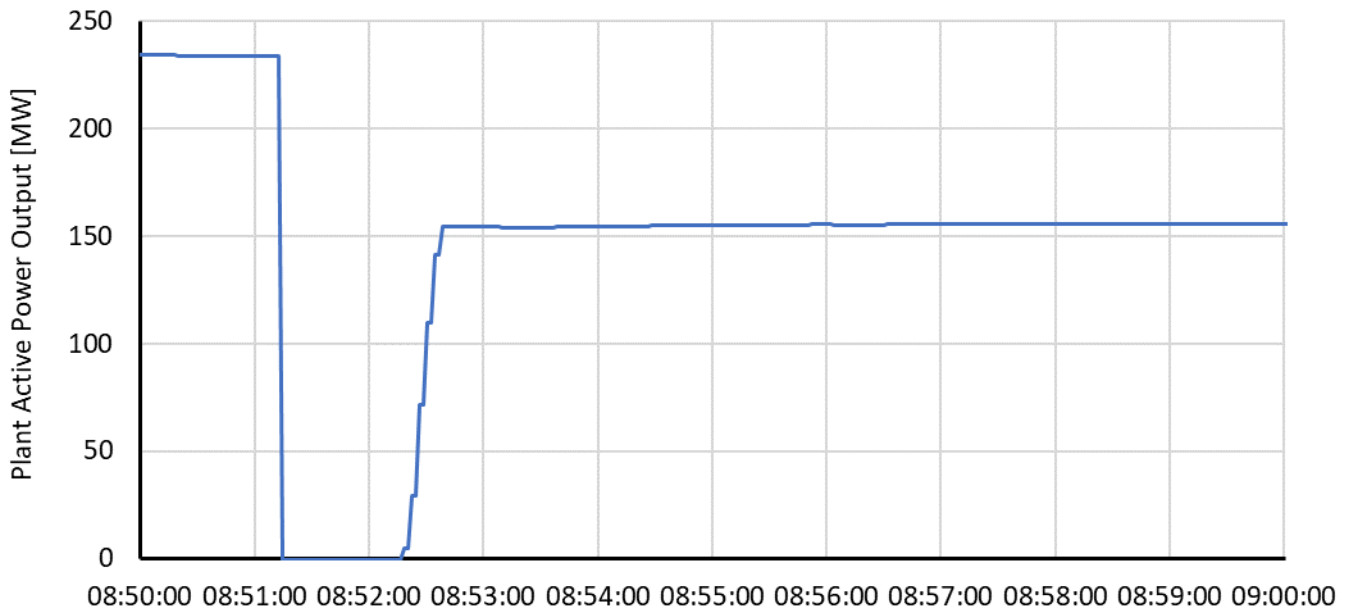
Figure A.4: Plant Active Power at POI

Plant D reduced output by 234 MW during the event (see [Figure A.4](#)). All inverters at the facility tripped. The inverters recorded fault codes involving instantaneous ac overvoltage above 125%, phase lock loop loss of synchronism, and dc reverse current tripping. The plant had no high resolution data available and did not capture any inverter-level oscillography data to analyze the tripping further.

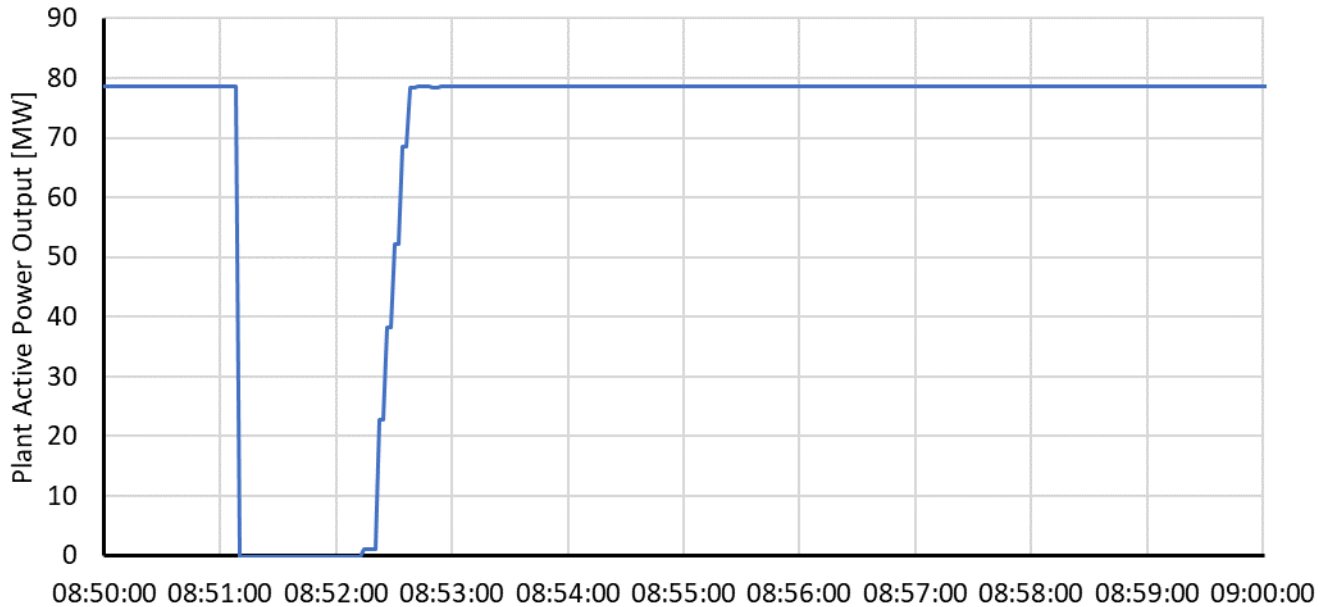
Figure A.5: Plant Active Power at POI

Plant E reduced output by 79 MW during the event (see [Figure A.5](#)). All inverters at the facility tripped. The inverters recorded fault codes for instantaneous ac overvoltage above 125% and phase lock loop loss of synchronism. The plant had no high resolution data available and did not capture any inverter-level oscillography data to analyze the tripping further.

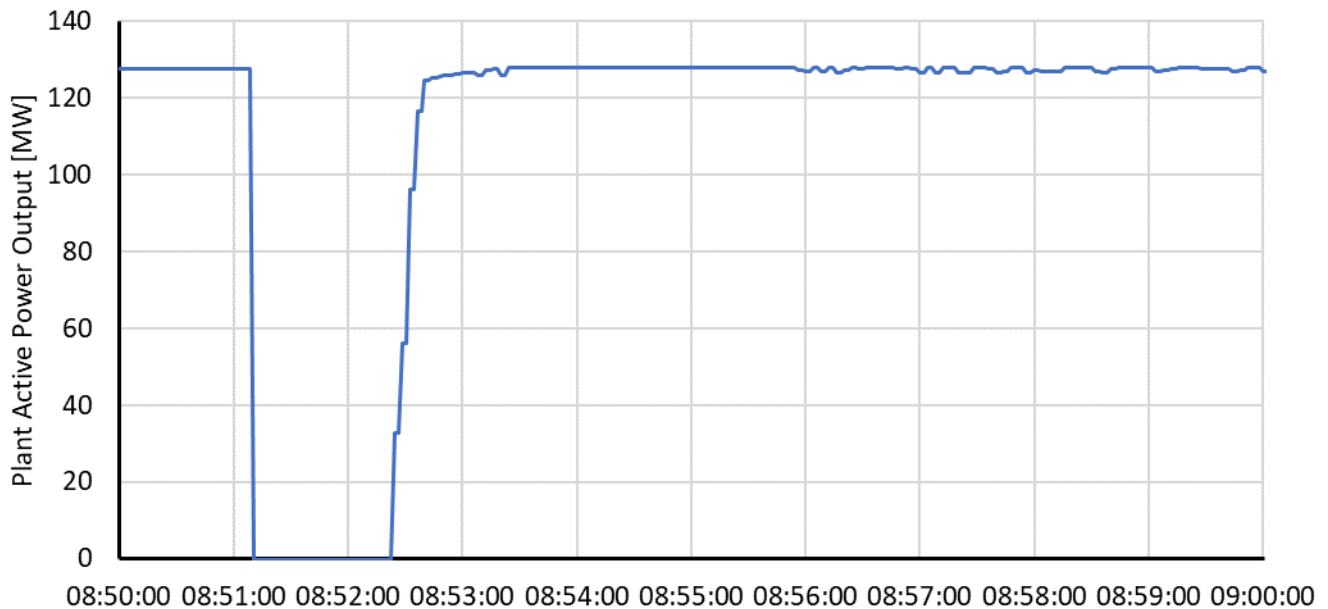
Figure A.6: Plant Active Power at POI

Plant F reduced output by 128 MW during the event (see [Figure A.6](#)). All inverters at the facility tripped. The inverters recorded fault codes involving instantaneous ac overvoltage above 125% and phase lock loop loss of synchronism. The plant had no high resolution data available and did not capture any inverter-level oscillography data to analyze the tripping further.

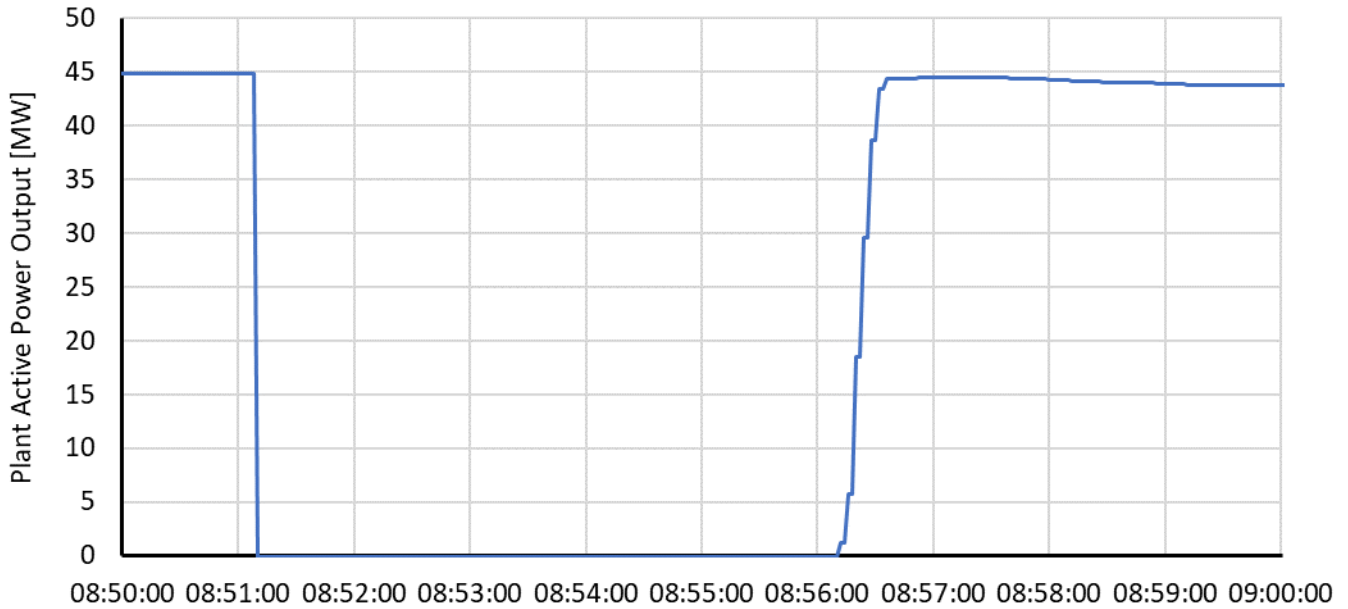
Figure A.7: Plant Active Power at POI

Plant G reduced output by 45 MW during the event (see [Figure A.7](#)). The GO was unable to identify the cause of reduction.

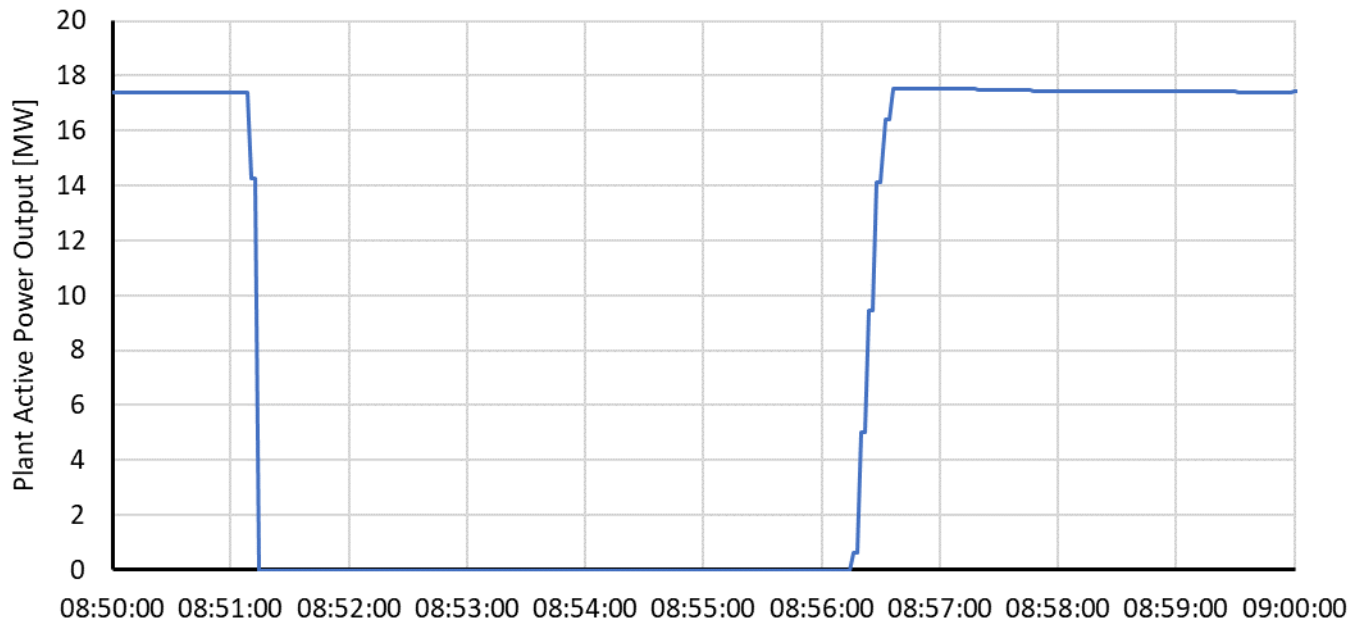
Plant H reduced output by 17 MW during the event (see [Figure A.8](#)). All inverters at the facility tripped on phase lock loop loss of synchronism. The protection was set with a voltage phase jump anti-islanding detection of 15 degrees within 500 ms.

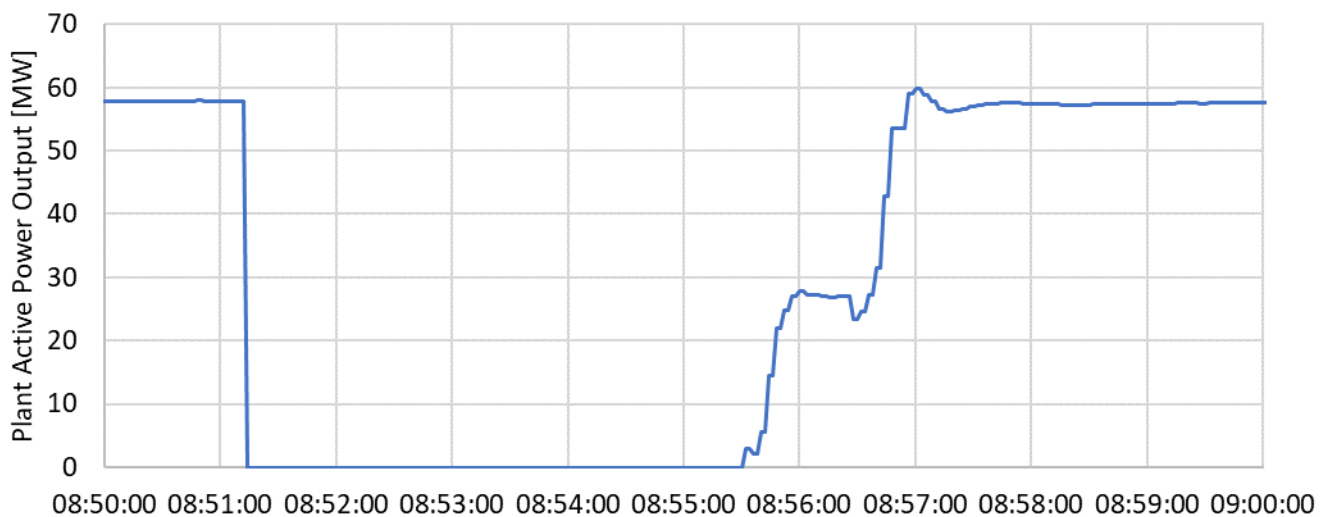
Figure A.9: Plant Unit 1 Active Power at POI

Plant I reduced output by 174 MW during the event (see [Figure A.9](#) and [Figure A.10](#)). Nearly all inverters at the facility tripped with fault codes indicating passive anti-islanding and ac overcurrent protection operating.

The GO identified that the low and high voltage ride-through “switch” parameters were disabled in all but two of their inverters, ultimately resulting in the unexpected tripping. The inverters with the setting enabled rode through the disturbance although they did enter momentary cessation due to these settings.

The GO also shared that they had proactively reached out to the inverter manufacturer for corrective actions. The inverter manufacturer focused primarily on IEEE 1547 standard requirements (particularly for disabling anti-islanding), which is an incorrect application of a distribution-centric standard to the bulk power system. The GO stated that they will be enabling LVRT with a “K-factor” of 2 to support ride-through performance.
