2022 Odessa Disturbance

Overview, Key Findings, and Recommendations

Informational Webinar
January 4, 2023

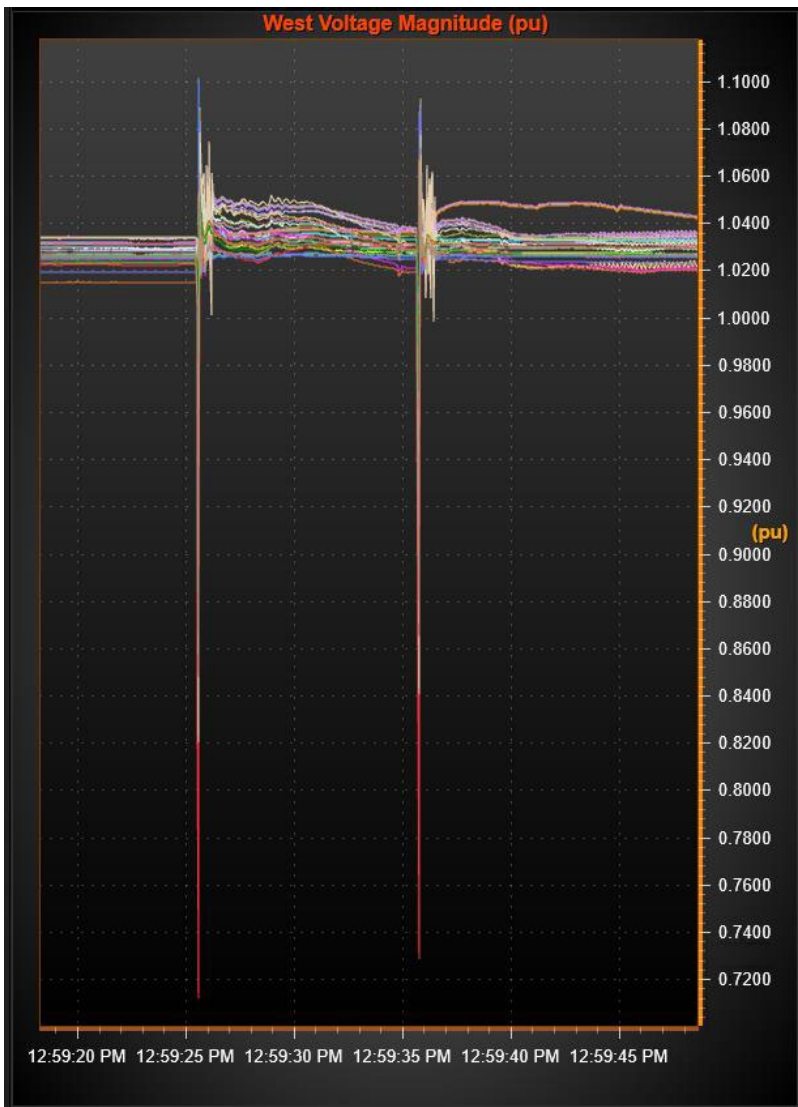
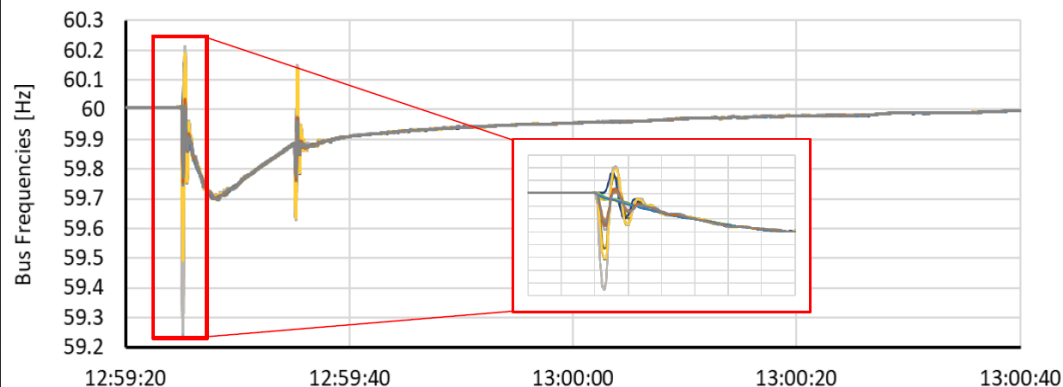
PMU Frequency and Voltage

- Lowest recorded voltage of 0.714 PU on 345 kV line in the area
- Highest recorded voltage of 1.102 PU on 138 kV line
- Attempted reclose ~ 10 seconds later
- Lowest frequency of 59.7 Hz on most PMUs
- Local transient frequencies seen as low as 58.83 Hz and as high as 60.26 Hz

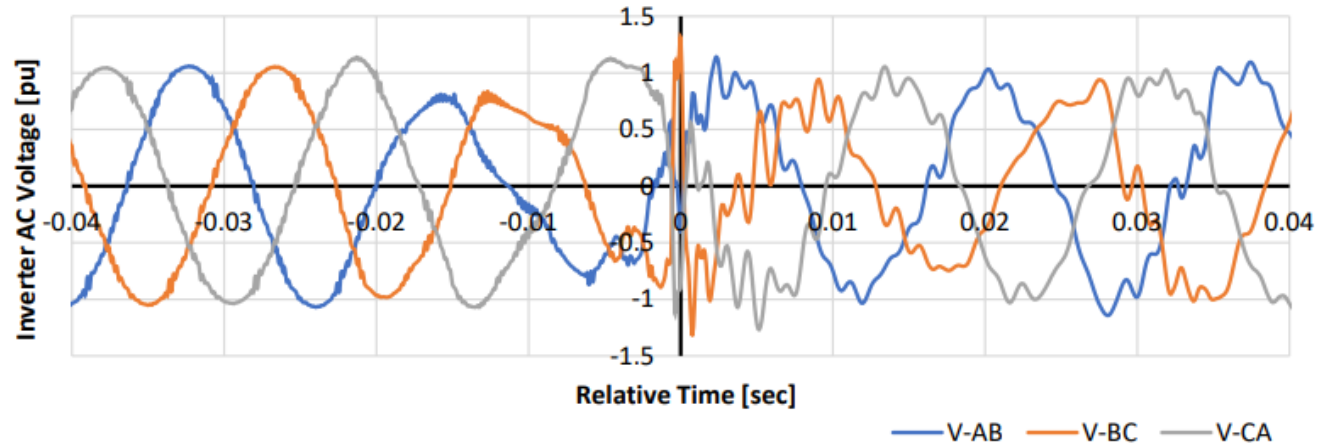
Figure 1.3: Inverter-Level High Speed Oscillography Voltage Data

- Observed across three inverter manufacturers; tripping primarily one large manufacturer
- Caused by inverter controls during on-fault conditions
 - Inverter drives ac current over ratings and trips during fault
- Software algorithm developed to mitigate tripping
 - Modifies inverter switching logic during faults
 - Testing confirmed with hardware-in-the-loop testbed
- Requires inverter personnel on-site to modify inverter firmware and parameters
- Changes only being made to facilities that request the update
- Changes to EMT model will be needed to reflect updated inverter control strategy

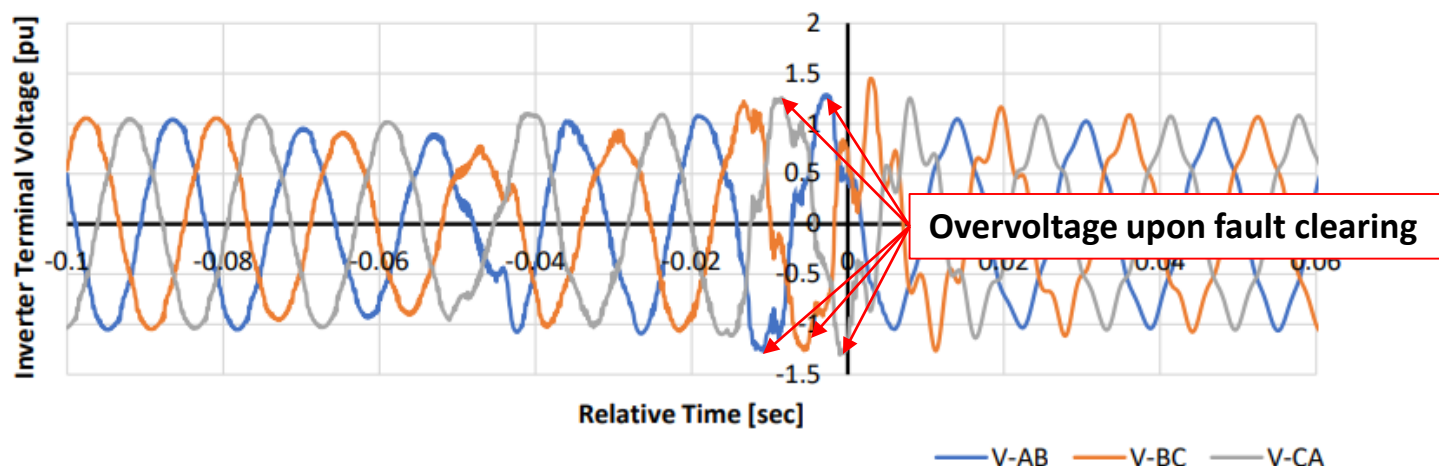
Figure 1.5: Inverter-Level High Speed Oscillography Voltage Data

- Persistent, recurring cause of tripping for solar PV
- Overvoltage occurs at fault clearing
- Linked to inverter control strategy during and immediately following fault condition
 - Tripping set at 1.25 pu for 0.2 ms
- Inadequacies in PRC-024-3 to address this cause of tripping
 - Uses POI voltages; but no industry standard to translate POI voltages to inverter voltages during faults
 - Requires extensive EMT modeling and studies to identify risk

- Inverter OEM updated inverter protection settings to extend ac overvoltage protection
 - Changes to user-settable and OEM-settable settings
 - Updates require inverter OEM technician on-site
 - Protections should match actual equipment capabilities
