## Lesson Learned

### Transmission Relaying – Undesired Blocking

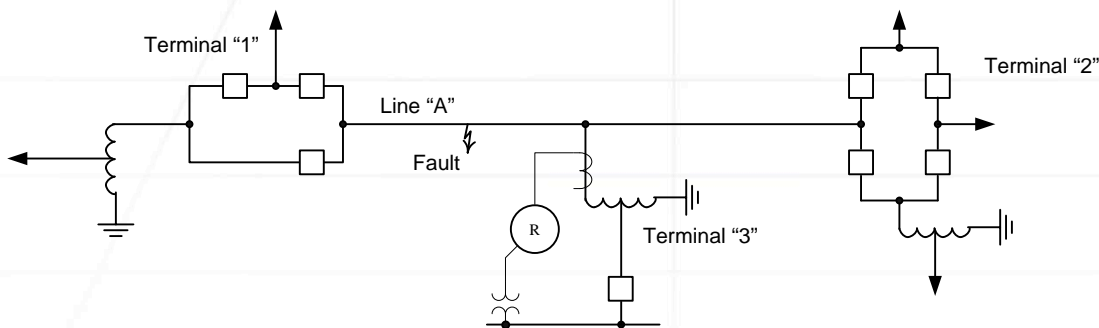
A permanent phase-to-ground Fault occurred on Line A which is a three terminal line. All three ends correctly cleared high speed on the initial Fault. When Terminal 1 reclosed, it cleared by a Zone 2 time delay. The Digital Fault Recorder (DFR) at Terminal 1 confirmed the high speed tripping for the initial Fault and delayed tripping for the subsequent Fault. The DFR also indicated the trip from Terminal 1 upon reclosing was delayed because it was receiving a block signal.

The cause of the delay in tripping was determined through the process of elimination and modeling the event. The Misoperation resulted from the following circumstances: (1) the design of the older electromechanical relay scheme and (2) the tapped autotransformer at one of the line terminals. At Terminal 3, there is no high side breaker, so the low side breaker of the tapped autotransformer is tripped for line Faults, leaving the primary of the transformer connected to Line A. The pilot scheme interlocks carrier stop with the circuit breaker position. When Terminal 1 reclosed into the Faulted line, the ground source contribution from the autotransformer was sufficient to start the blocking carrier signal by the non-directional ground element at Terminal 3. However, because the low side autotransformer breaker

was open, the carrier stop relays at Terminal 3 could not operate. This resulted in the carrier signal not being stopped which blocked the remote end from tripping high speed.

The line protection scheme was modified at Terminal 3 to stop carrier when the low side breaker is open.
