Odessa Disturbance

NERC Event Analysis and Engineering

Industry Webinar – October 2021

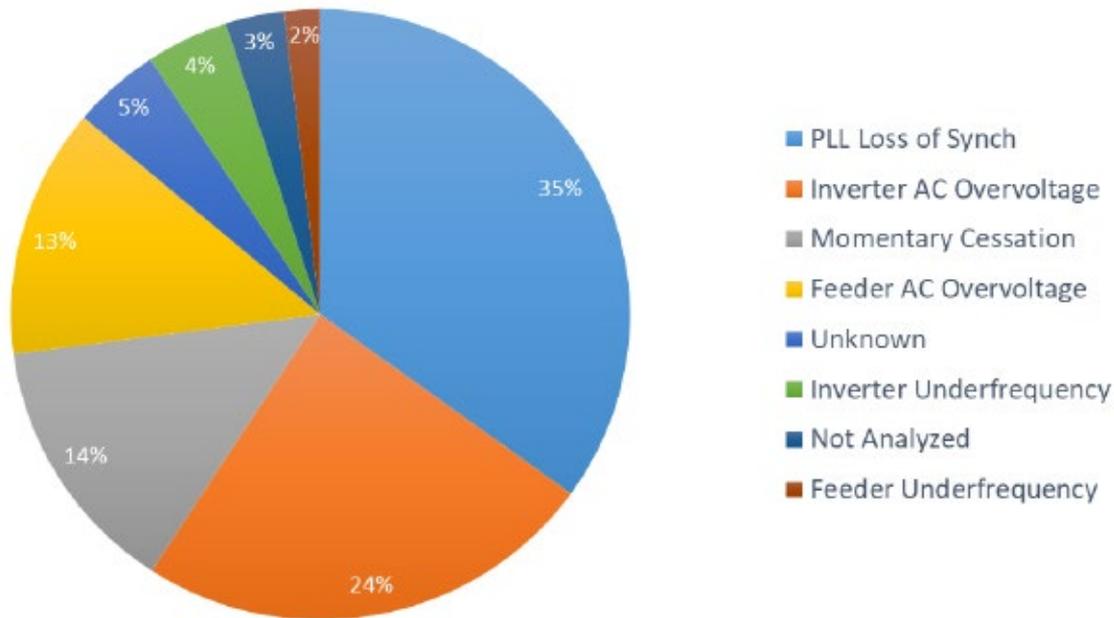
- Two BES facilities – reductions of 239 MW and 150 MW
- Attributable to one inverter OEM
 - Identified in multiple prior events analyzed by NERC
 - “Tripping on phase jump protects against PLL instability”
- Systemic concern for facilities with this inverter type

- Existing facilities with this inverter OEM likely susceptible to tripping
 - Inverters issue fault code and shut down – function separate from “ride through settings”
 - Default setting of 10 degree voltage phase angle shift
- Inverter OEM removing this trip function from inverters at existing facilities only upon request; shipping newer inverters with function disabled

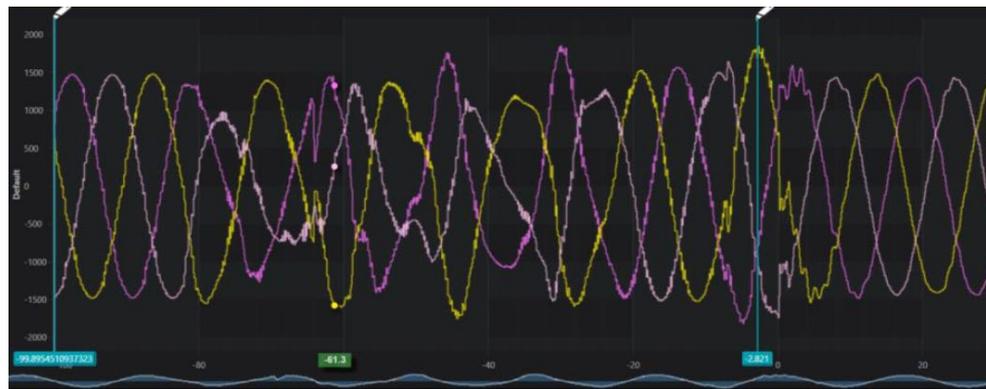
- POI oscillography data shows voltage within PRC-024-3 voltage “no trip” curve
- Inverter experiences spikes (instantaneous peak) above 1.3 pu at terminals
- 1.3 pu threshold hard-coded by OEM; separate from HVRT settings configurable by plant personnel (used to demonstrate compliance with PRC-024-3).
- Settings cannot be modified for any existing facilities
 - AC overvoltage tripping for this OEM will likely continue to occur in future
- PRC-024-3 not adequate protection to ensure IBRs ride through faults and support BPS post-fault (essential reliability service)
 - Identified in nearly all solar PV disturbances analyzed by NERC

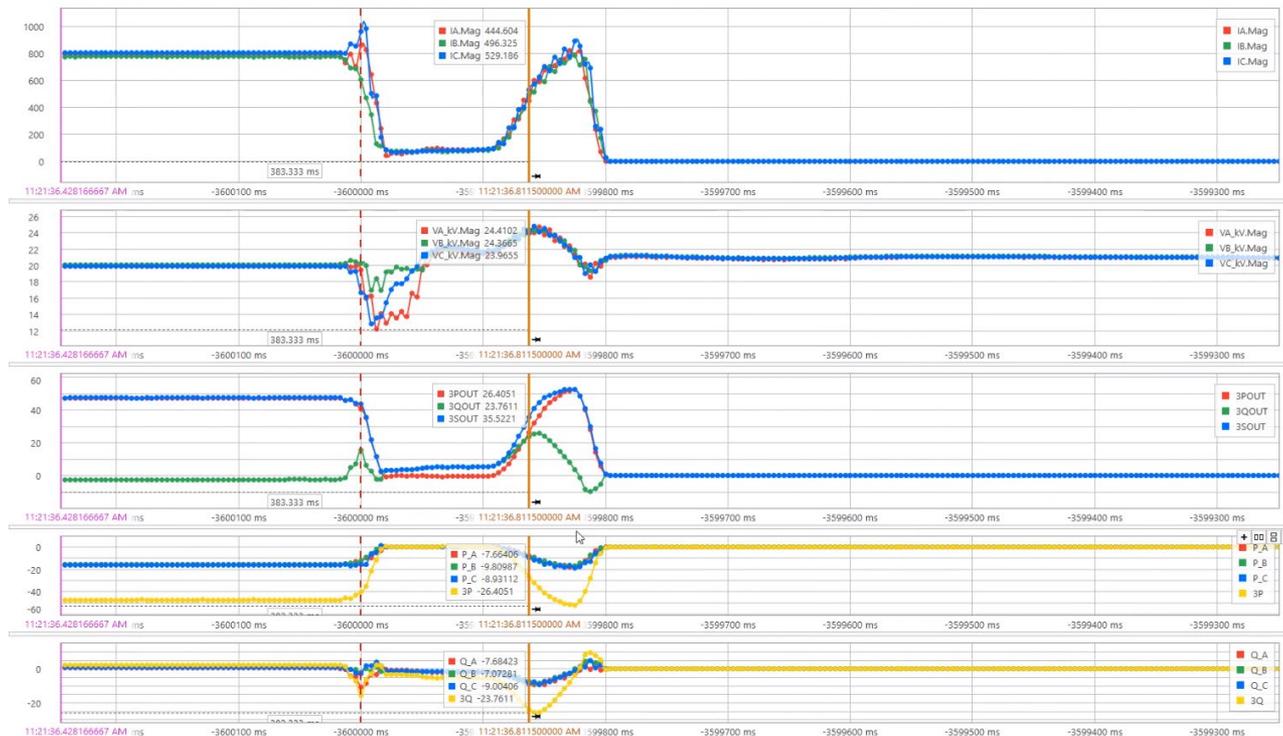
- Voltage driven high by abnormal inverter controls during and after fault
- All feeder protection at one facility set to trip on inst phase ac overvoltage
 - Set at 1.2 pu – directly on PRC-024-3 curves
- Review team questioned need for this feeder-level protection
 - Plant personnel unable to clarify what the voltage protection was protecting

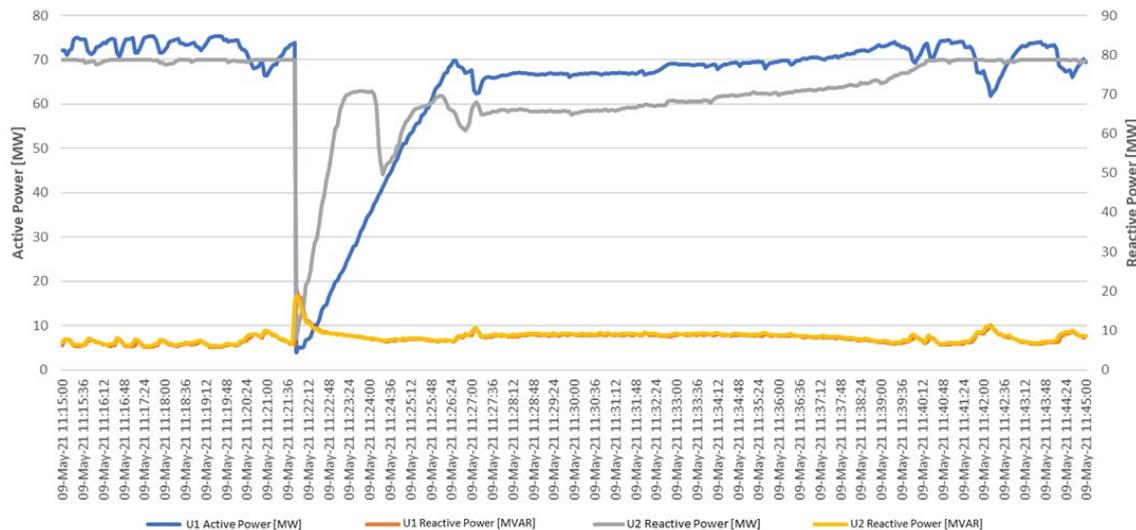
- Legacy inverters at one plant – momentary cessation below 0.9 pu voltage
 - Inverters should recover to predisturbance output relatively quickly when voltage recovers
- Plant-level controller interactions – slowed recovery to BA ramp rate limits
- Not appropriate use of these limits; negatively impacting system stability
- Not meeting recommended performance in NERC reliability guidelines
