Vegetation-Related Transmission Outage Report

2015 Annual Report

May 3, 2016

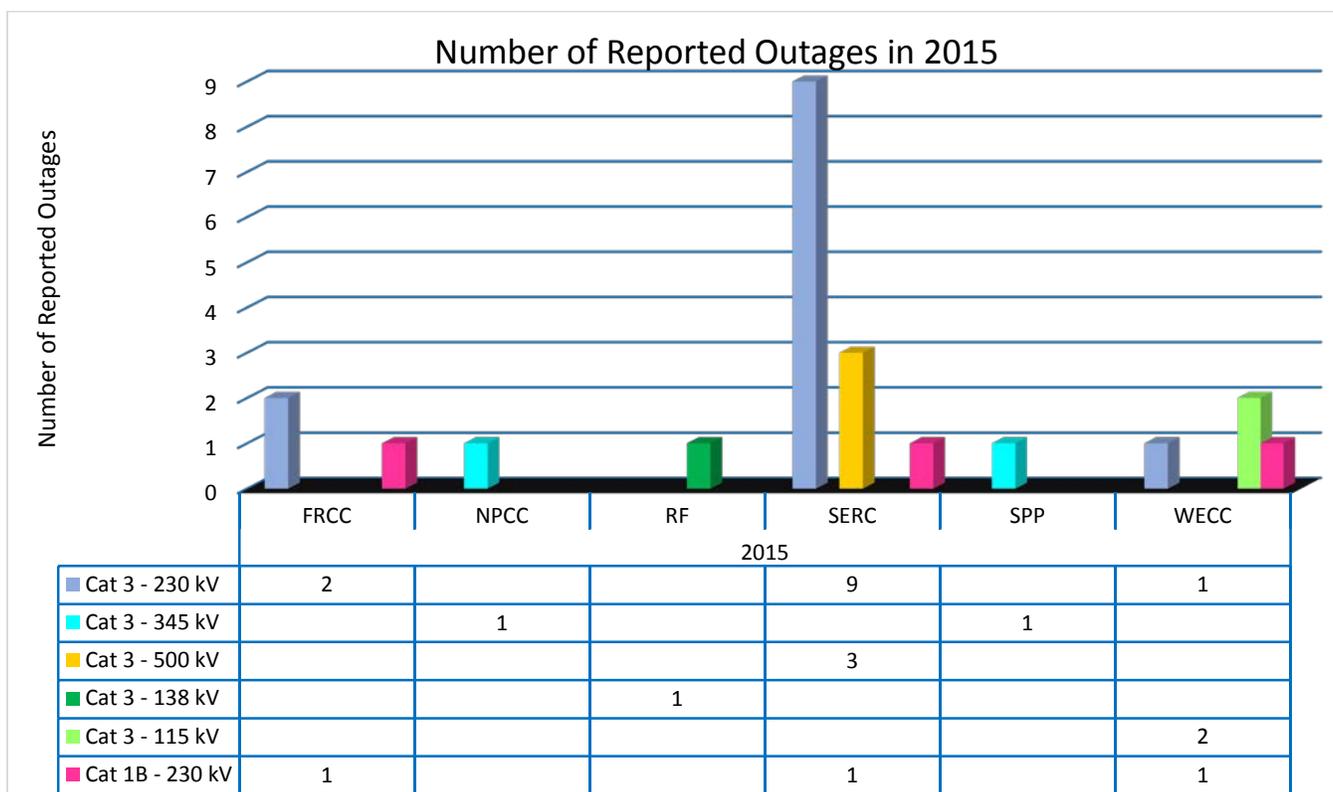
Figure 1: Vegetation-Related Outages by Regional Entity, Voltage Class, and Outage Category in 2015

Registered entities reported a total of 23 outages in 2015. As shown below, 20 reported outages were caused by vegetation falling into lines from outside the ROW (Category 3) mostly during severe weather. The remaining three were due to vegetation growing into applicable lines from within the ROW (Category 1B). The three Category 1B outages occurred in different RE footprints on 230 kV transmission lines. None of these three lines had experienced a vegetation-related transmission outage within the last eight reporting quarters.

All Category 3 outages occurred during severe weather conditions. Four of the lines had experienced a vegetation-related transmission outage within the last eight reporting quarters. All previous outages were also Category 3 and weather-related.

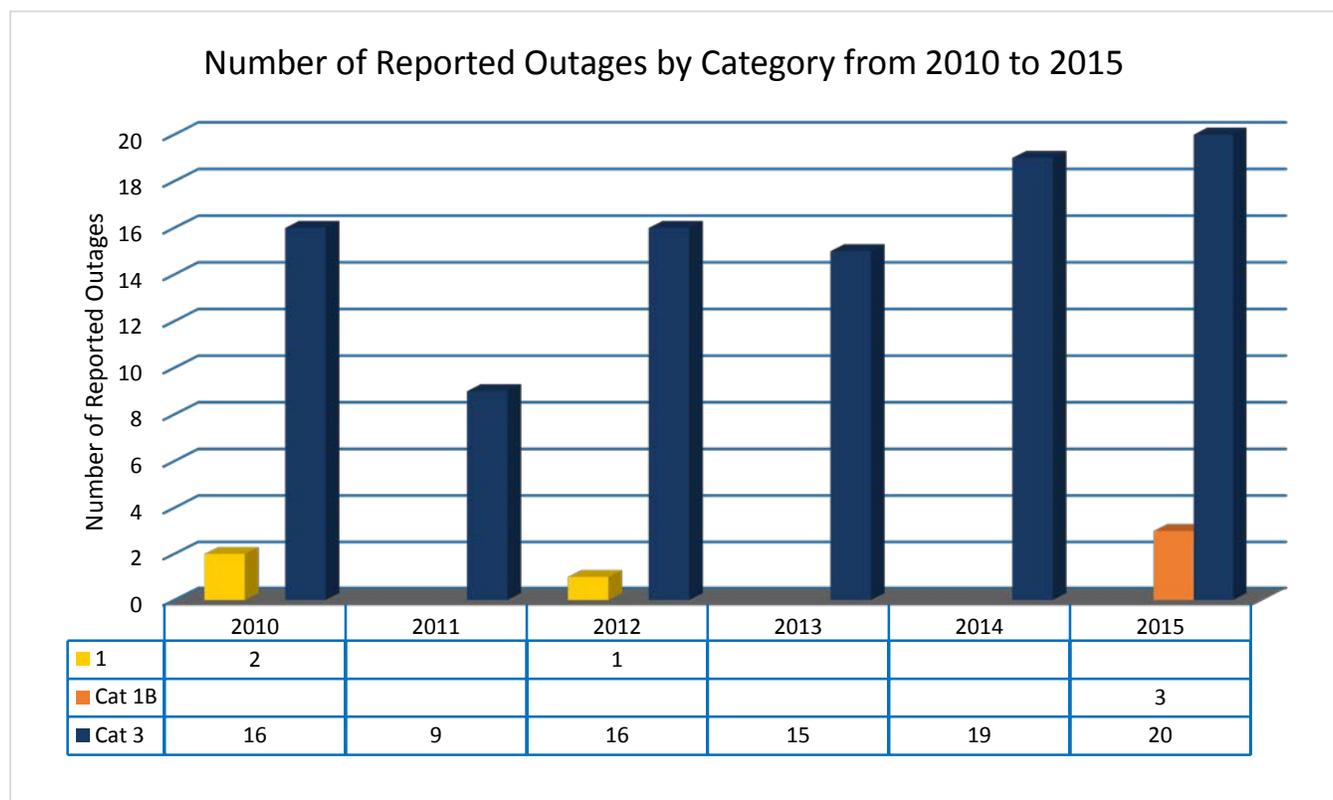
Figure 2: Vegetation-Related Outages by Outage Category from 2010 to 2015

As noted in figure 2, there has been a slight increase in Category 3 outages in 2014 and 2015. NERC's review indicated that the Category 3 outages were isolated weather-related events that did not represent a trend or pose a significant risk to the reliability of the BPS.

The last Category 1⁵ outage in the U.S. occurred in 2010 (see Figure 2).⁶ The three registered entities experiencing Category 1B occurrences in 2015 have self-reported noncompliance with FAC-003 to the ERO Enterprise. The issues are under review by enforcement.
