NORTH AMERICAN ELECTRIC RELIABILITY COUNCIL

Technical Analysis of the August 14, 2003, Blackout: *What Happened, Why, and What Did We Learn?*

**Report to the NERC Board of Trustees
by the NERC Steering Group**

July 13, 2004

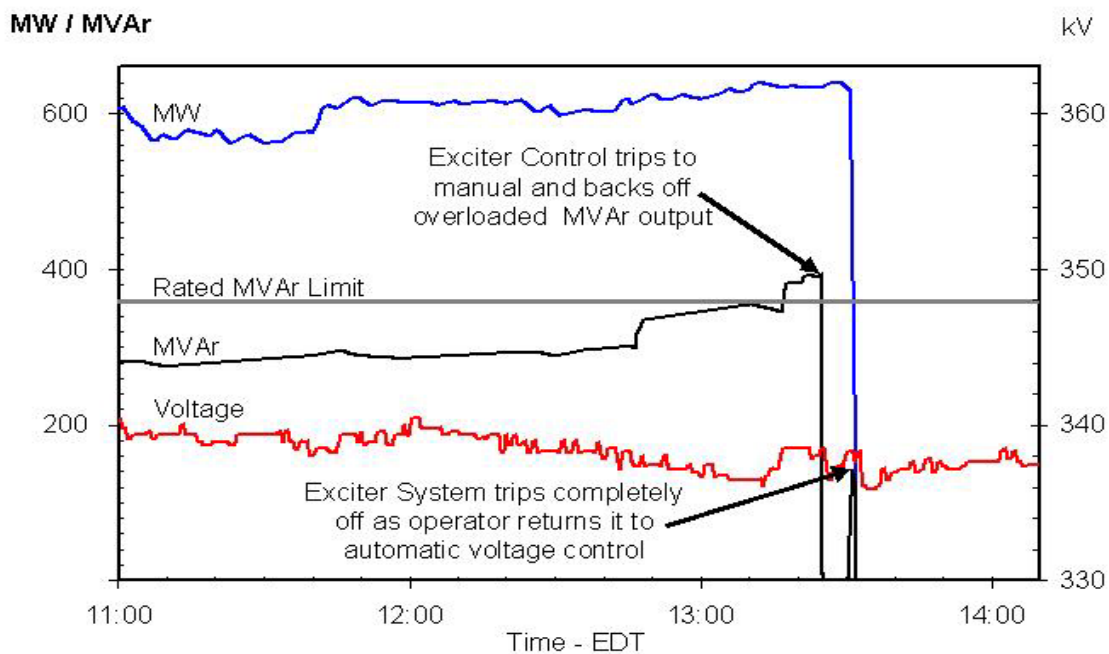
Figure III.1 — Eastlake 5 Output Prior to Trip at 13:31 EDT

About four or five minutes after the Mvar output decreased to zero, the operator was increasing the terminal voltage and attempting to place the exciter back on AVR control when the excitation system tripped altogether (see Figure III.1). The unit then tripped off at 13:31:34 when the loss of excitation relay operated. Later phone transcripts indicate subsequent trouble with a pump valve at the plant that would not re-seat after the trip. As a result, the unit could not be quickly returned to service.

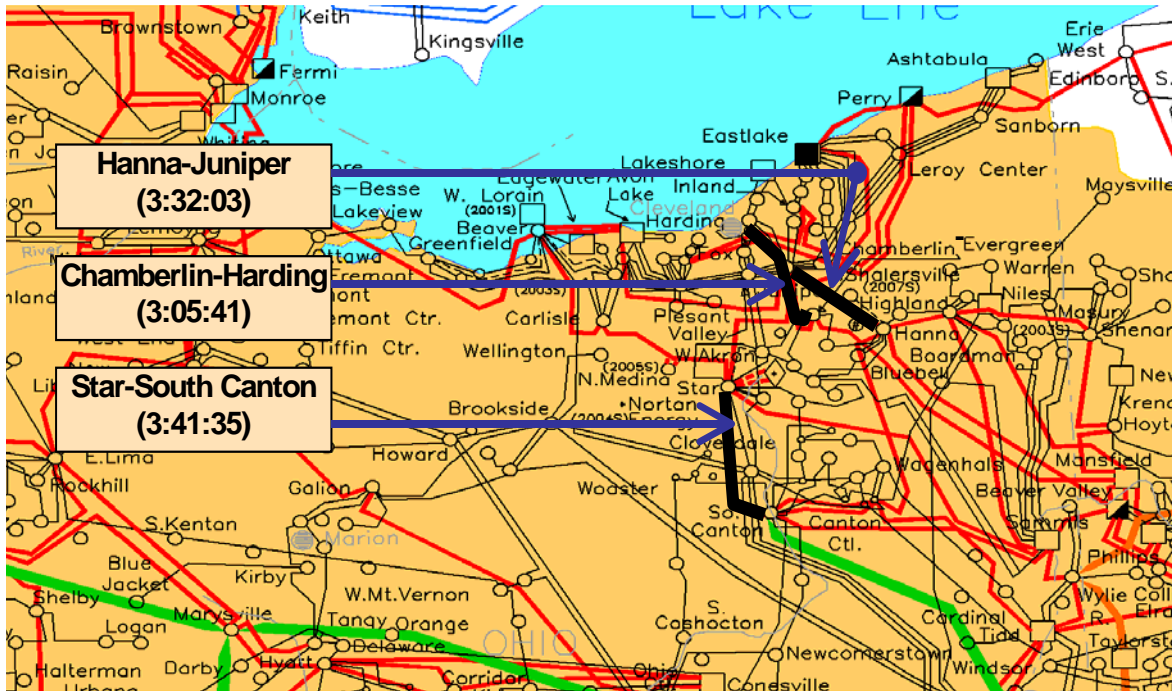
Figure III.3 — Location of Three Line Trips

Figure III.3 shows the location of the Chamberlin-Harding line and the two subsequent critical line trips.

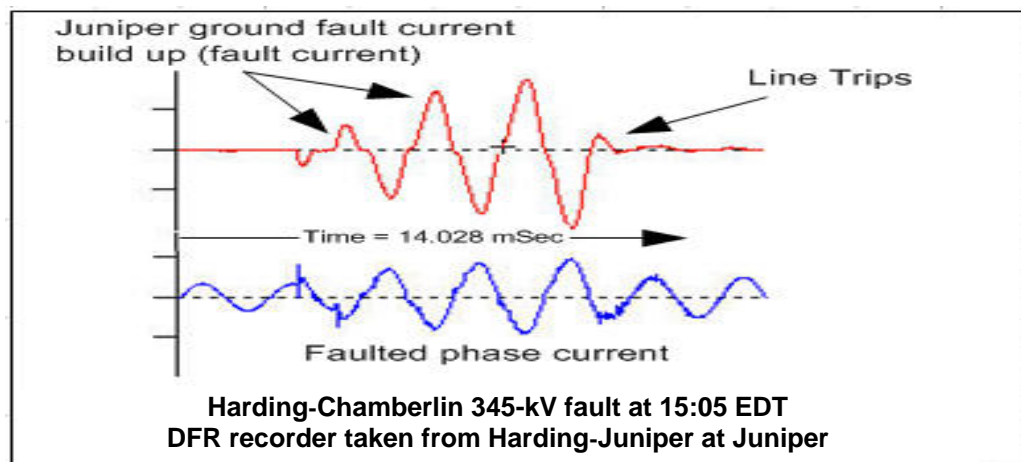
Figure III.4 — Juniper DFR Indication of Tree Contact for Loss of the Chamberlin-Harding Line

At 15:05:41, The FE Chamberlin-Harding 345-kV line tripped and locked out while loaded at 500 MVA or 43.5 percent of its normal and emergency ratings of 1,195 MVA (which are the same values). At 43.5 percent loading, the conductor temperature did not exceed its design temperature and the line could not have sagged sufficiently to allow investigators to conclude that the line sagged into the tree due to overload. Instead, investigators determined that FE had allowed trees in the Chamberlin-Harding right-of-way to grow too tall and encroach into the minimum safe clearance from a 345-kV energized conductor. The investigation team examined the relay data for this trip, which indicated high impedance Phase C fault-to-ground, and identified the geographic location of the fault. They determined that the relay data match the classic signature pattern for a tree-to-line fault (Figure III.4). Chamberlin-Harding tripped on directional ground relay — part of a directional comparison relay scheme protecting the line.

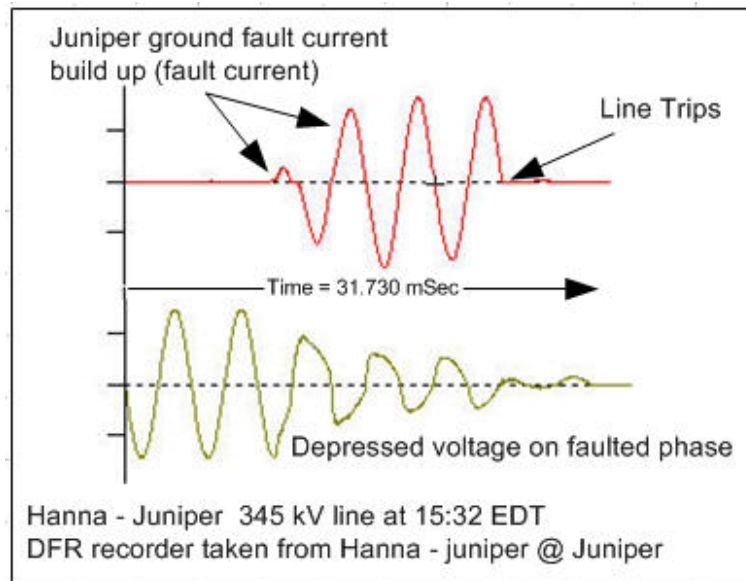
Figure III.5 — Juniper DFR Indication of Tree Contact for Loss of Hanna-Juniper

Incremental line current and temperature increases, escalated by the loss of Chamberlin-Harding, caused enough sag on the Hanna-Juniper line that it experienced a fault current due to tree contact, tripped and locked out at 15:32:03, with current flow at 2,050 amperes or 87.5 percent of its normal and emergency line rating of 2,344 amperes. Figure III.5 shows the Juniper digital fault recorder indicating the tree signature of a high-impedance ground fault. Analysis showed high arc resistance limiting the actual fault current well below the calculated fault current assuming a "bolted" (no arc resistance) fault.

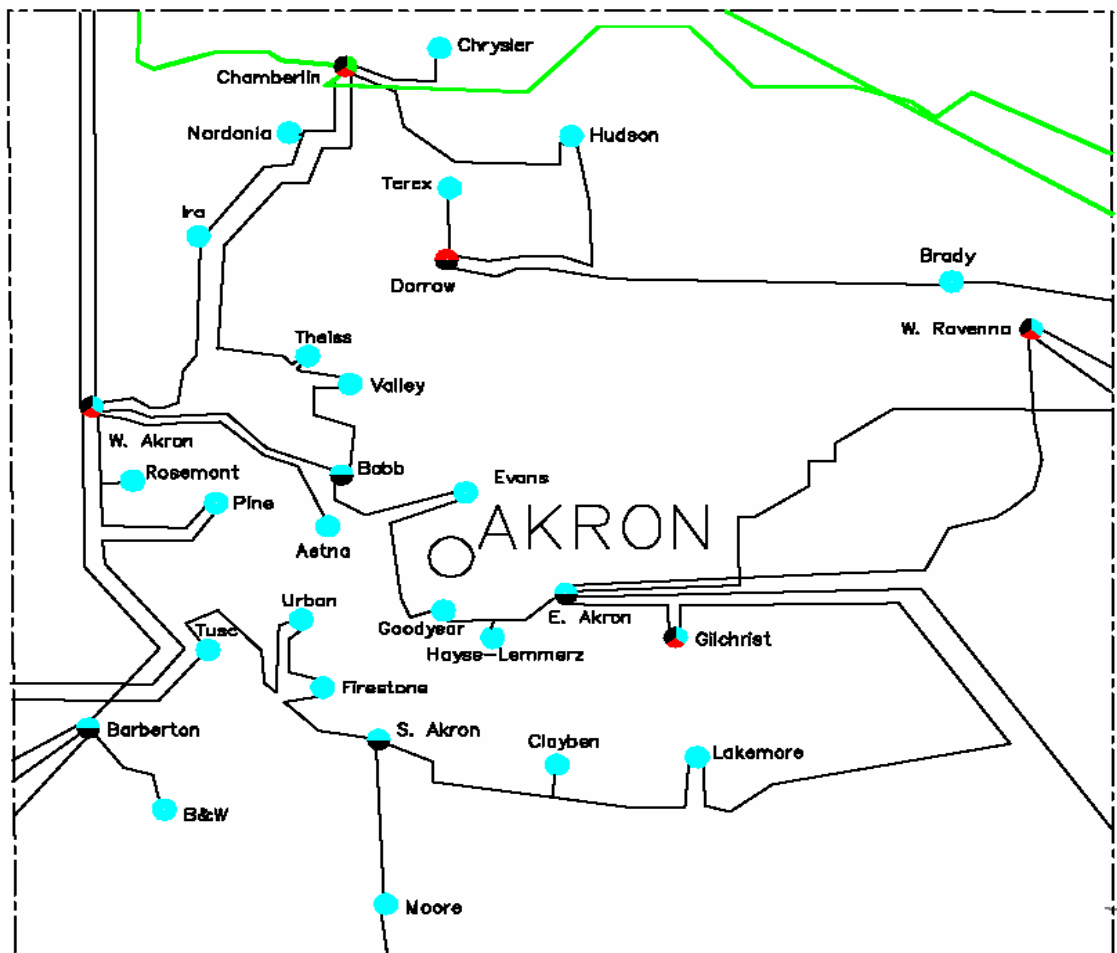
Figure III.7 — Akron Area Substations Participating in Localized 138-kV Cascade

Approximately 600 MW of customer loads were shut down in Akron and areas to the west and south of the city during the cascade because they were being served by transformers connected to those lines. As the lines failed, severe voltage drops caused a number of large industrial customers with voltage-sensitive equipment to go off-line automatically to protect their operations.

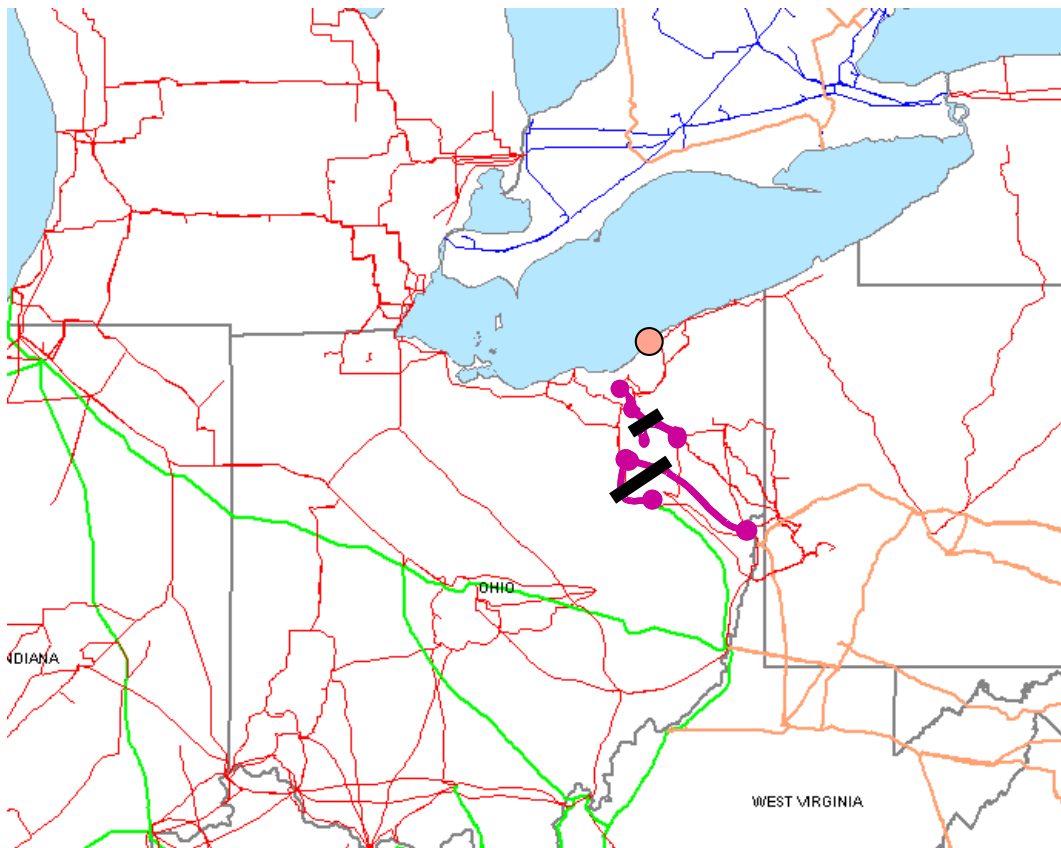
Figure III.8 — Cleveland-Akron Cut Off

As shown in Figure III.8, the Sammis-Star line trip completely severed the 345-kV path into northern Ohio from southeast Ohio, triggering a new, fast-paced sequence of 345-kV transmission line trips in which each line trip placed a greater flow burden on those lines remaining in service. After Sammis-Star tripped, there were only three paths left for power to flow into northern Ohio: (1) from northwestern Pennsylvania to northern Ohio around the south shore of Lake Erie, (2) from southern Ohio, and (3) from eastern Michigan and Ontario. Northeastern Ohio had been substantially weakened as a source of power to eastern Michigan, making the Detroit area more reliant on 345-kV lines west and northwest of Detroit, and from northwestern Ohio to eastern Michigan.

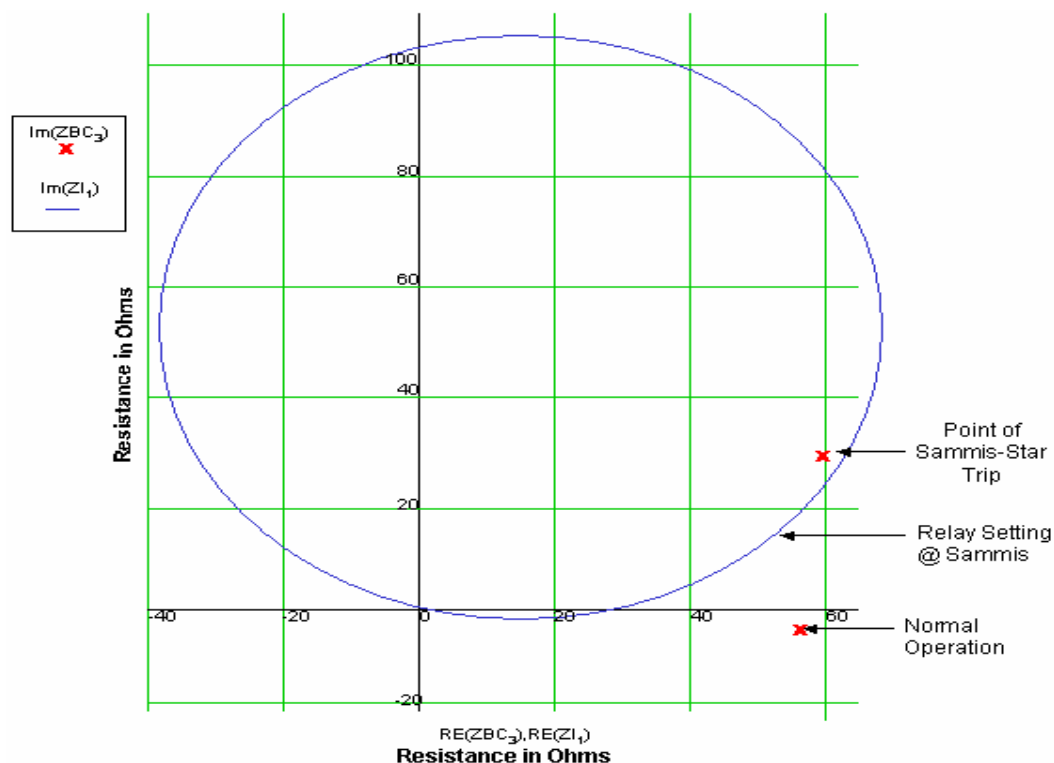
Figure III.9 — Load Encroachment of Sammis-Star Zone 3 Impedance Relay

A zone 3 relay can be defined as an impedance relay that is set to detect system faults on the protected transmission line and beyond.⁵ It sometimes serves a dual purpose. It can act through a timer to see faults beyond the next bus up to and including the furthest remote element attached to the bus. It is used for equipment protection beyond the line and it is an alternative to equipment failure communication systems sometimes referred to as breaker failure transfer trip. Zone 3 relays can also be used in the high-speed relaying system for the line. In this application, the relay needs directional intelligence from the other end of the line that it receives via a highly reliable communication system. In the Sammis-Star trip, the zone 3 relay operated because it was set to detect a remote fault on the 138-kV side of a Star substation transformer in the event of a breaker failure.

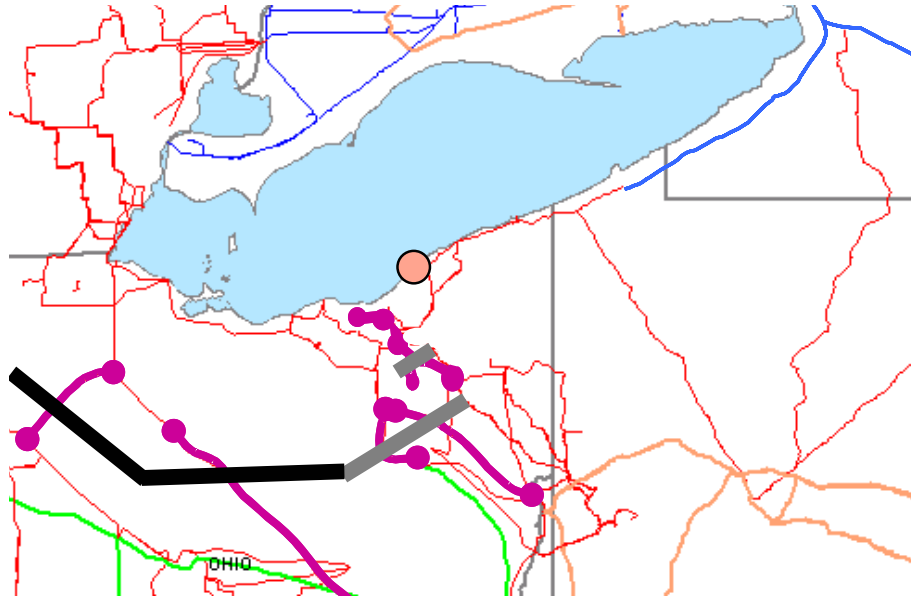
Figure IV.7 — Ohio 345-kV Lines Trip, 16:08:59 to 16:09:07

numerous 138-kV line trips in central Ohio, the East Lima-Fostoria Central line tripped at 16:09:06 on zone 3 relay operation due to high current and low voltage (80 percent). Modeling indicates that if automatic under-voltage load-shedding had been in place in northeastern and central Ohio, it might have been triggered at or before this point and dropped enough load to reduce or eliminate the subsequent line overloads that spread the cascade. The line trips across Ohio are shown in figure IV.7.

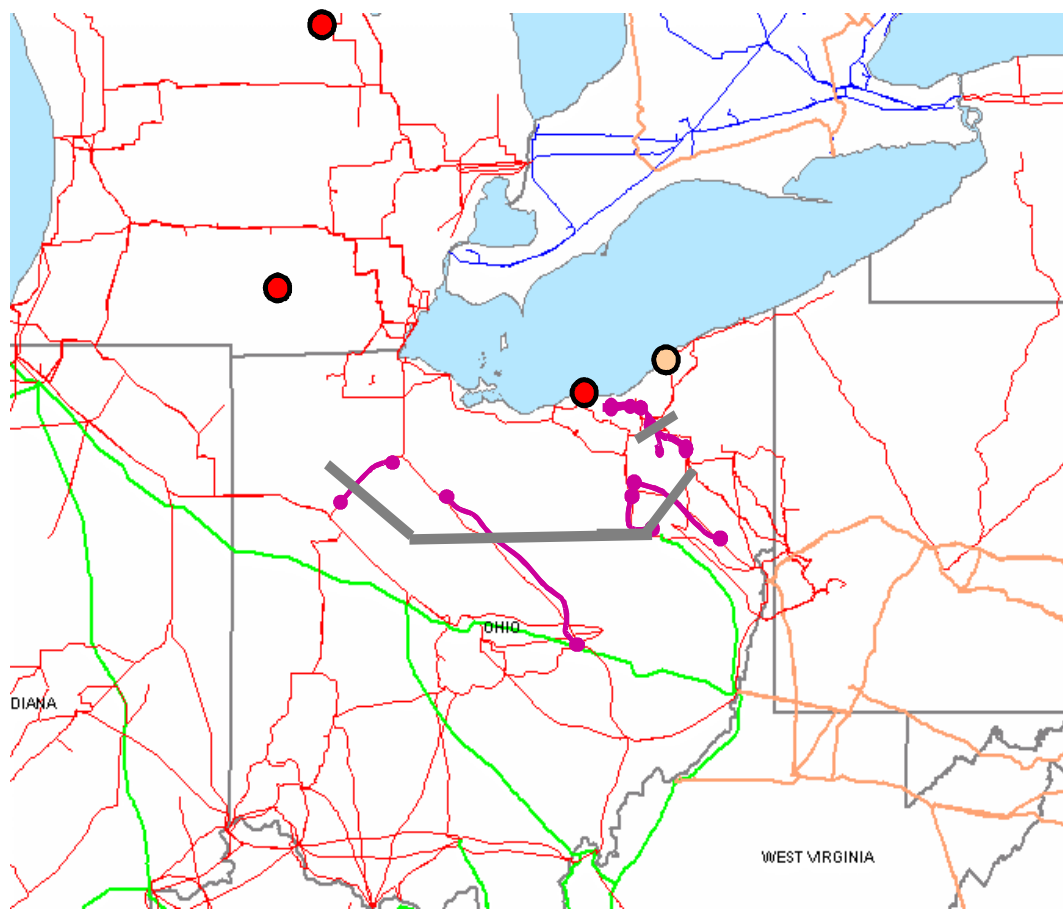
Figure IV.11 — Michigan and Ohio Power Plants Trip or Run Back

The MCV plant in central Michigan experienced a 300 MW run-back. The Avon Lake 7 unit tripped due to the loss of the voltage regulator. The Burger units tripped after the 138-kV lines from the Burger 138-kV generating substation bus to substations in Ohio tripped from high reactive power flow due to the low voltages in the Cleveland area. Three units at the Kinder Morgan generating station in south-central Michigan tripped due to a transformer fault and over-excitation.

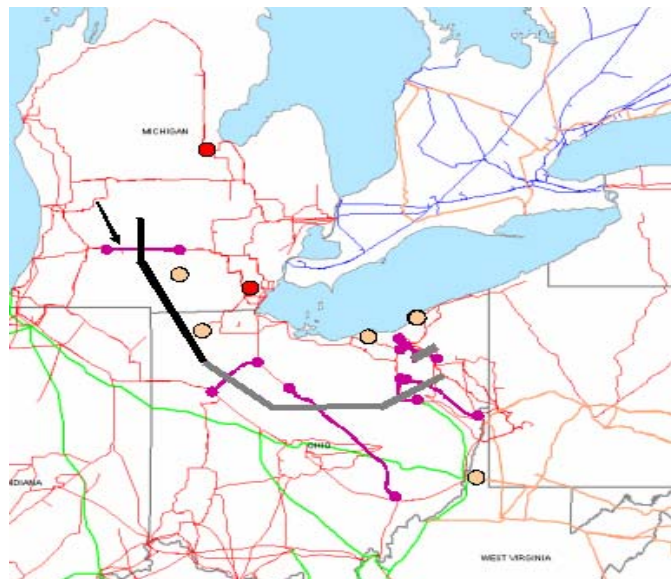
Figure IV.12 — Transmission and Generation Trips in Eastern Michigan, 16:10:36 to 16:10:37

Together, the above line outages interrupted the west-to-east transmission paths into the Detroit area from south-central Michigan. The Sumpter generating units tripped in response to under-voltage on the system. Michigan lines west of Detroit then began to trip, as shown in Figure IV.12.
