NORTH AMERICAN ELECTRIC
RELIABILITY CORPORATION

Eastern Interconnection Oscillation Disturbance

January 11, 2019 Forced Oscillation Event

December 2019

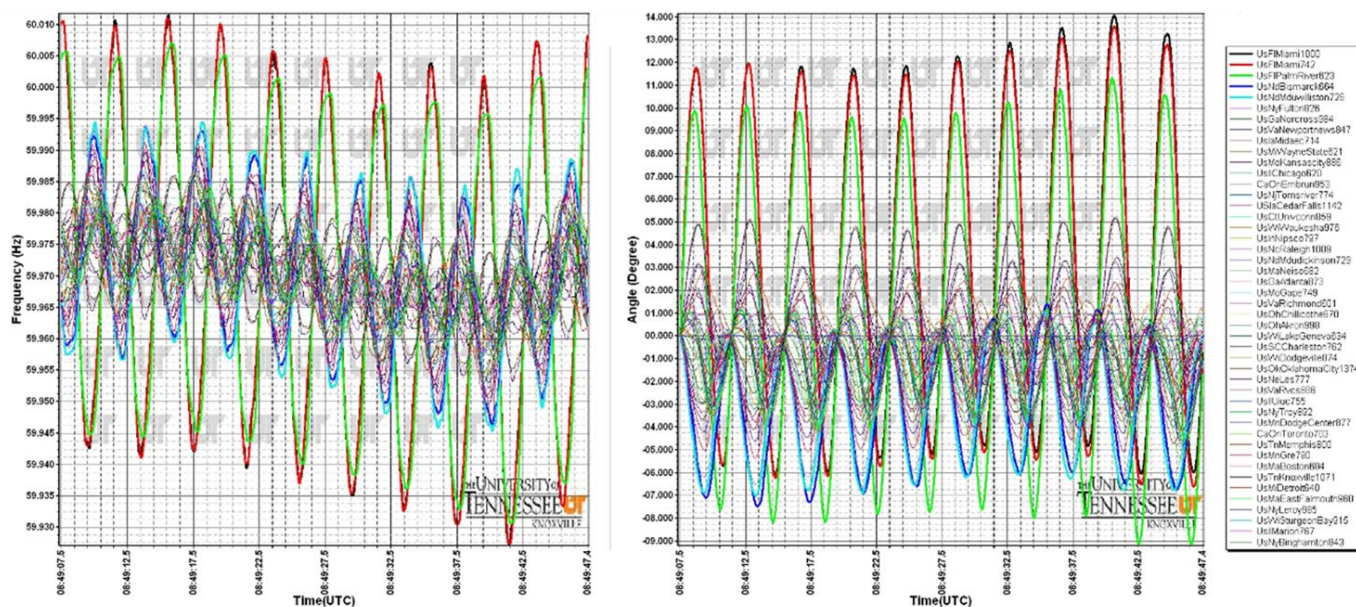
Figure E.1: Frequency and Phase Angle Measurements from across EI²
[Source: UTK/ORNL]

On January 11, 2019, a steam turbine at a combined cycle power plant in Florida experienced a faulty input to a control system that resulted in oscillations that persisted for around 18 minutes before the plant operator manually removed the unit from service. The oscillations were caused by a perceived power load imbalance (PLI) condition in the turbine controls that was initiated by a failed potential transformer (PT) connection and errored voltage measurement in the control system. The source of the oscillation was removed by the plant operator taking actions to shut down the plant following identification of inadvertent intercept valve operations due to the failure. The steam turbine experienced an oscillatory behavior that occurred near a 0.25 Hz frequency (about a four-second periodic behavior) that interacted¹ with the natural system modes of the Eastern Interconnection (EI). For this reason, the oscillation propagated through the entire EI, impacting entities across the EI. This was observed by phasor measurement units (PMUs) and other dynamic disturbance recording devices across all Reliability Coordinators (RCs) in the EI (see [Figure E.1](#)).

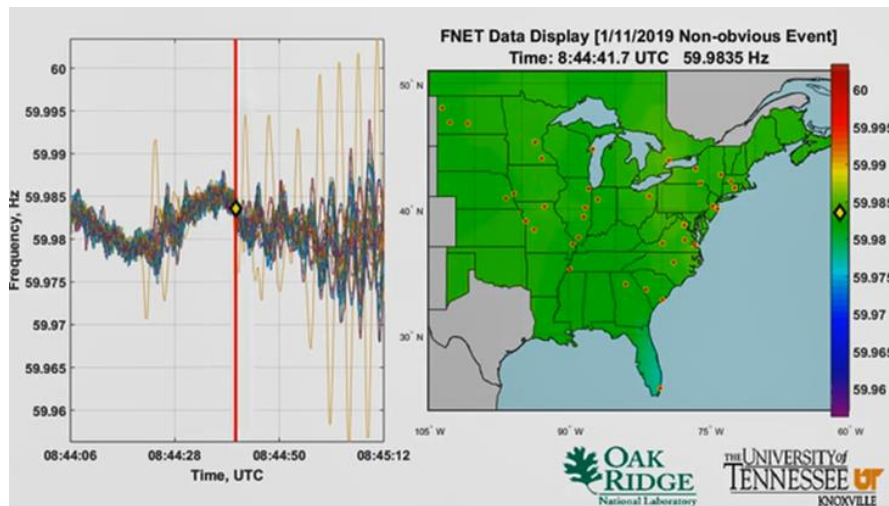
Figure 1.1: Beginning of Oscillation Disturbance
[Source: UTK/ORNL]

On January 11, 2019, around 08:44:16 coordinated universal time (UTC), an oscillation was observed in the Florida area as shown in [Figure 1.1](#). Subsequently, around 08:44:40 UTC, an oscillation began that persisted for approximately 18 minutes. At around 09:02:26 UTC, the oscillation died down and the BPS returned to normal oscillatory behavior (see [Figure 1.2](#)). During the oscillation, the dominant oscillation frequency observed across the EI was around 0.25 Hz with a near-zero damping ratio (see [Table 1.1](#)).⁶

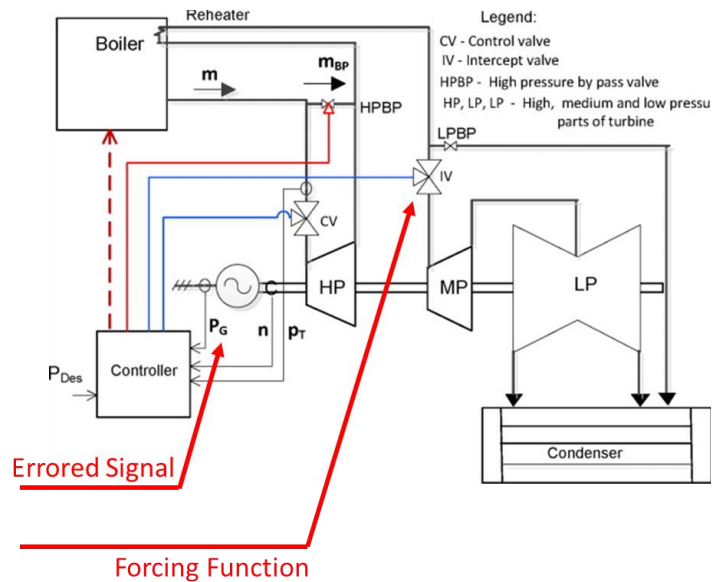
Figure 1.3: Basic Illustration of PLI Failure Mode

The forced oscillation occurred on the steam turbine⁸ generator at a 4x1 combined-cycle facility that oscillated by approximately 200 MW peak-to-peak until the unit was manually tripped by the plant operator. The oscillation was caused by a perceived mismatch between electrical output power and steam flow (input power), a function of the PLI control. The PLI control interfaces with the fast closing actions on the intercept valves. Refer to [Figure 1.3](#) for a simplified control diagram, a marked error signal, and the location of the forced oscillation caused by the controls. The perceived mismatch was driven by the failure of a PT connection feeding the calculation of generator electrical power output. When an unbalance is identified by the control system, the control system attempts to remedy the unbalance by controlling the valve position. The controls were programmed to only take action after a 20% imbalance. When the PLI threshold is reached, the controls engage the reheat intercept valves.⁹ The valves go through an open/close cycle with a predefined time period.

Upon the closing of the reheat intercept valves, the electrical power output drops quickly, and the imbalance between input and output power is eliminated since both approach zero. Once the threshold is met, a timer is started and

once exceeded when the valves are released. The PLI controls then reopen the valves and the unit can again quickly ramp up power output. However, since the PT measurement still failed, the PLI controls again perceive a mismatch and the process is repeated on a continual basis. The periodicity of this closing and reopening of the intercept values was approximately four seconds.

¹⁰ Vibration over time could have caused the door to move slightly, developing a weak connection for the PT measurement. This was likely a leading candidate for the signal being dropped.

- Turbine controls should not have a single point of failure, including PT and current transformer input measurements that could fail and cause abnormal or unexpected turbine actions.

- The PLI circuit design in the turbine and generator control systems should consider tripping the unit after a short time for these types of persistent alarms to ensure integrity and safety of plant equipment and personnel.

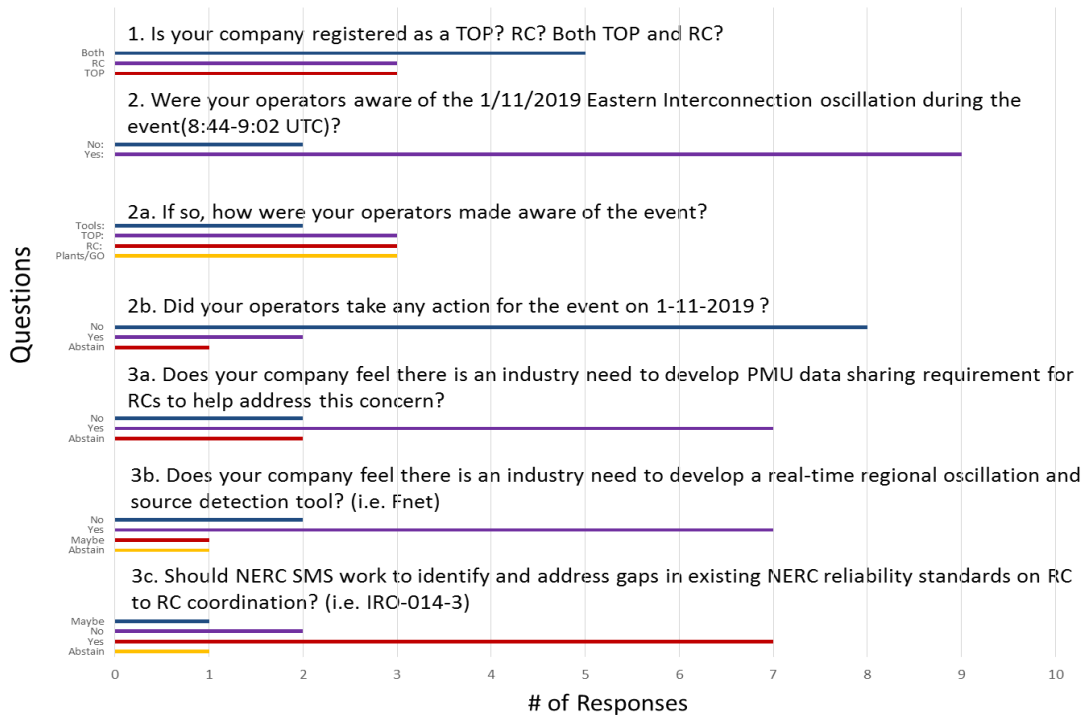
Figure 1.4: NERC SMS Survey Results

- Most RCs and TOPs queried were aware of the oscillation event while it was occurring to some extent. While the RCs were aware of the oscillation, the level of situational awareness was relatively low.

- Few RCs took actions during the event to mitigate the oscillation. One entity removed generating units from AGC during the event but failed to mitigate the oscillation in any way.

- RCs need to improve the guidance and operating plans that are provided to system operators on what actions should be taken when oscillation events occur.

- The industry agreed that some form of PMU data sharing requirements for RCs to better identify issues and address interconnection-wide disturbances, such as oscillation events, is warranted. More visibility and effective data sharing and communication are needed for these types of events.

- Existing NERC Reliability Standards should be reviewed closely to determine if the requirements need to be more descriptive to address these types of events. While RCs may have some degree of situational awareness, these types of oscillation events require close RC-to-RC communication to identify the source location and take appropriate mitigating action in a timely manner.

NERC SMS should investigate tools that can provide interconnection-wide oscillation detection and source location. Further, NERC SMS and the NERC Operating Reliability Subcommittee should continue developing training and education materials on oscillation events, particularly focused on appropriate operator actions.

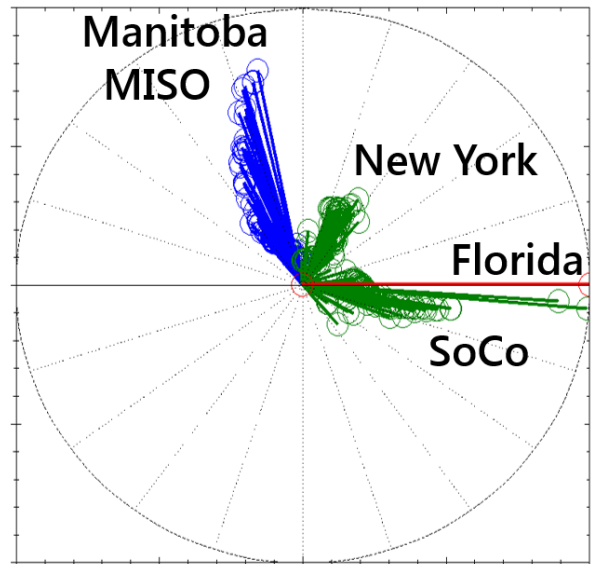
Figure 2.4: 0.25 Hz Forced Oscillation Mode Shape

The natural system mode shapes are shown in **Figures 2.1–2.3** and match closely to the modes previously identified in the NERC oscillation analyses.²⁰ The forced oscillation mode shape is shown in **Figure 2.4**. Refer back to **Figure** , which shows a snapshot in time during the forced oscillation period. The different parts of the EI oscillating clearly map to the mode shape plot in **Figure 2.4**.

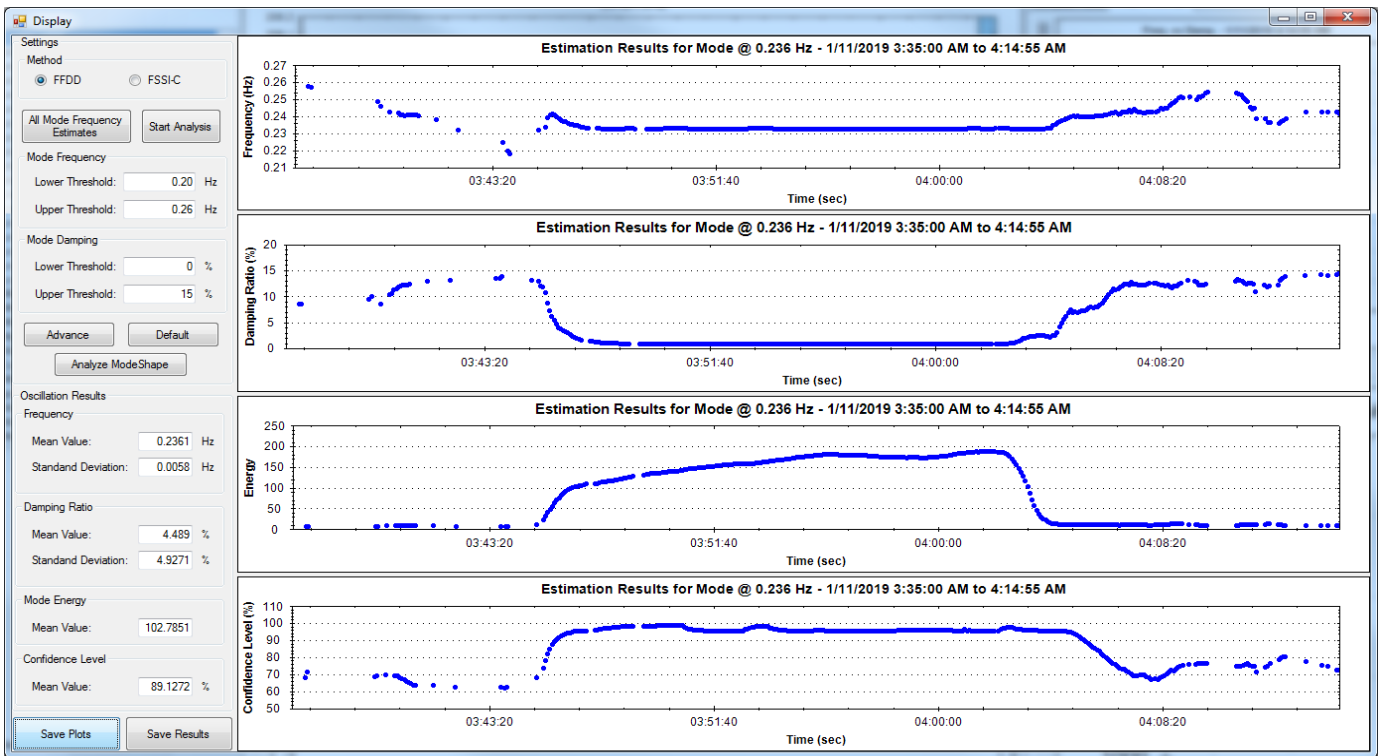
Figure 2.5: Time Series Results of Oscillation Analysis

Figure 2.5 shows a time domain representation of the oscillation analysis, illustrating oscillation frequency, damping ratio, energy, and the confidence level estimate. At the time of the forced oscillation, the frequency remains right around 0.23–0.24 Hz. The estimated damping ratio during this time drops to near zero due to the sustained forced oscillation. The oscillation energy continues to grow during the forced oscillation, and confidence level of the estimate is high during this time. Note that the growing oscillation energy across the EI is not well understood at this time. Electrical waveforms from the source of the oscillation show a constant peak-to-peak active power oscillation.

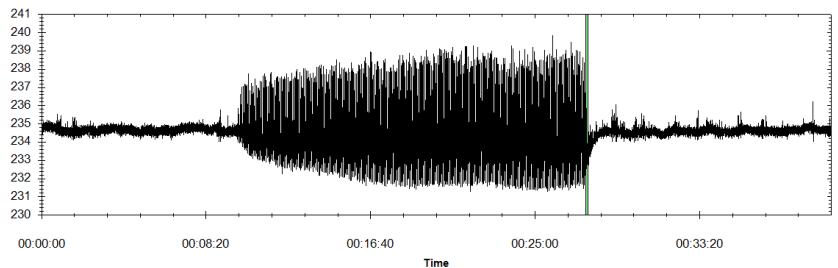
Figure 2.6: Growing Magnitude of Oscillation Observed in Bus Voltage Magnitude

Figure 2.6 shows a 230 kV bus magnitude during the time of the oscillation, starting with around 4 kV and ending around 8 kV peak-peak swings. The reasons for the growing oscillation energy should continue to be explored by the industry in further studies.

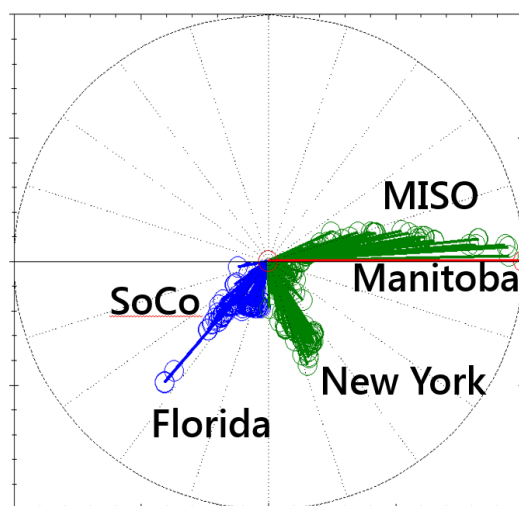
Figure 2.7: Mode Shape for the Identified 0.24-0.25 Hz Mode

Ringdown analysis at the end of the forced oscillation period was also used to evaluate the damping level of the natural system modes following the removal of the forced oscillation. Upon unit disconnection, the EI exhibited a classical ringdown of frequencies and voltage angles as the system returned to steady-state. [Table 2.3](#) shows the results from ringdown analysis. The 0.24 Hz mode dominated the relative energy, and its mode shape is shown in [Figure 2.7](#).

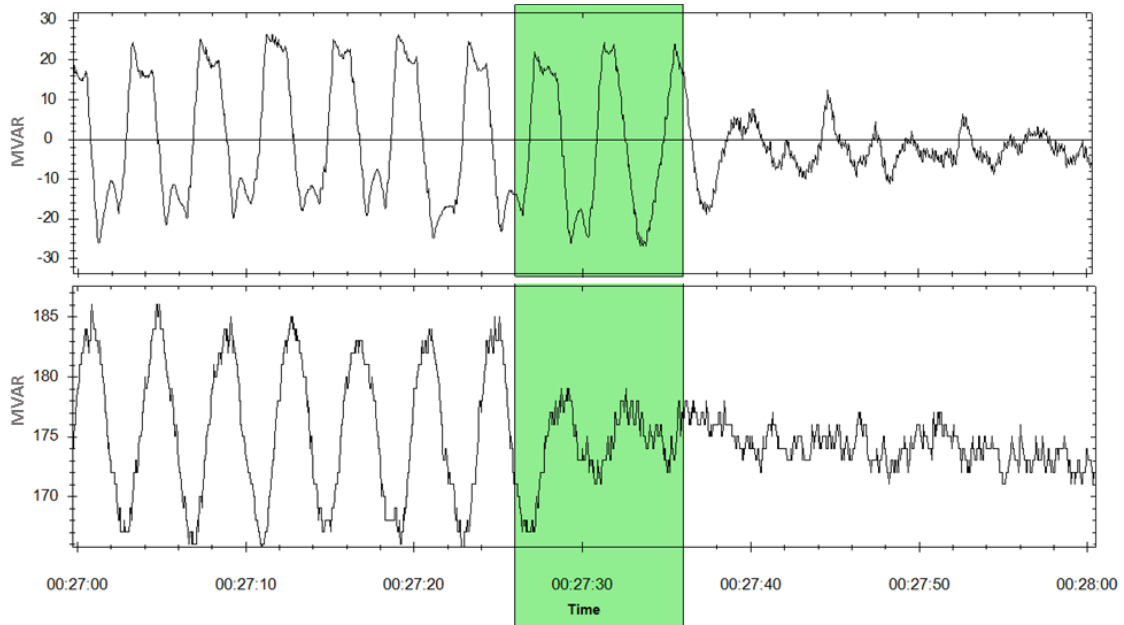
Figure 2.8: Window Demonstrating Forced Oscillation Overlap

Initial estimates of this mode were challenging due to a nonlinear contribution from some PMU measurements. [Figure 2.8](#) illustrates how a separate forcing function caused the ringdown analysis to identify different modal properties for the 0.24–0.25 Hz mode based on local oscillatory signals. The top plot in [Figure 2.8](#) from a PMU near the oscillation source shows that the forced oscillation was removed from the system around time 27:25 (relative plot time). The bottom figure in [Figure 2.8](#) shows that the forced oscillation was present at a different generator electrically far from the oscillation source until around 27:35 (relative plot time).²¹ This initially caused incorrect estimation of the damping ratio for the system mode. After changing the time window to be after 27:35 (in [Figure 2.8](#)), the damping ratio returned to the specified value in [Table 2.3](#). Entities using PMU measurement data sets²² should ensure that any signals containing spurious or nonlinear measurements are omitted from the analysis dataset. Verifying the oscillation analysis results by using results from multiple signal groups and different time windows also helps verify the validity of the results.

²¹ The persisting oscillatory behavior was attributed to voltage regulator controls tuning issues at that generating facility. The owner of this data was notified of this issue.

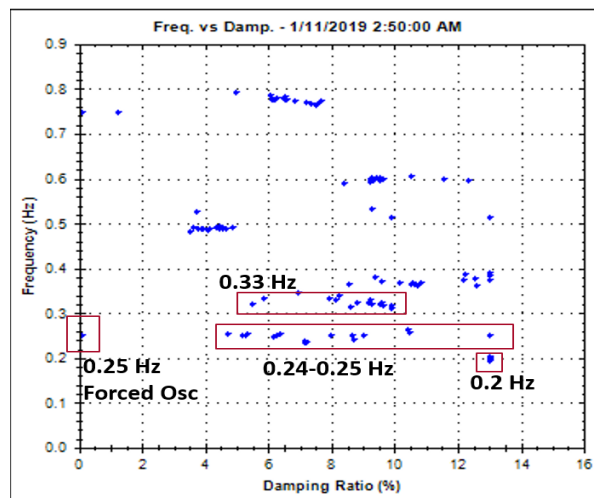
Figure 2.9: Estimate of Modes during Oscillation Event

Figure 2.9 shows the estimates of oscillation frequency and damping ratio during the forced oscillation event. Each red box shows an estimate cluster associated with one mode or oscillation. The results show the simultaneous presence of the 0.25 Hz forced oscillation (cluster with zero damping) and a well-damped natural system mode at around 0.24–0.25 Hz (the other cluster around that frequency). There are also noticeable system modes that are well-damped around 0.2 Hz and 0.33 Hz. Mode shapes for the system modes during the event match those from pre-event and post-event time periods.
