**NERC**

# Multiple Solar PV Disturbances in CAISO

Disturbances between June and August 2021  
Joint NERC and WECC Staff Report

April 2022

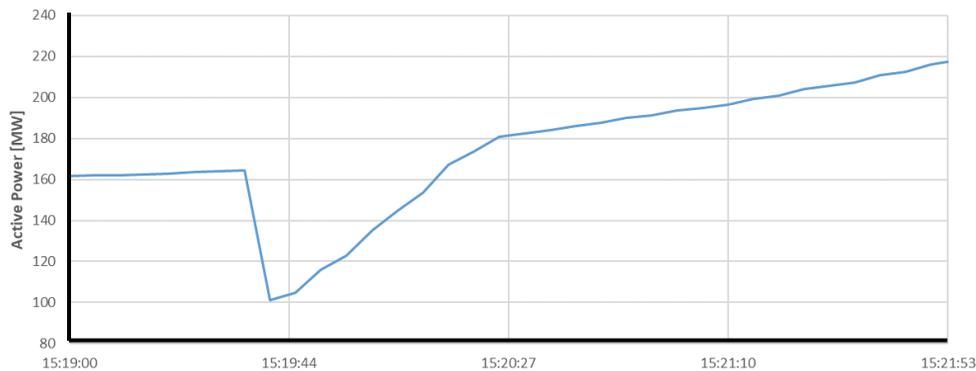
**Figure 2.5: Example of Plant Prolonged Active Power Recovery Post-Fault**

Coordination between NERC, WECC, the plant owner/operator, and the equipment manufacturer(s) led to successful root cause analysis and the development of a corrective action to improve performance at this facility; other facilities with these interactions should explore similar updates to their controls to mitigate these types of issues, if identified.

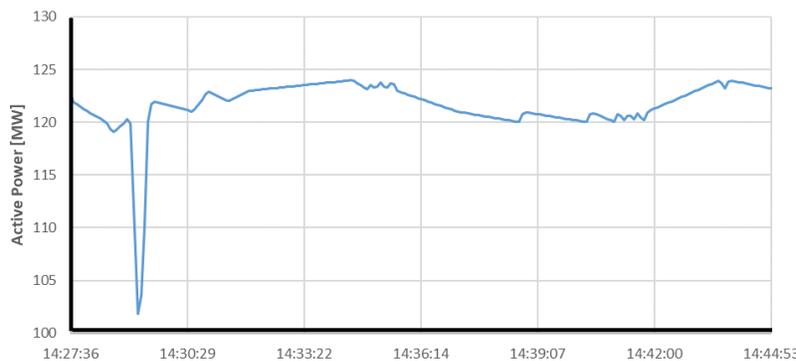
**Figure 2.6: Example of Slow Active Power Recovery Following Fault**

A number of the facilities identified by CAISO as being involved in these disturbances exhibited a response to the fault events that dynamically responded slower than expected. These facilities did not appear to have any abnormal plant controller interactions, had no inverters or feeders trip due to the fault, and did not have inverters configured with momentary cessation enabled. While all of these facilities were unable to provide any more information regarding their response (since no inverters tripped or provided any other fault code indicators), NERC and WECC believe that the facility, specifically the inverters or other controls, are simply programmed to respond post-fault relatively slowly. **Figure 2.6** shows an example of one facility that appears to have close to the desired performance with relatively fast recovery of active power to predisturbance levels; however, the plants takes about 25 seconds for this recovery to occur. Refer to NERC *Reliability Guideline: BPS-Connected Inverter-Based Resource Performance*<sup>15</sup> for more details.

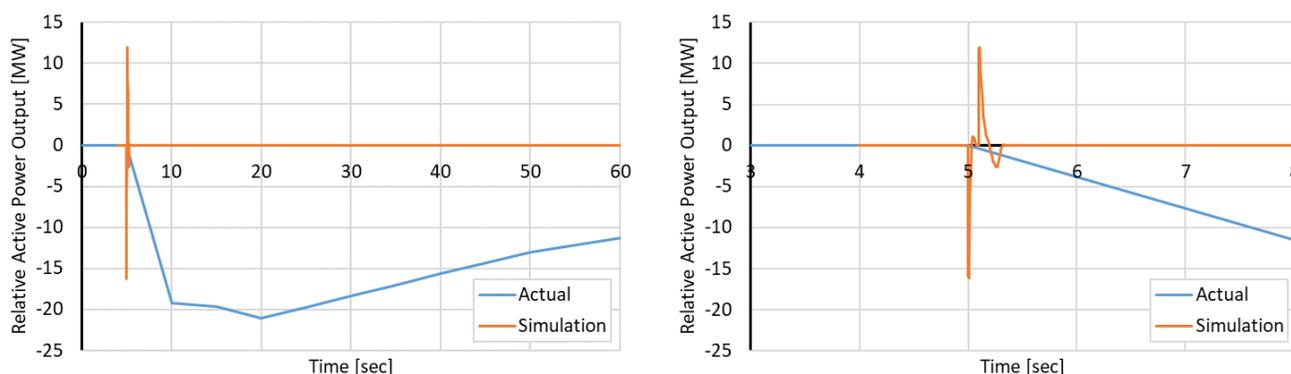
**Figure 4.1: Simulated Versus Actual Response of Affected Facility**

**Figure 4.1** shows a comparison of the simulated response versus the actual response to one of the four disturbances for one of the affected facilities. As the plots show, this facility experienced a 20+ MW reduction of active power that persisted with slow active power recovery well beyond 60 seconds after the fault. While the 5-second SCADA data does not provide high resolution, it does capture the overall trend of the reduction and recovery. A planner uses dynamic models to ensure reliable BPS operation and expects that the model, which includes inverter electrical controls models and a plant-level controller model, to match the actual response relatively closely.<sup>27</sup> In this case, the dynamic model shows the facility exhibiting minor jumps in active power during and immediately following the fault event with the plant returning to predisturbance output within 200 ms. These modeling errors are not minor issues regarding parameterization; they are vast modeling errors or gaps where the plant control modes and interactions are not captured with sufficient fidelity. This plant is being operated in an unplanned and unstudied operating state.

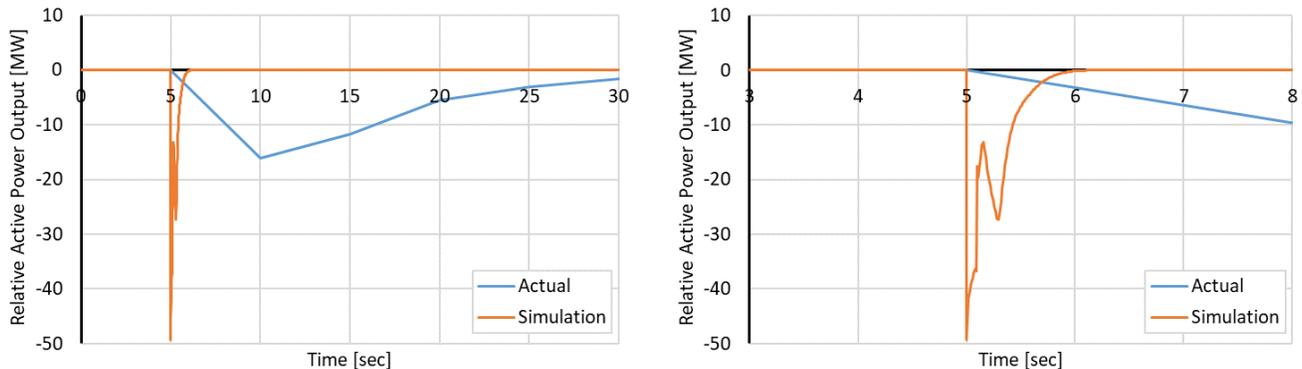
**Figure 4.2: Simulated Versus Actual Response of Affected Facility**

Figure 4.2 shows a similar comparison of a different facility that illustrates the vast difference between simulated versus actual response. As with the example above, this facility reduces power output by about 15 MW and recovers within about 30 seconds. The model shows a much more severe power reduction at the time of the fault (this is attributed to high fidelity simulation results and a more severe fault studied) but does not capture any of the delayed recovery of active power. The simulated response shows that the plant returns to predisturbance output within 1 second. This example again illustrates a plant with a dynamic model that performs very well whereas in actual operation the facility is operating in an unstudied operating state because the model is vastly different from actual performance.

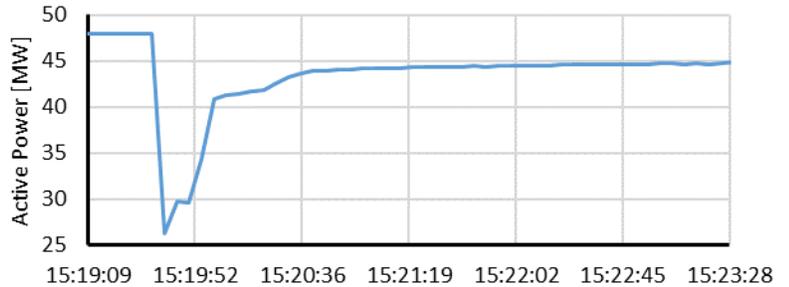
Three inverters tripped on ac overcurrent protection at 150% of rated current. These inverters have momentary cessation settings at 0.9 pu voltage, 0.1 second delay to restart, and no programmed ramp rate (should return within one second); however, the inverters experienced a delayed recovery for about 30–45 seconds.

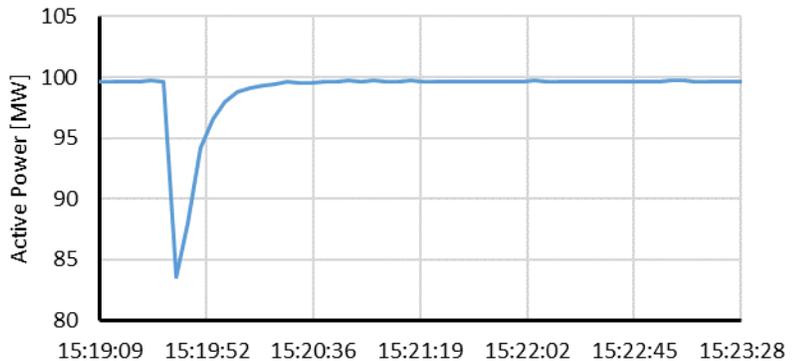
**Plant B**

This plant includes inverters that were initially programmed with momentary cessation; however, momentary cessation was disabled following the NERC alert. This plant now provides reactive power support during low voltage events, but active power is sacrificed and its recovery to predisturbance levels is relatively slow (i.e., does not meet the recommendations of the NERC reliability guidelines).

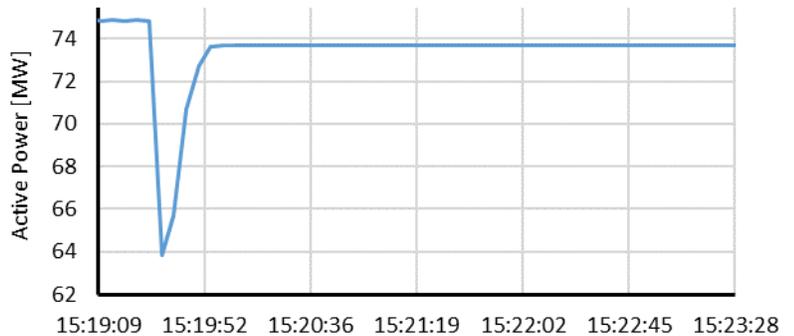
**Plant C**

This plant includes inverters that were initially programmed with momentary cessation; however, momentary cessation was disabled following the NERC alert. This plant now provides reactive power support during low voltage events but active power is sacrificed and its recovery to predisturbance levels is relatively slow (i.e., does not meet the recommendations of the NERC reliability guidelines).

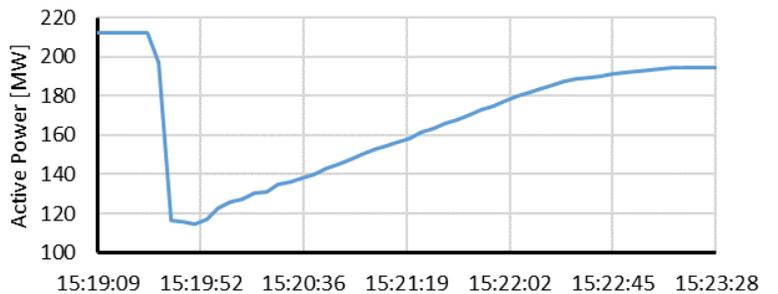
**Plant D**

This plant includes legacy inverters with momentary cessation enabled at 0.875 pu voltage, 1,020 ms delay to recover, and 8.2%/sec ramp rate to restore active power output. On dc overcurrent protection, 13 inverters tripped.

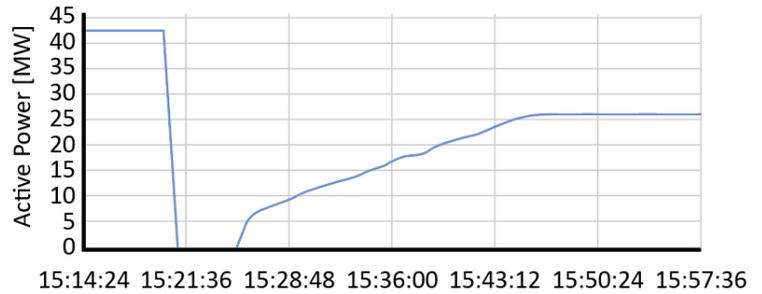
**Plant E**

Twenty-seven inverters tripped; however, the GO was not able to provide any information regarding the cause of the trip. The plant restored power output five minutes later. For the rest of the day, 11 inverters remained off-line.

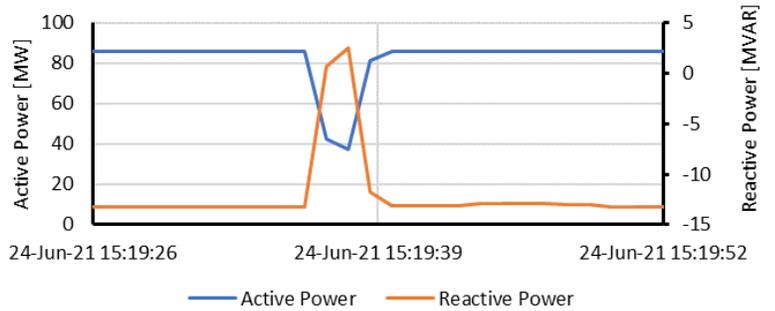
**Plant F**

Inverters provided reactive power support during the fault; however, they sacrificed active power output, which required about 5 seconds to recover. This recovery is relatively quick but is longer than recommendations from NERC reliability guidelines.

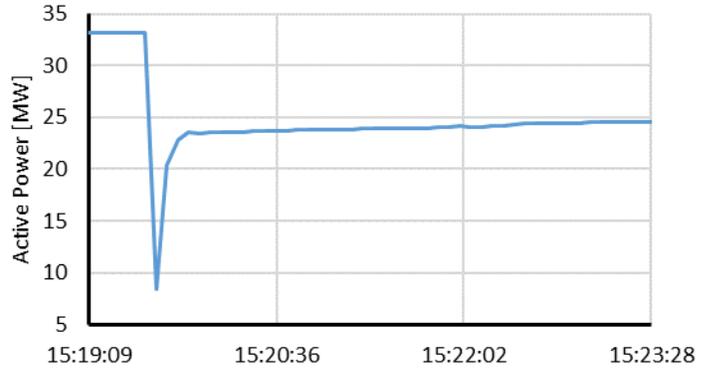
**Plant I**

On ac overcurrent protection, 7 inverters tripped at 150% of rated current. Other inverters entered momentary cessation and recovered within 15–20 seconds. Those inverters are set with momentary cessation settings of 0.9 pu voltage with 0.1 second delay to start active power recovery and “no programmed ramp rate (should return to full output in < one second).” These inverters are unable to eliminate momentary cessation or modify settings. The plant should recover around one second but recovers at a much slower rate.

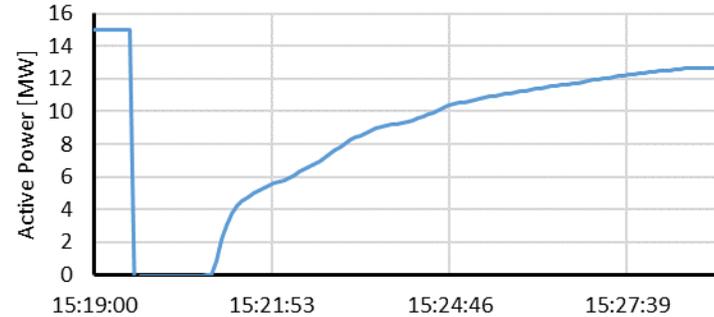
**Plant Q**

All inverters tripped on ac overcurrent above 110% of rated instantaneous peak current. These inverters all had momentary cessation enabled as well. The inverter manufacturer is out of business, so changes to inverter settings cannot be made to mitigate risks of tripping or momentary cessation. The plant returned to predisturbance levels in about 10 minutes, and one inverter remained off-line for an extended duration.

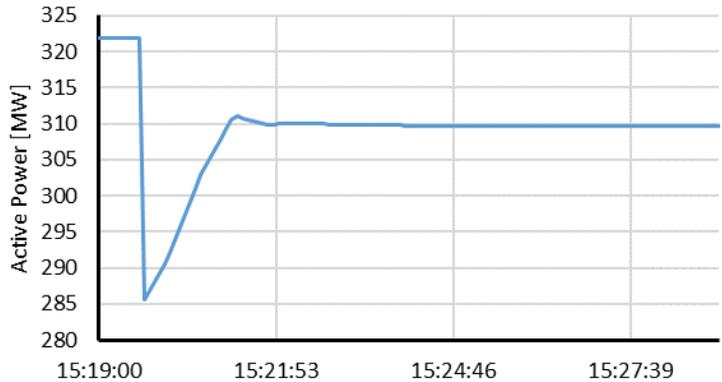
**Plant T**

The plant reduced active power output by 36 MW and increased reactive power output by 11 MVAR. However, active power recovery to predisturbance levels took one minute 35 seconds. Some inverters tripped, but the plant owner was unable to identify any fault codes that caused the trip. The inverter and plant-level controllers are from different manufacturers with a third-party having programmed the plant controller. The active power ramp rate in the plant-level controller is set to 0.167 %/sec. A global ramp rate limit also exists that limits plant ramps to 0–100% in 10 minutes. Inverters are set with a ramp rate of 0–100% in one minute. One or more of these ramp rates hindered the plant from returning to predisturbance levels following faults, degrading system stability, adversely affecting system frequency response, and failing to meet the recommendations set forth in NERC reliability guidelines.

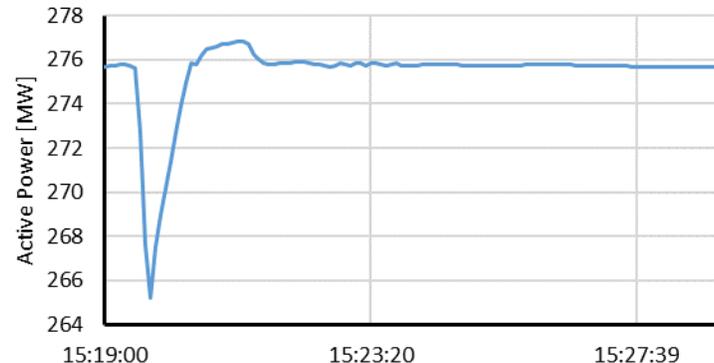
**Plant U**

This plant provided reactive power support during the fault but sacrificed active power (11 MW) and required over one minute to return to predisturbance levels. This does not meet the recommendations in the NERC reliability guidelines.

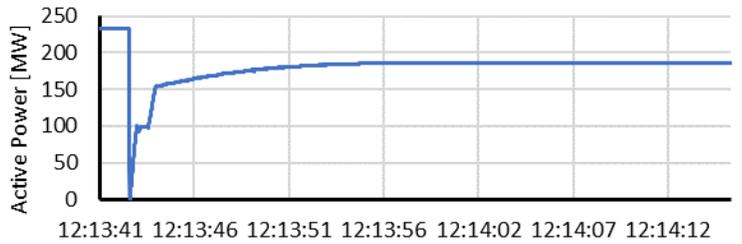
**Plant D**

This plant includes legacy inverters with momentary cessation enabled at 0.875 pu voltage, 1,020 ms delay to recover, and 8.2%/sec ramp rate to restore active power output. Six inverters tripped on dc overcurrent protection.

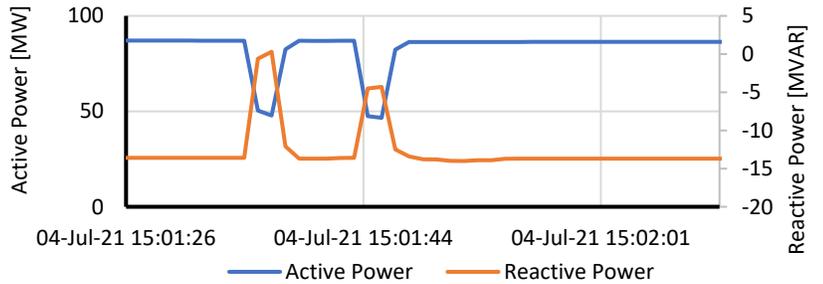
**Plant F**

Inverters provided reactive power support during the fault; however, they sacrificed active power output, which required about four seconds to recover. This recovery is relatively quick but is longer than recommendations from NERC reliability guidelines.

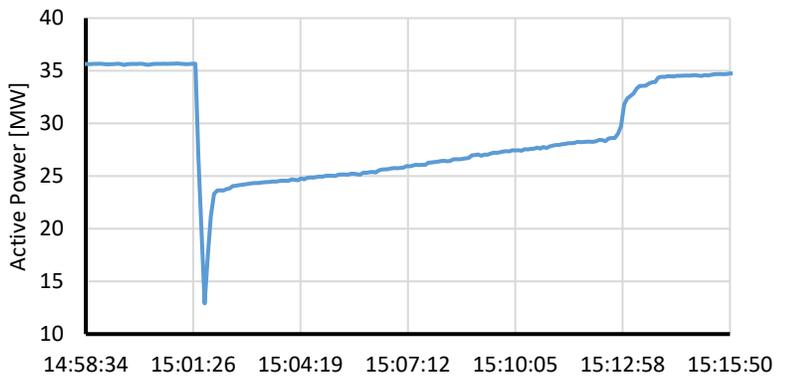
**Plant I**

Eight inverters tripped on ac overcurrent protection at 150% of rated current. Other inverters entered momentary cessation and had settings of 0.9 pu voltage, 0.1 second delay to start active power recovery, and “no programmed ramp rate (should return to full output in < one second).” These inverters were unable to eliminate momentary cessation or modify settings. However, the plant should recover to predisturbance levels within about one second but takes 15–20 seconds to recovery, indicating plant-level controller interactions.

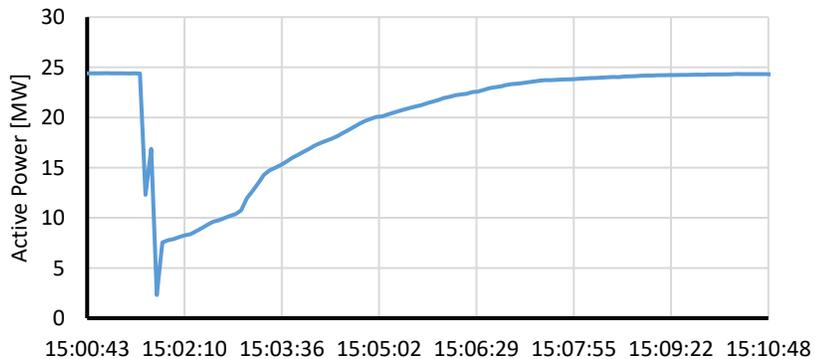
**Plant K**

Six inverters tripped on instantaneous ac overcurrent protection at 110% of peak nominal current. Other inverters at the facility likely entered momentary cessation. The inverter manufacturer is out of business, so additional details are unavailable and the plant is unable to make modifications to the inverter settings. The plant returned to predisturbance output levels in about six minutes.

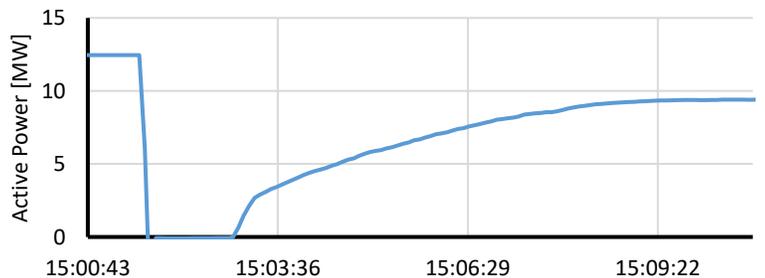
**Plant Q**

All inverters tripped on instantaneous ac overcurrent protection set at 110% of peak nominal current. The inverter manufacturer is out of business, so additional details are unavailable and the plant is unable to make modifications to the inverter settings.

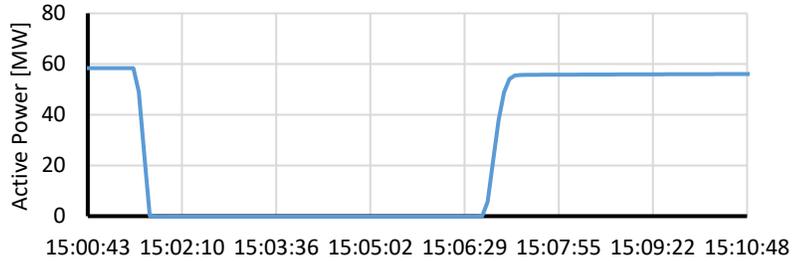
**Plant R**

Two inverters tripped due to uninterruptible power supply failure and remained off-line for the rest of the day. All other inverters tripped but the plant was unable to provide any details as to the cause of inverter tripping.

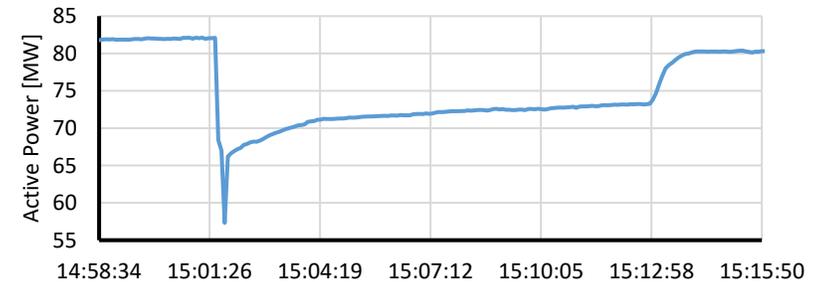
**Plant V**

Five inverters tripped on ac overcurrent protection at 150% of rated current. Three inverters logged no cause of tripping. These inverters are also configured with momentary cessation enabled.

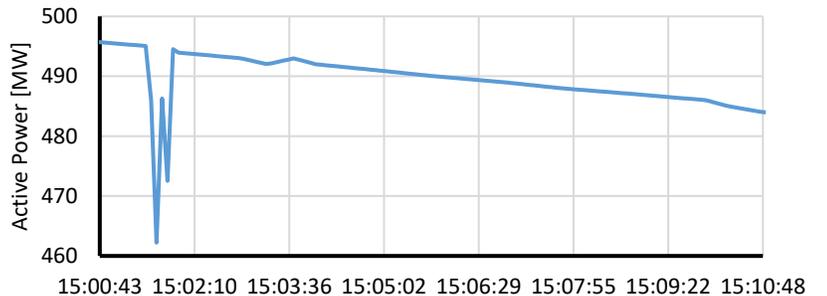
**Plant X**

One inverter tripped with no fault code. The remaining inverters responded dynamically to the fault event; no inverters at the facility are configured with momentary cessation enabled. According to SCADA data, the plant required about 30 seconds to fully recover to predisturbance output levels.

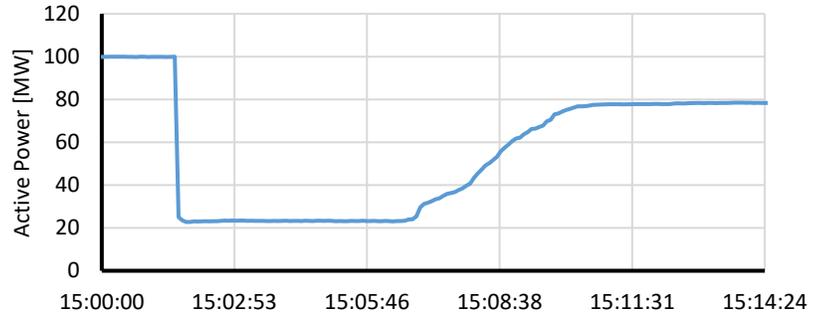
### Plant AC

All inverters entered momentary cessation and started recovering 33 ms after fault clearing. Fourteen inverters restored output very quickly. The remaining inverters tripped, and sixteen returned in 10 minutes while eight did not return until later in the day. Inverter fault code records indicate that inverters tripped on “unbalanced voltage” conditions. There are three collector feeders in this plant. The inverters that tripped are all located on

feeders that have an underground collector portion; the inverters that remained on-line are located on a fully-overhead collector system. The plant owner also stated that the voltage ride-through protection had been disabled in May 2021 unexpectedly during maintenance procedures and were restored at the end of August 2021. It is unclear if this was a contributor to this resource tripping abnormally for this event.

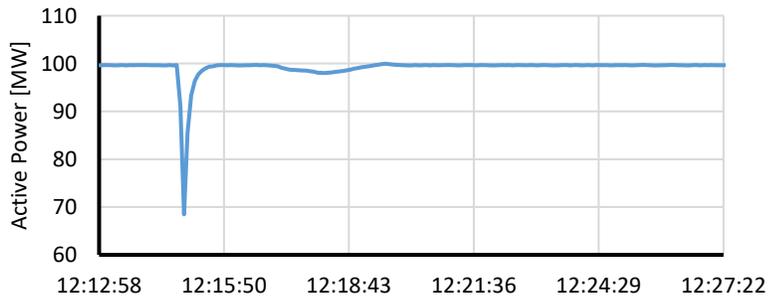
**Plant B**

This plant includes inverters that were initially programmed with momentary cessation; however, momentary cessation was disabled following the NERC alert. This plant now provides reactive power support during low voltage events but active power is sacrificed and its recovery to predisturbance levels is slower than recommended in NERC reliability guidelines.

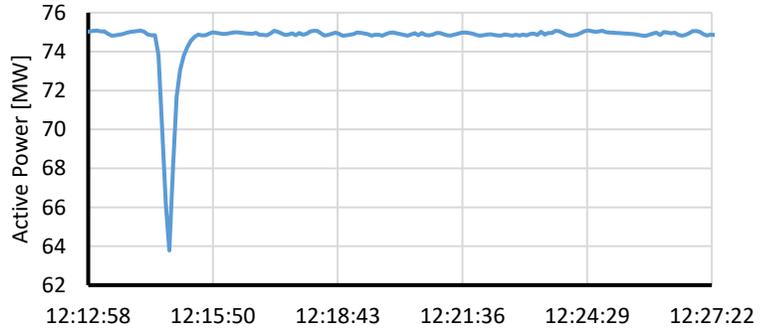
**Plant C**

This plant includes inverters that were initially programmed with momentary cessation; however, momentary cessation was disabled following the NERC alert. This plant now provides reactive power support during low voltage events but active power is sacrificed and its recovery to predisturbance levels is slower than recommended in NERC reliability guidelines.
