# Panhandle Wind Disturbance

Texas Event: March 22, 2022  
Joint NERC and Texas RE Staff Report

August 2022

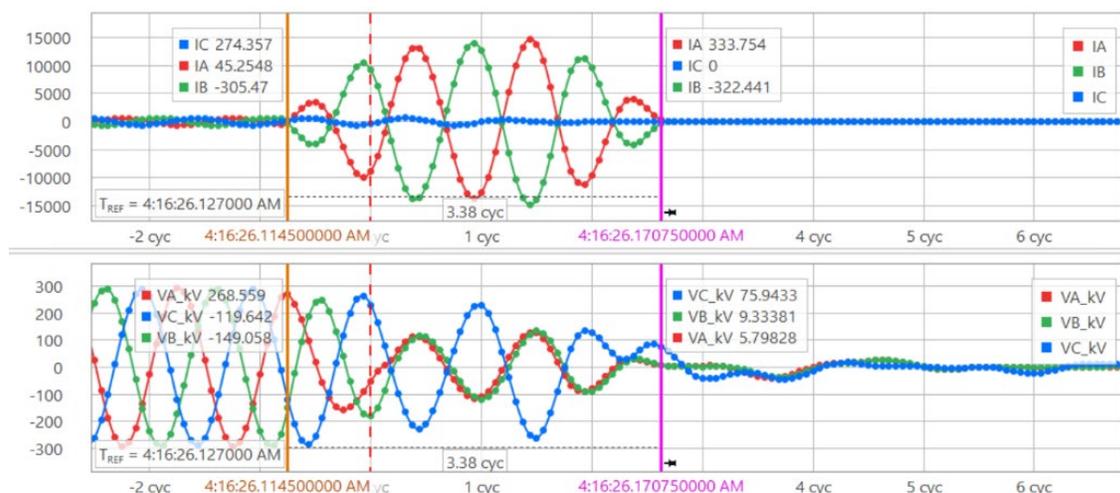
Figure I.2: A–B Fault on Generator Tie Line [Source: Oncor]

- Event 1:** The first fault was an A–B phase fault that cleared normally in 3.38 cycles. The fault occurred on a generator tie line about two miles from the 345 kV transmission substation (see [Figure I.2](#)) and subsequently tripped 273 MW of wind generation.

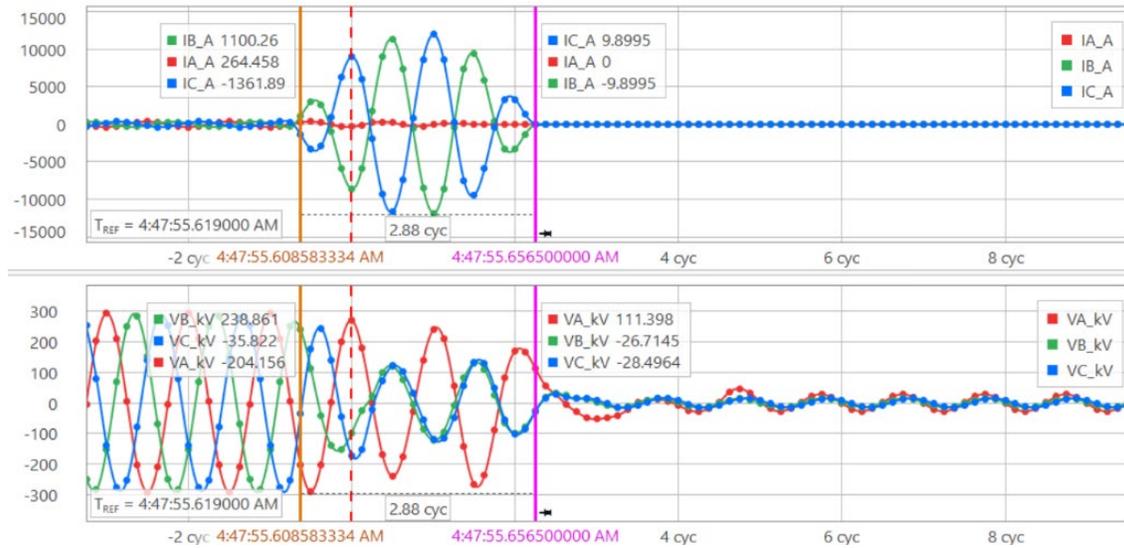
**Figure I.3: B-C Fault on 345 kV Transmission Circuit [Source: Oncor]**

- Event 2:** The second fault was a B–C phase fault that cleared normally in 2.88 cycles (see [Figure I.3](#)). The fault occurred on a 345 kV transmission circuit about three miles from the same substation in Event 1. ERCOT operations noted that the fault occurred due to galloping conductors.

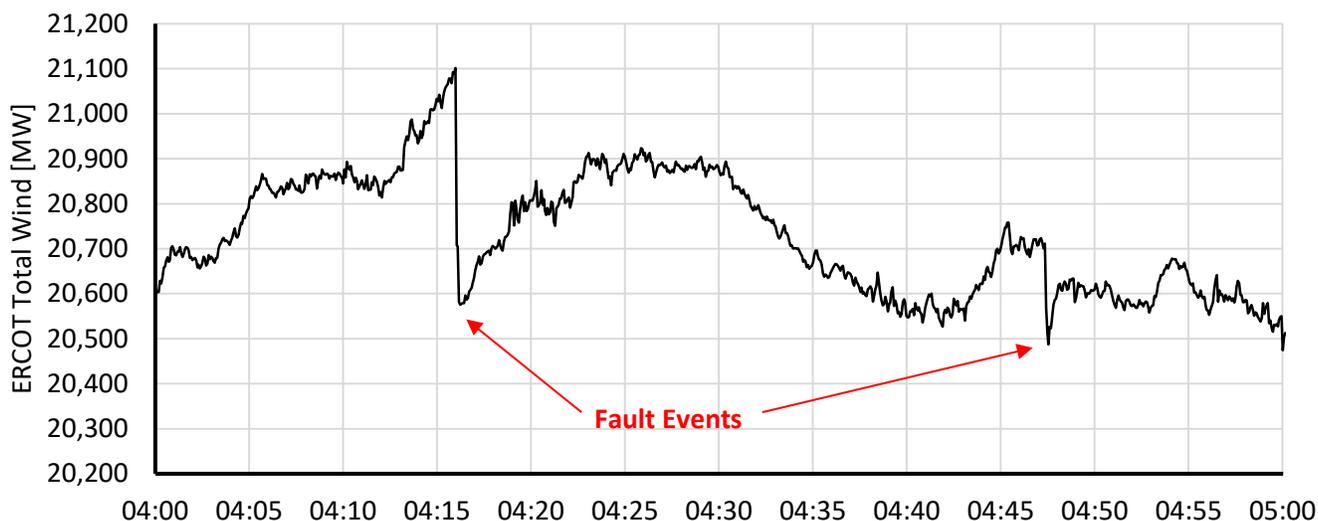
**Figure I.5: ERCOT Wind Output during Disturbances**

**Figure I.5** shows the reduction in wind resources reported by the ERCOT SCADA system. As with the past disturbance reports that involve fault-induced inverter-based resource reductions, the size of the active power reduction is determined by using SCADA data from the affected BA (i.e., ERCOT) in addition to analyzing data provided by individual facilities. Discrepancies may exist between the values due to SCADA scan rate limitations, meter resolutions, accounting practices, and other factors; however, the reductions in wind plant output provide a relative indicator of the impact of these reductions compared to past disturbances.

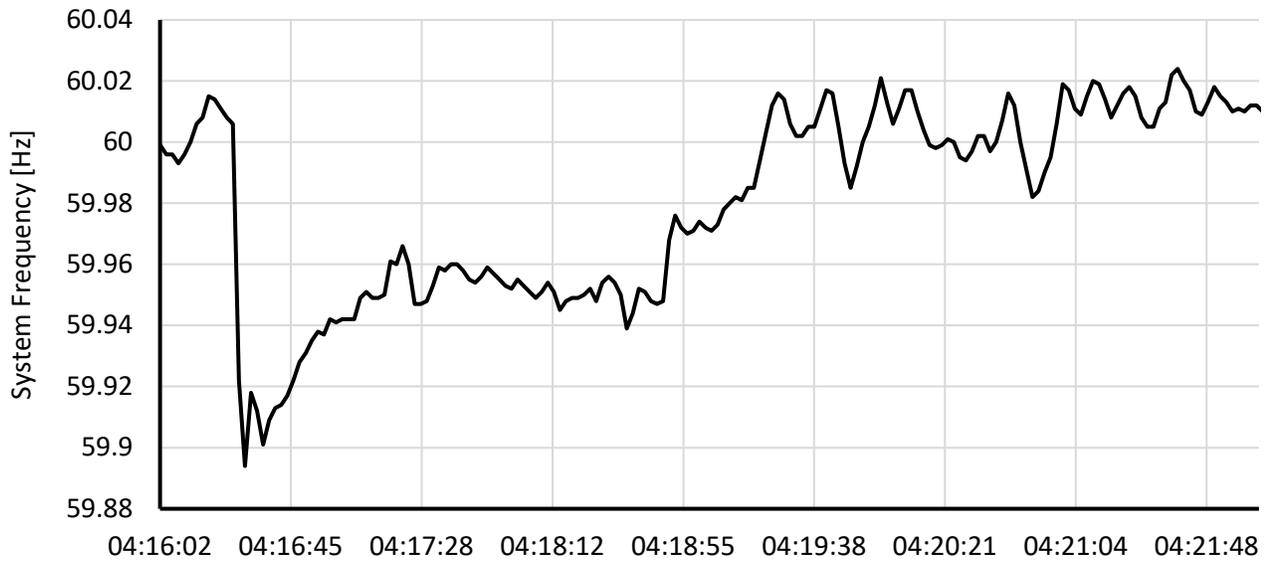
**Figure I.6: System Frequency Response for First Fault Event**

The first fault-induced generation loss event caused frequency to drop from 60.01 Hz to 59.9 Hz (see **Figure 6**). A total of 524 MW of generation responsive reserve service (RRS)<sup>6</sup> and 0 MW of load resources (LR)<sup>7</sup> were deployed in response to the frequency drop. Governor action and RRS deployment helped frequency recover within two minutes and 52 seconds. Calculated inertia at the time of the event was relatively low (130.4 GW-seconds) due to the high wind penetration at the time (over 61%). Measured maximum rate of change of frequency was 0.098 Hz per second, and the time from the event start to the frequency nadir was measured at 1.9 seconds (much lower than the average range of 5–6 seconds) due to the low-inertia conditions.

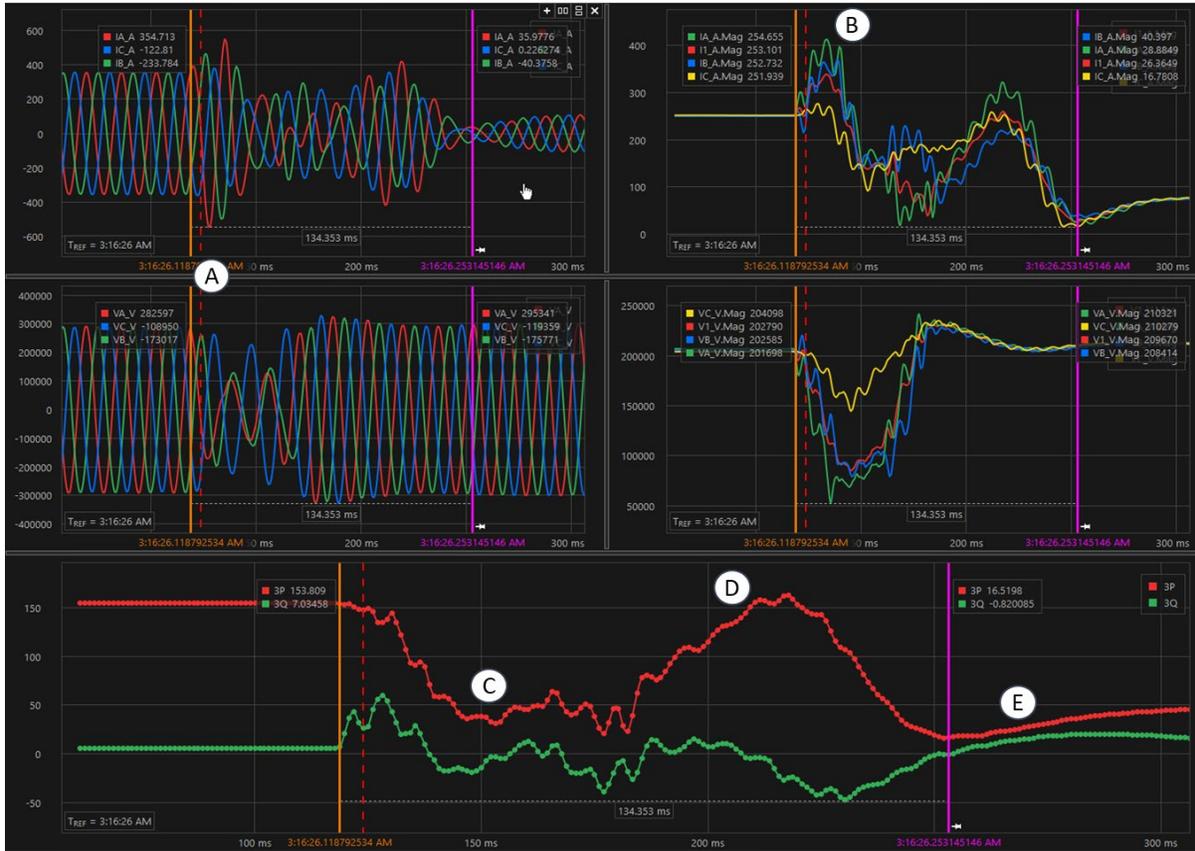
**Figure 1.3: Abnormal Dynamic Response of Wind Power Plant**

- **D:** Active power recovers back to predisturbance output upon fault clearing within about 50 ms. This is a very quick recovery and supports grid frequency control but needs to be balanced with local grid voltage stability.

- **E:** After fault clearing and once voltages have recovered, active power quickly drops to near zero and begins an extended ramp back to predisturbance values. It is likely that the turbine low voltage ride through controls kick in, having the turbine return to predisturbance output on a ramped output. Prior NERC guidance has stated that resources should return to predisturbance values within one second; however, it is unclear why the resource recovers within 50 ms and then reduces output to near zero and begins a much slower recovery. Again, it is critical that these types of dynamics are appropriately modeled in positive sequence and electromagnetic transient (EMT) models. It is suspected that they are not in many positive sequence models.

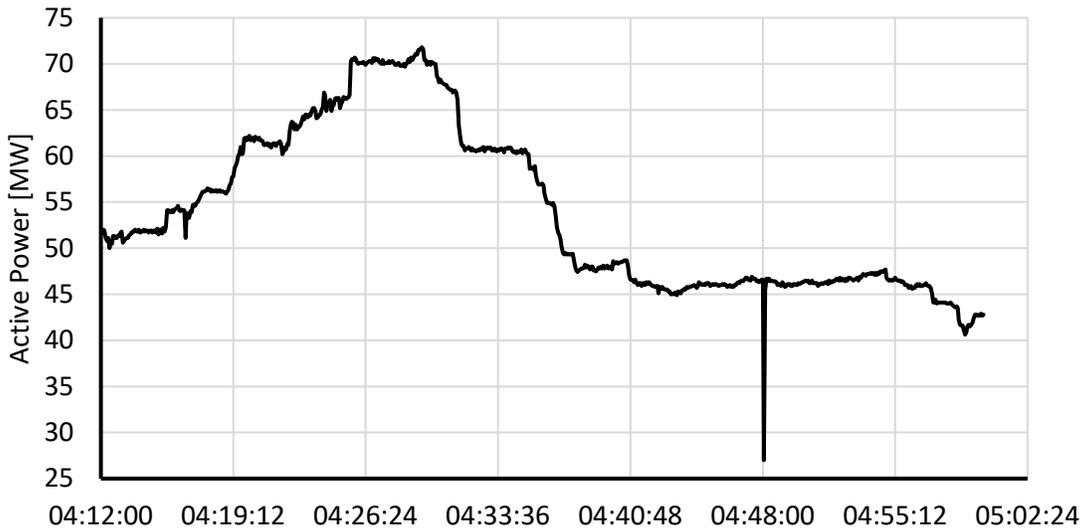
**Figure 1.4: Reduction of Active Power during Fault Conditions**

The relatively significant reduction in active power is often caught by SCADA data depending on scan rates. **Figure 1.4** shows an example of a plant that reduced output for both the first and second fault with active power dropping to near zero and recovering very quickly. SCADA data essentially missed the first fault and only picked up a partial reduction for the second fault. **Figure 1.5** shows the high speed oscillography data capturing the plant going to zero output during the fault and recovering over a time period of 1–1.5 seconds.

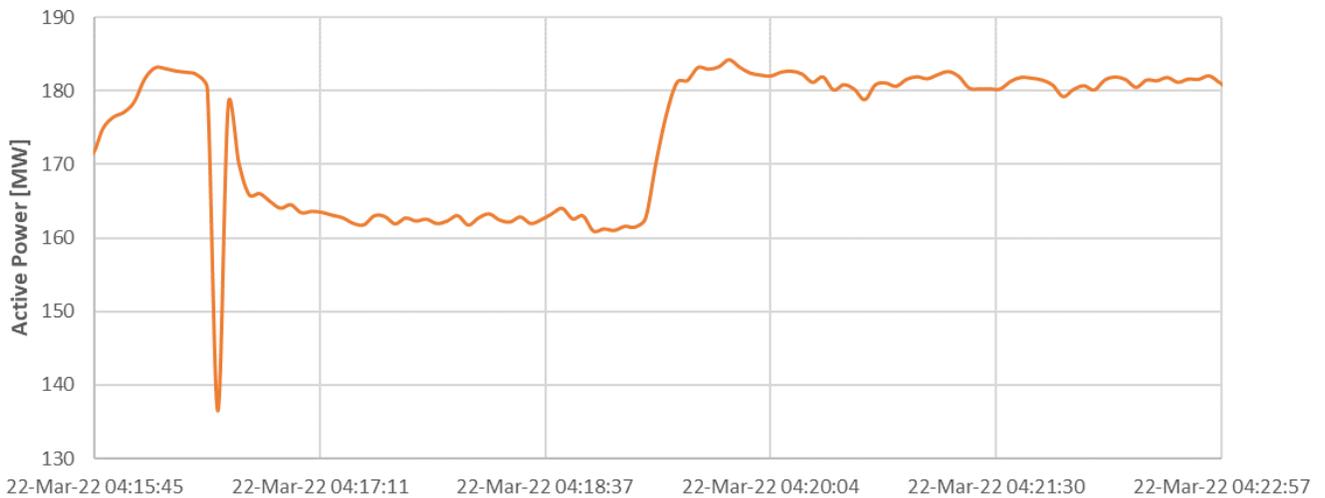
**Figure 1.7: Plant Active Power-Frequency Controller Interactions**

In the March 2022 disturbance, the plant controller active power-frequency response controls are incorrectly sending dispatch signals to the individual turbines immediately following the LVRT condition; this is partly caused by abnormal or unexpected response of the individual turbines after fault clearing. [Figure 1.6](#) shows one plant where the turbines provide fault current during the low voltage fault; however, turbine current then rapidly decreases post-fault, causing active power output to drop drastically from about 180 MW predisturbance down to a low of 116 MW. During this time, the plant controller is regaining control of the turbines' output and latches on to a plant power output of about 163 MW during the swing. That latched value becomes the new set point dispatch for the active power-frequency controller. So the turbines settle at a new output of 163 MW even though there is sufficient wind speed for 180 MW. Frequency remains low for a couple minutes and the new dispatched set point is held until frequency recovers and the erroneous dispatch from the controller is released. Once frequency returns to near nominal, the plant rapidly recovers back to predisturbance output (see [Figure 1.7](#)).

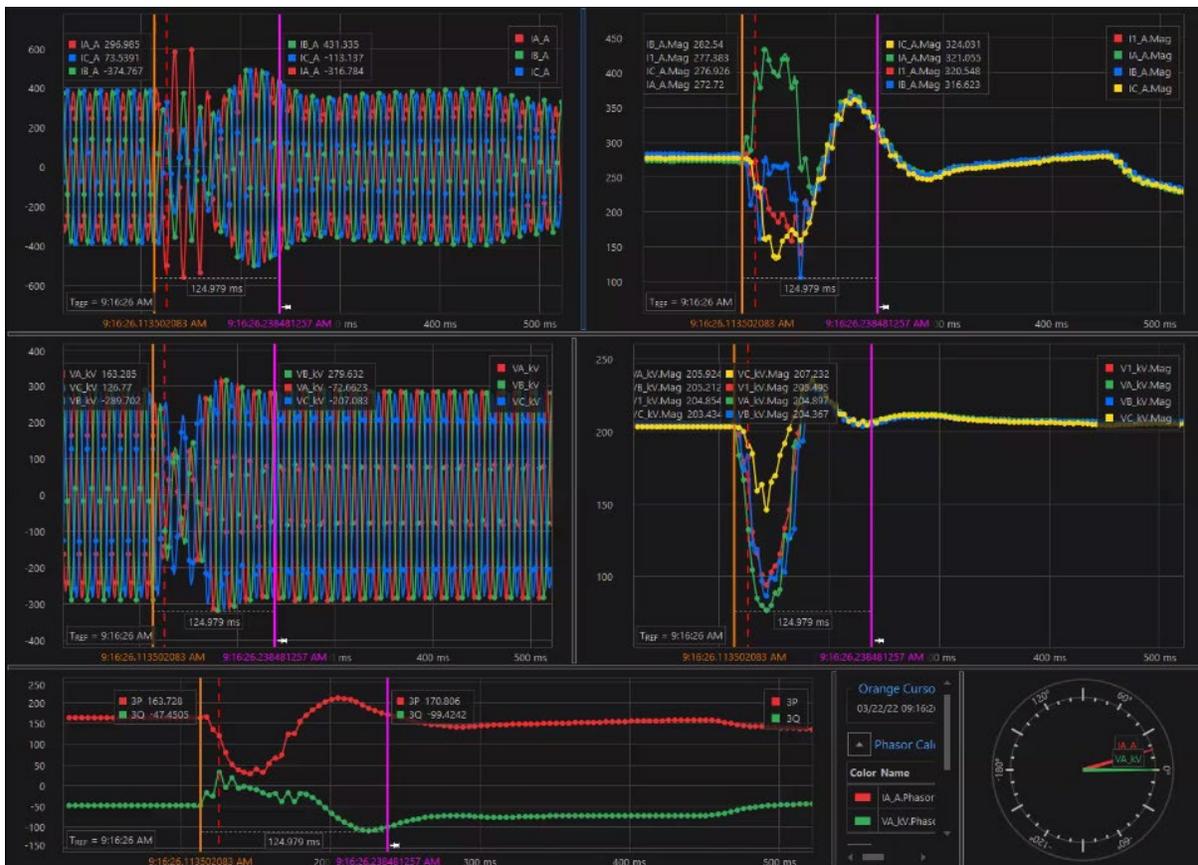
Figure 1.8: Affected Plant High Speed Measurement Data

The affected facility had extensive high-speed measurement data that provided the analysis team and the plant turbine manufacturer with the ability to perform detailed forensic analysis. Figure 1.8 shows the plant dynamic response of the facility captured with oscillography data from a digital relay at the POI. The fault occurs and turbine power naturally drops and recovers back to pre-disturbance output within about 50 ms. After returning to predisturbance conditions, plant output starts dropping about 150 ms later; this is suspected to be the time that the turbines begin tripping on SSR protection. However, this response is not indicative of any SSO conditions occurring at the facility based on the data provided.

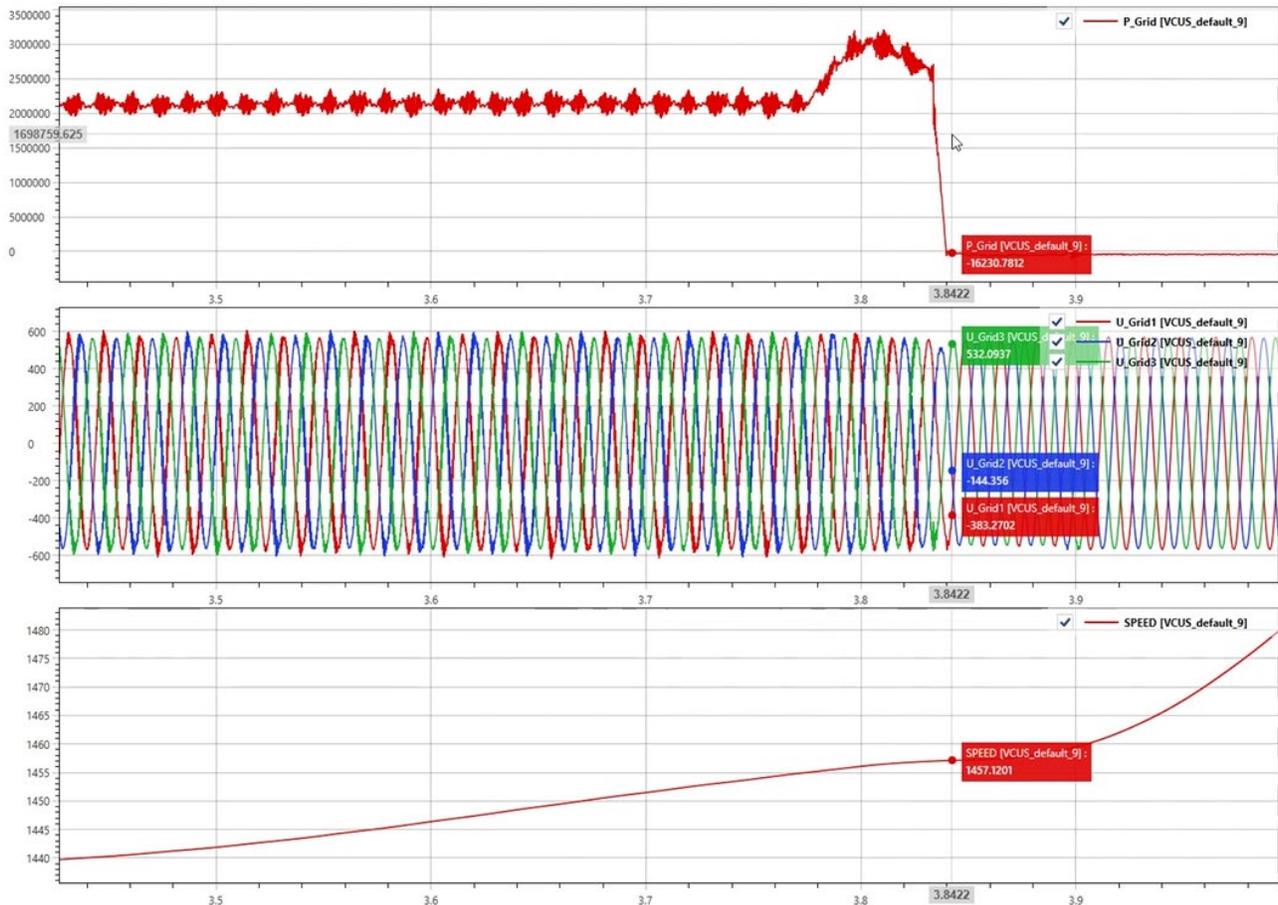
**Figure 1.9: Turbine High Speed Data Capturing Turbine Tripping for Different Event**

The turbine manufacturer with their ability to quickly remotely connect to the turbines at the affected facility informed NERC, Texas RE, and ERCOT that another fault-induced tripping of the turbines occurred a couple weeks later. Since this event was more recent, the turbine manufacturer was able to gather 10 kHz high resolution data from the turbine directly to observe what the turbine experienced immediately prior to tripping. **Figure 1.9** shows the active power (top), turbine voltage (middle), and turbine speed (bottom) during the fault. Note that the measurements are taken in front of the turbine filter capacitors and are unfiltered quantities, so they show more oscillations and noise in the data since they are not yet smoothed by the filter capacitors. As the plot shows, when the fault occurs, the turbine (rated at 2 MW) rapidly ramps up active power to about 3.2 MW and then quickly trips. No anomalous or abnormal data is observed in voltage or speed measurements at the turbine. The turbine manufacturer is continuing to investigate the cause of this tripping and will further determine if tripping may be attributed to SSO issues or some other cause. While sustained SSCI is not observed, it is plausible that the turbine tripped on the first unstable swing of an oscillation that could have been caused by SSO-related issues.

The turbines also alarmed on a 700% ac overvoltage condition. The turbine manufacturer explored this alarm in detail by using all available information at the facility and determined that the code used to alarm only (not control or protect the turbine) had a bug that resulted in an incorrect value reported to the turbine logger. NERC, Texas RE, and ERCOT also observed that plant POI voltage only reached a maximum of 1.2 pu, so 7.0 pu voltage is not feasible. This issue is being explored by the manufacturer in more detail and will be corrected with a firmware update.

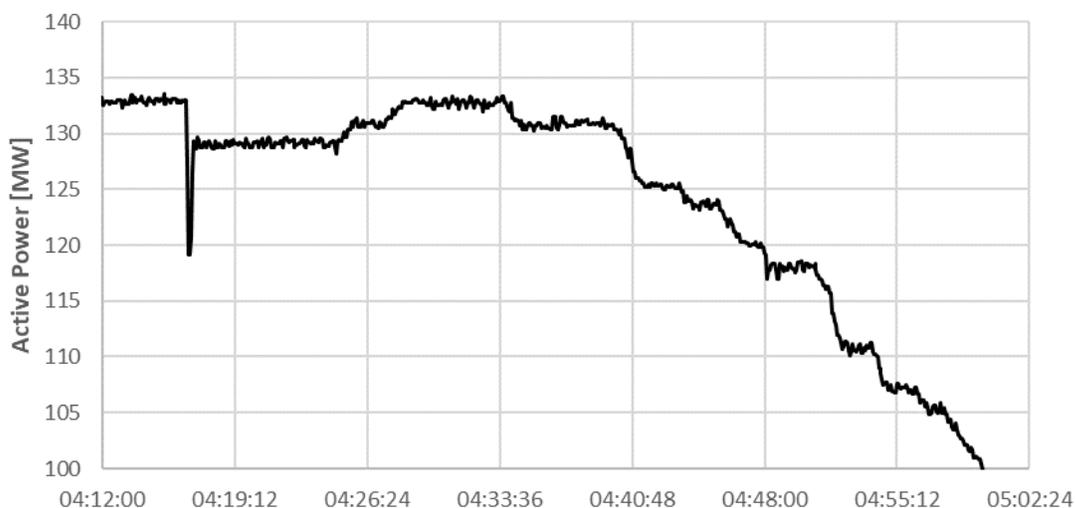
**Figure A.1: Plant Active Power Output**

This plant reduced power output by 14 MW during the first fault (see [Figure A.1](#)). A couple turbines tripped and recovered in about 15 minutes. The plant did not noticeably reduce output during the second fault. The analysis team did not perform a detailed analysis of this plant; therefore, the causes of reduction are not known.

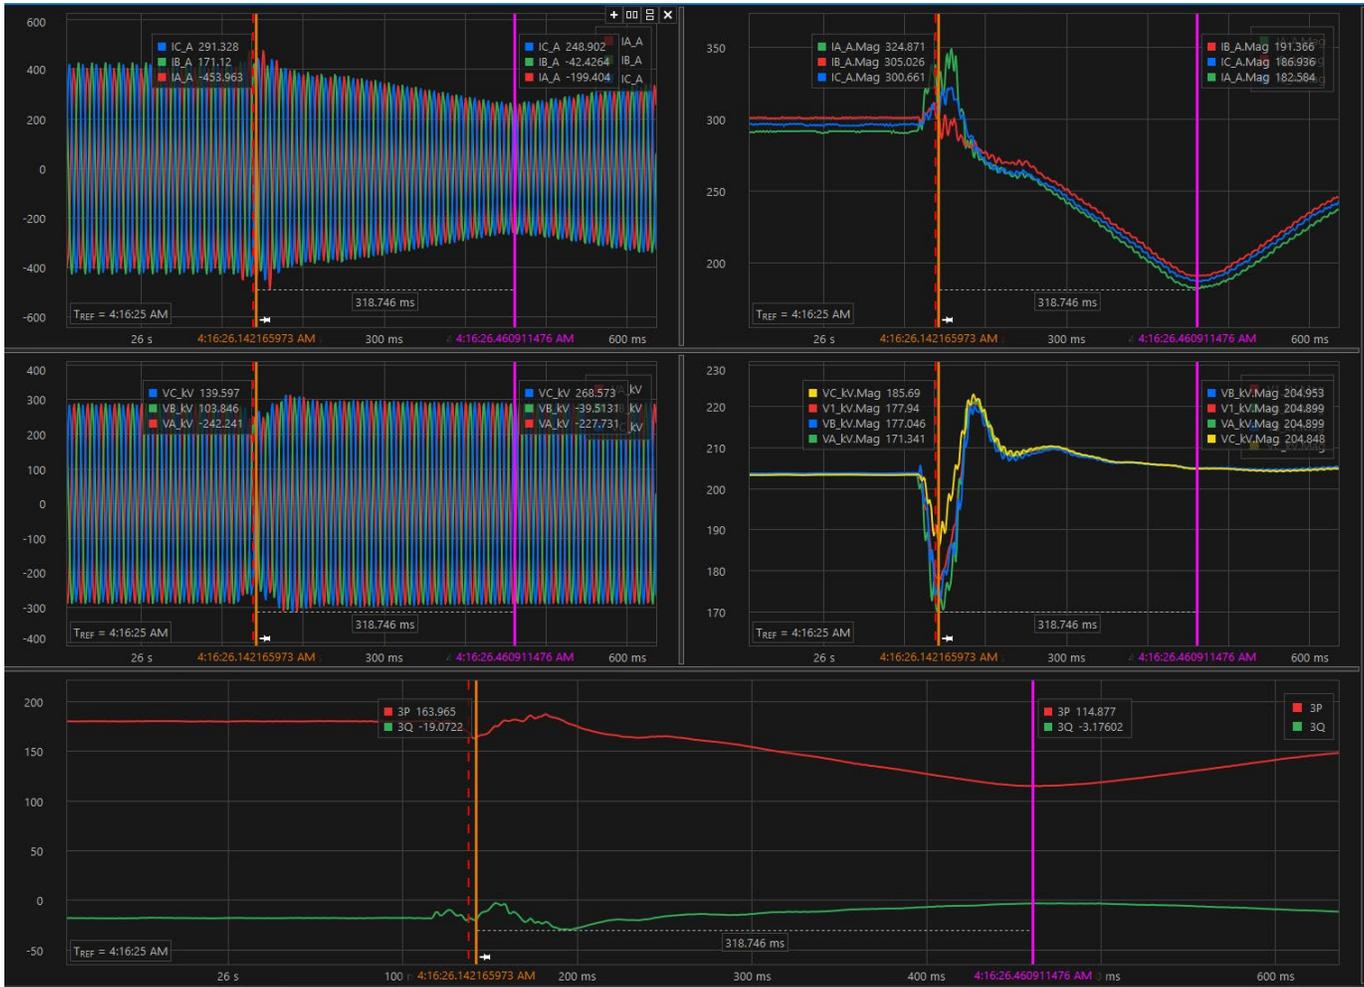
**Figure A.2: Wind Plant Dynamic Response during Fault 1**

Upon the fault clearing, the active power rapidly ramped down from about 180 MW to 116 MW in about 275 ms. The rapid reduction of active power after fault clearing could not be attributed to any specific cause during the analysis. This is anomalous behavior for wind turbines during and immediately after faults and should be explored further. It may be involved with the subsequent plant controller interaction described below; however, this cannot be confirmed.

As the turbines responded to the LVRT condition, the plant controller paused control and the individual turbines took over local control. Upon the fault clearing, the plant-level controller latched on to a new active power set point in its frequency response controller. However, the turbines experienced an anomalous ramp down in power output so the plant-level frequency response controller latched on to an erroneous set point value that was then issued to the turbines. The uncoordinated latch of a new active power set point in the frequency response controller is what caused the plant to reduce output for an extended period of time. Grid frequency dropped and remained slightly depressed for a few minutes, and the erroneous set point was held for an extended period of time until frequency recovered, holding active power down near 163 MW (the erroneously latched power output) for that time.

NERC, Texas RE, and ERCOT held a follow-up discussion with the affected plant GO/GOP and the wind turbine OEM to understand these interactions. The OEM and GOP are exploring mitigation measures to eliminate this interaction in the future. In particular, the team discussed investigating the anomalous turbine dynamic response upon fault clearing and also coordinating the active power-frequency control set point latching with LVRT response of the turbines. This could involve using a total available power signal or other suitable measurement.

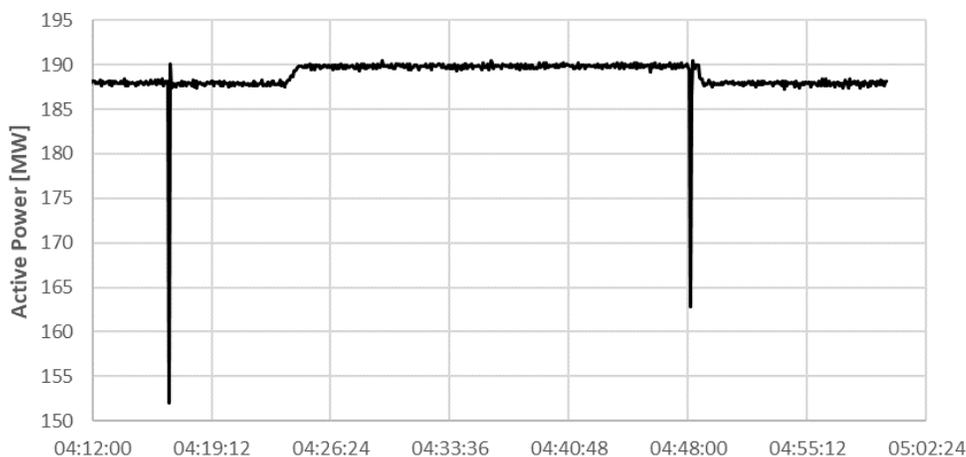
**Figure A.4: Plant Active Power Output**

This facility reduced power output by 32 MW during the first fault and 27 MW during the second fault and restored power output to predisturbance values very quickly in both cases (see [Figure A.4](#)). This reduction is noted here due to the depth of the active power reduction captured with SCADA data; however, no further analysis was conducted.

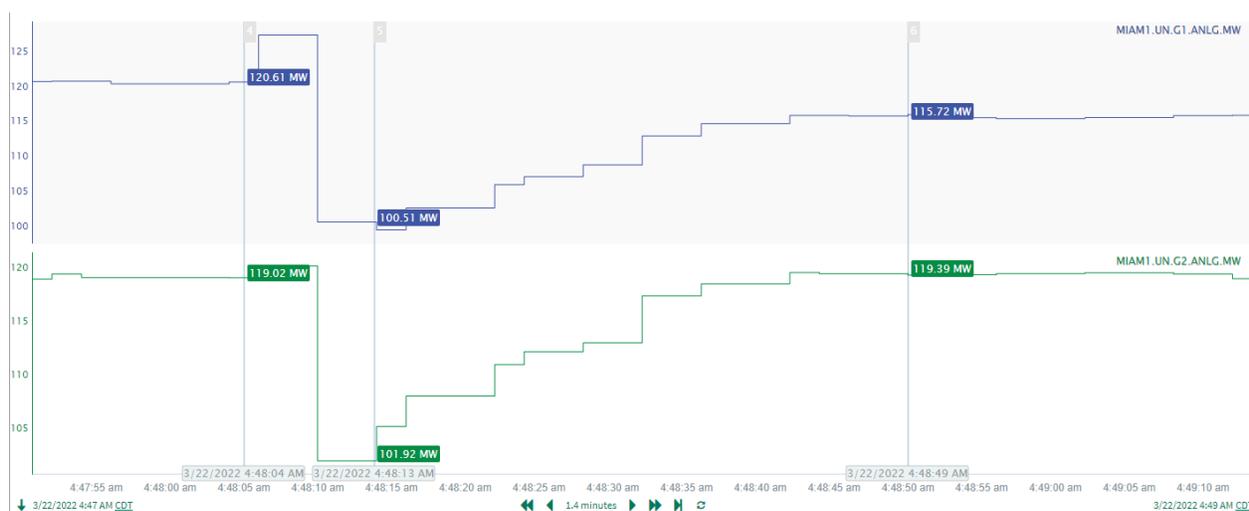
**Figure A.5: Unit 1 and Unit 2 Active Power Response to Fault 2**

- Plant Frequency Controller Interactions:** During the fault, the plant frequency response controller sends a command to the individual turbines to reduce power output. However, frequency is lower than nominal at this time; therefore, this is not the correct operation of this facility. The root cause of this abnormal performance is unclear, but both the plant owner/operator and the turbine manufacturer have acknowledged that this response is unacceptable and should be investigated and a corrective action developed to avoid this in the future. This interaction causes the delayed ramped recovery of active power that is observed in [Figure A.5](#).

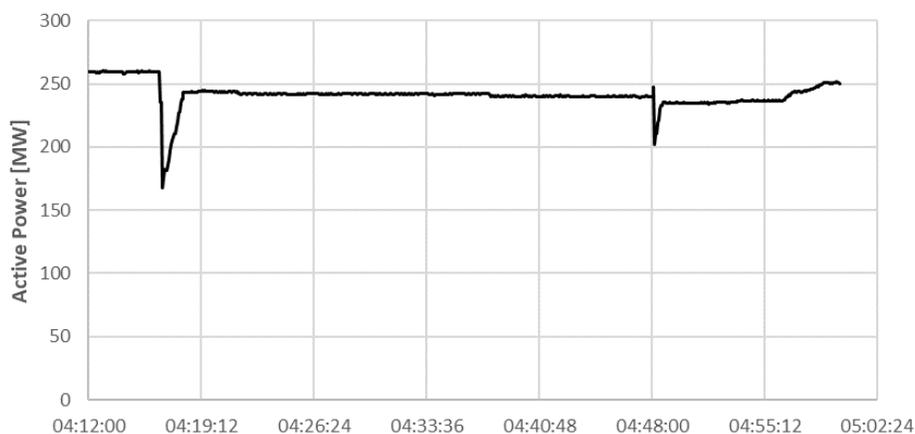
**Figure A.6: Plant Active Power Output**

- Turbine Tripping on Pitch Converter Faults:** Nine turbines tripped on the first fault and four turbines tripped on the second fault due to pitch converter faults. Turbines that tripped during the first fault were not restarted prior to the second fault occurring, resulting in cumulative power reductions (see [Figure A.6](#)).<sup>20</sup>

The plant owner stated that no modifications or changes to protection settings have been made to this plant; however, they are investigating both the pitch converter fault and plant controller interactions more closely with the turbine manufacturer. ERCOT will be following up with the GO to ensure that mitigating measures are put in place. The GO also stated that they have reviewed relevant NERC guidelines and alerts and incorporated recommendations where possible; no further performance improvements are planned at this time.

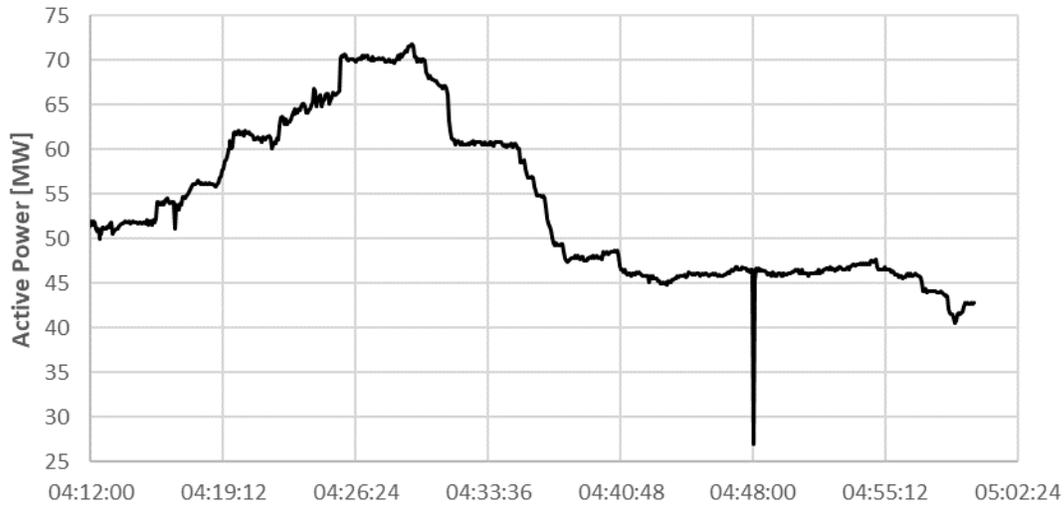
**Figure A.9: Plant Active Power Output**

This facility reduced power output by 19 MW during the second fault and restored power output to predisturbance values very quickly (see [Figure A.9](#)). This reduction is noted here due to the depth of the active power reduction captured with SCADA data; however, no further analysis was conducted.

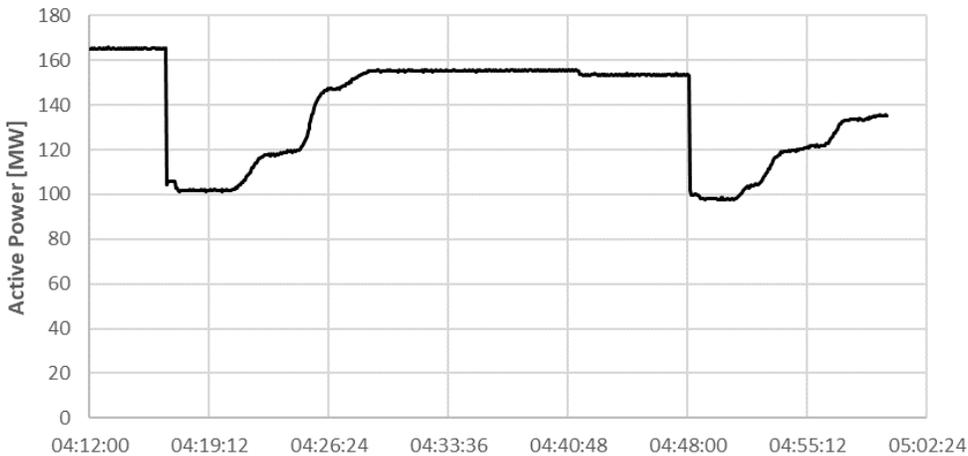
**Figure A.10: Plant Active Power Output**

[Chapter 1](#) provides details regarding the SSR and ac overvoltage alarms. The turbine manufacturer is currently performing extensive analysis of the response of the turbines to the BPS faults; however, the cause of tripping is unknown at this time. The response of the turbines to the fault are not indicative of classical SSR conditions or response, but the manufacturer is not ruling out some related issue. Another event occurred a couple weeks later that caused the turbines to experience a significant injection of active power beyond the turbine rating, demonstrating some form of unexpected energy transfer between the turbine and the system. The turbines at this site are Type 3 turbines, which are prone to subsynchronous oscillation issues. These turbines have SSR protection as well as an SSR mitigation package that may need to be revisited by the plant owner in coordination with the turbine manufacturer.

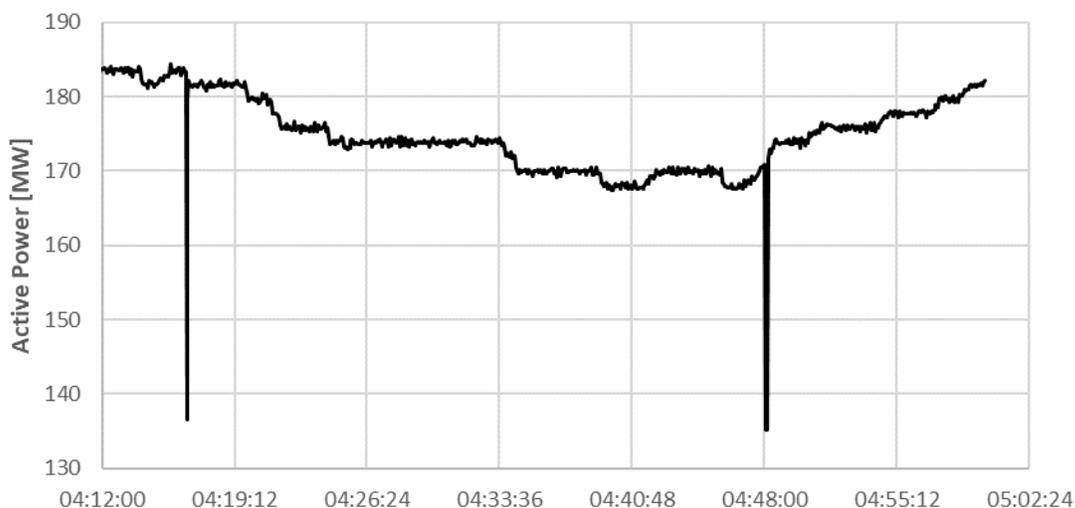
**Figure A.11: Plant Active Power Output**

This facility reduced power output by 47 MW during the first fault and 36 MW during the second fault and restored power output to predisturbance values very quickly in both cases (see [Figure A.11](#)). This reduction is noted here due to the depth of the active power reduction captured with SCADA data; however, no further analysis was conducted.
