Lesson Learned

Breaker Failure due to Multiple Reclose Attempts

20190804

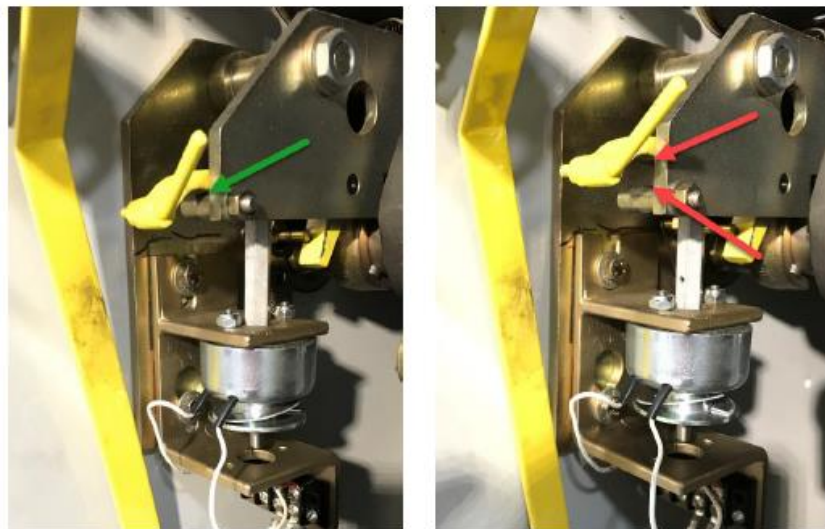
1. **Figure 5a:**

- a. **No Visible Gap exists:**
 - i. Close lever is correctly resting on the close-lever stop pin. No further action required.
 - ii. Report findings in "SUBS Alert 0005_ABB PM Bkr W FSA-2 Mech, self-initiated reclose" inspection MxOrder, then close the MxOrder. **These are Priority 2 MxOrders and should be completed by 6/1/2019.**
- b. **Visible Gap exists:** Possible issue, more inspection required. Go to Inspection Results / Step 2.

Figure 5a – Visible Gap Between Close Lever and The Close-Lever Stop Pin

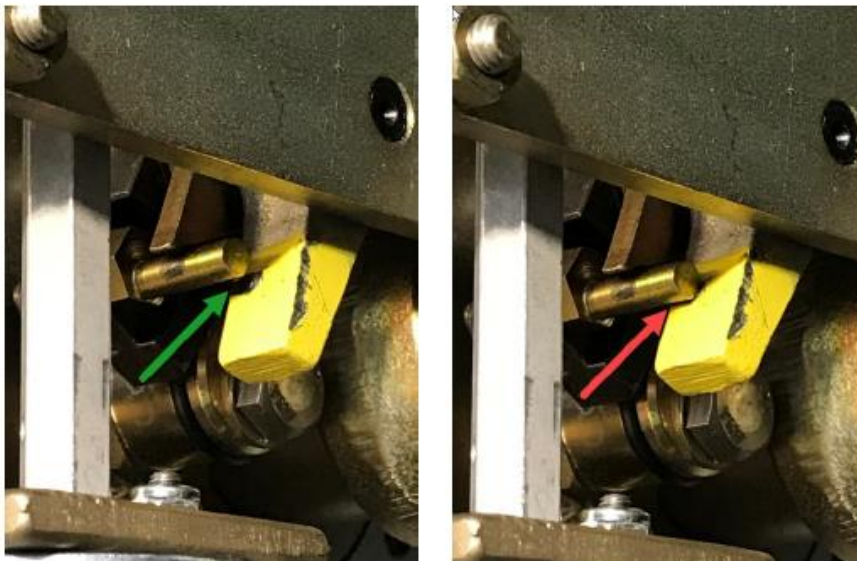
2. Figure 5b:

- a. Visible Gap exists:
 - i. No further action required.
 - ii. Report findings in "SUBS Alert 0005_ABB PM Bkr W FSA-2 Mech, self-initiated reclose" inspection MxOrder, then close the MxOrder. **These are Priority 2 MxOrders and should be completed by 6/1/2019.**

- b. No Visible Gap exists:
 - i. Inform local operations & SPC that this breaker has the potential to self-initiate recloses as required under **OPERATING PRIOR TO ADJUSTMENT**, Step 1.

Figure 5b – Visible Gap Between Close Finger and Close Lever

- ii. Operations to work with dispatch to get reclosing cut out on the affected breaker and to operate the breaker as outlined in **OPERATING PRIOR TO ADJUSTMENT**, Steps 2 & 3.

- iii. Report findings in "SUBS Alert 0005_ABB PM Bkr W FSA-2 Mech, self-initiated reclose", Priority 2 inspection MxOrder, then close the MxOrder.
 - iv. Create a new CO MxOrder "SUBS Alert 0005_ABB Corrective Action" in Cascade, **with a Priority 2 rating**.

- v. Schedule an outage on the breaker as soon as possible (within 6 months).
 - vi. Use the "SUBS Alert 0005_ABB Corrective Action" CO MxOrder, and perform the steps listed under **ADJUSTMENT & TESTING** below.

- vii. As per ABB: Retime the breaker to ensure that it operates within manufacturer's parameters.
 - viii. Report findings in the "SUBS Alert 0005_ABB Corrective Action" CO MxOrder, then close the MxOrder.

3. Loosen bolts holding the close-coil mounting bracket to the close-latch assembly. Drop & adjust the close-coil mounting bracket. Attain the mfg’s recommended gap between the top of the close-coil plunger and the close lever (with the lever lifted to touch the release finger) as outlined in the instruction book.
