Lesson Learned

Circuit Breaker Modification Leads to Inadvertent Trips

20140502

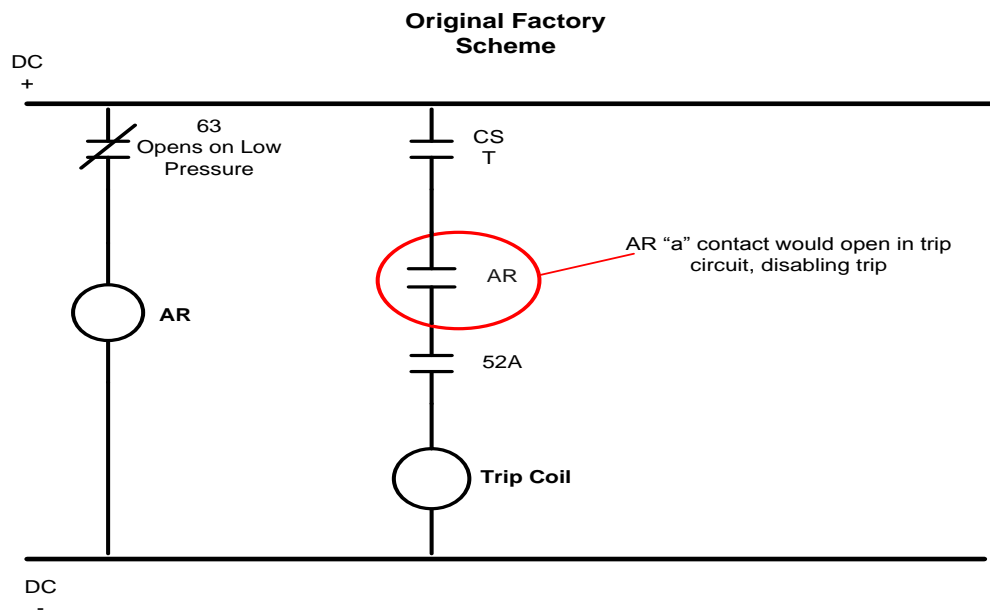
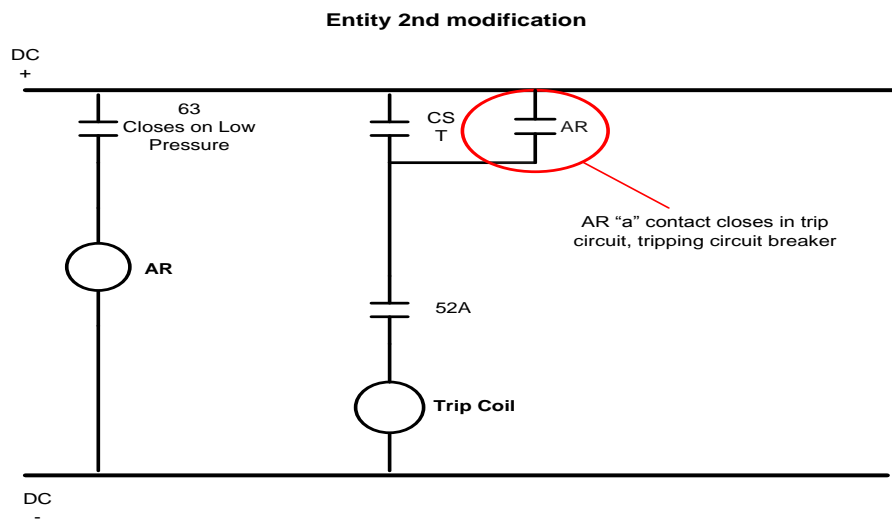
This scheme worked correctly as long as the DC to the trip circuit was not disconnected. However, when the DC was removed, the low-pressure auxiliary relay coils became de-energized, closing the contacts ("b" contacts) connected to the trip circuits. This set up a trip signal to the trip coils which was initiated as soon as the DC source was turned back on because the operating time of the low-pressure auxiliary relay to re-open the tripping contacts is several cycles.

During construction activities, the DC secondary power source (DC #2) to multiple SF6 gas circuit breakers in a station was temporarily removed to facilitate relocation of a DC disconnect box. The DC #2 source fed the low gas and low air pressure trip circuits. When the DC circuits were re-energized, this resulted in multiple SF6 gas circuit breakers opening upon restoration of the DC power. This action open ended multiple transmission lines and resulted in a generation facility being disconnected from the system.

The entity reconfigured/redesigned the pressure switch and auxiliary relay circuit. The pressure switch was changed to energize the auxiliary relay on falling/low pressure. Consequently, the tripping of the circuit breaker is accomplished through an auxiliary relay "a" contact. This alleviated a standing trip on the circuit breaker when DC supply power was removed from the gas circuit breaker. (See attached schematic)
