Lesson Learned

System Protection Review Prior to Disabling Protective Relays

Lesson Learned #: 20140903

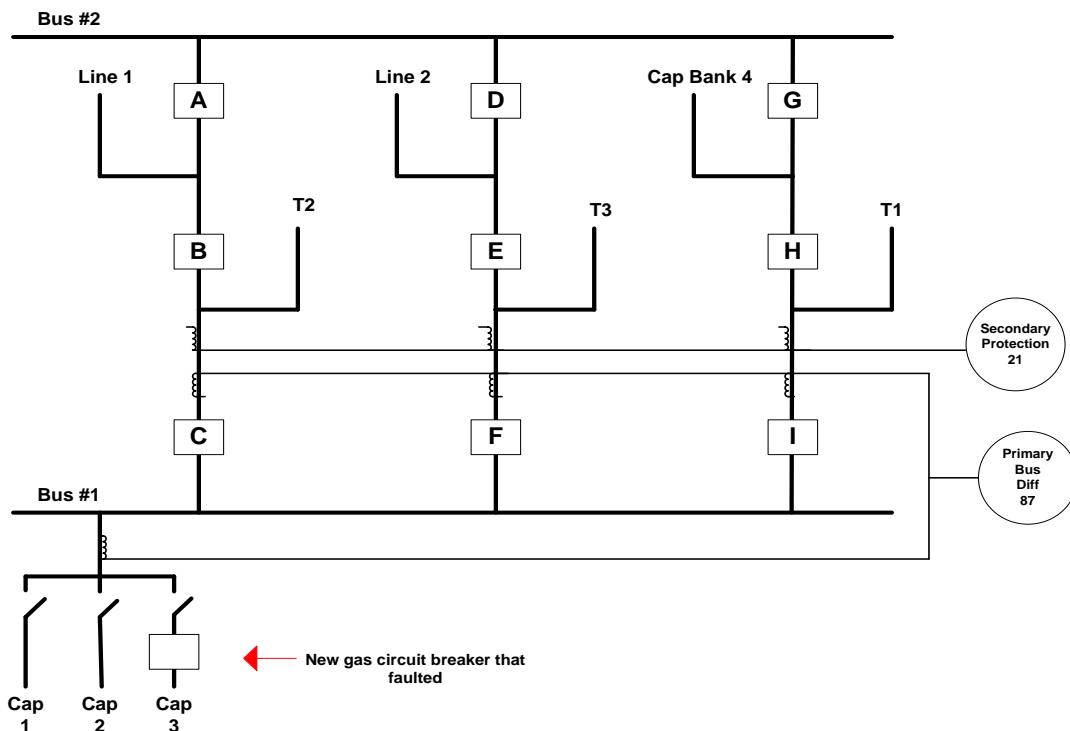
Figure 1: Zones of Protection

Relay technicians had previously disabled the trip outputs of the secondary protective distance relaying for 345 kV bus 1, which included the failed GCB in its zone of protection prior to the closing of the disconnect switches by a separate work group. The trip outputs of the 345kV bus 1 secondary protective distance relaying had been disabled to minimize the risk of unwanted tripping during related construction wiring in a control panel. A systematic review of the protection system had not been performed prior to disabling the protective relay. The work groups did not adequately communicate their actions, so the relay technicians incorrectly thought that the primary protective differential relaying was adequate for the equipment that was energized. The primary protective relaying for 345kV bus 1 was in service, but the new GCB was not in its zone of protection (see figure 1). As a result, remote-end tripping was needed to clear the fault.

- A memo was attached in the asset management system to denote that for any work order on the secondary protective distance protective relay on the 345kV bus, the 345 kV bus needs to be removed from service. This will alert relay technicians to request a 345kV bus outage prior to disabling the secondary protective distance relay.
- A specific switching order was created for maintaining the 345kV bus 1 secondary protective distance relay that requires the removal of the 345kV bus from service. This switching order is indexed to the memo that is attached to the asset management system for the 345kV bus secondary protective distance relay.
- A review of the current protection scheme is being undertaken to determine if additional relay protection is required for the protected facility.
