Lesson Learned

Bus Differential Power Supply Failure

Problem Statement

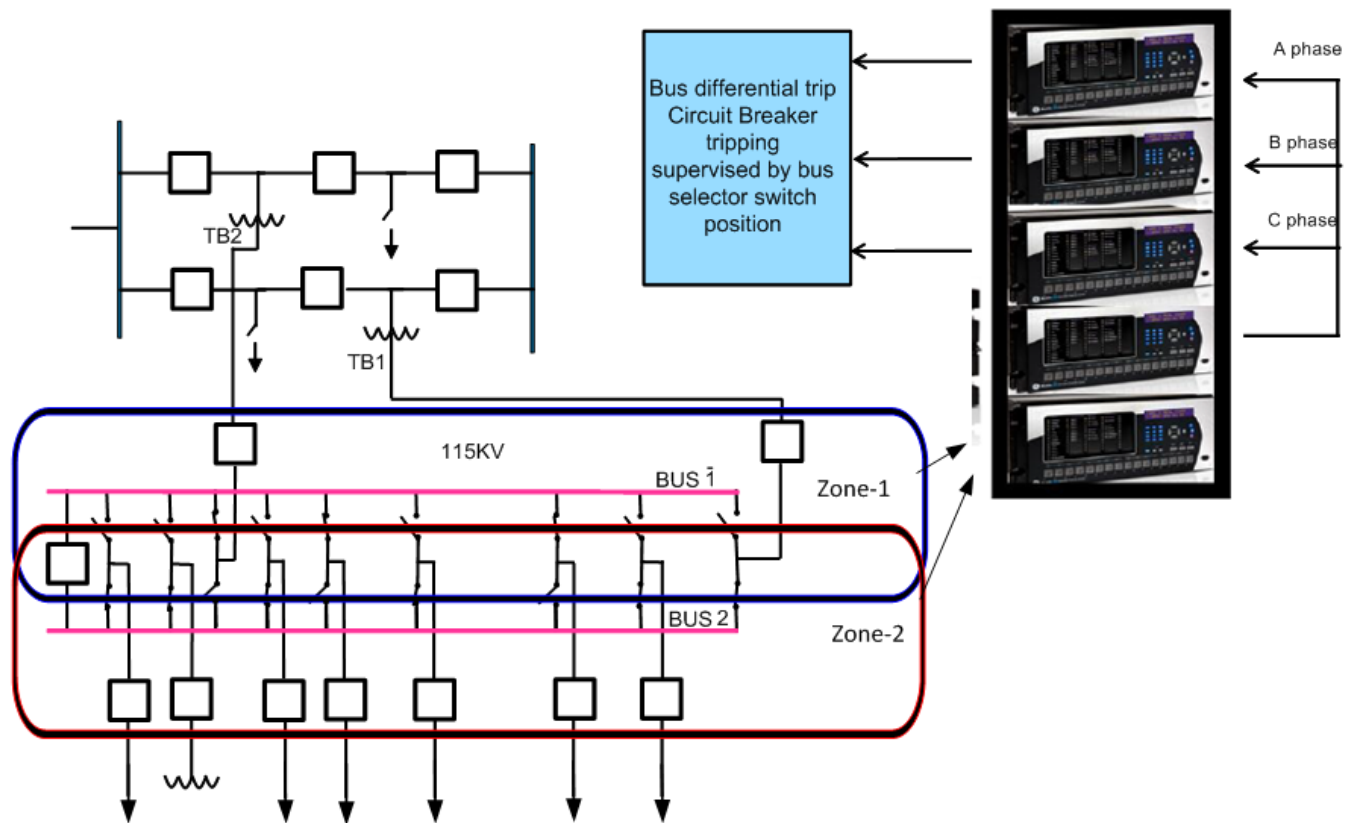
Figure 1: Substation Double Bus Single Breaker Bus Differential Scheme

The substation had a 115 kV single-breaker double-bus configuration with 10 elements, and was protected by a B90 bus differential scheme. The scheme consisted of: (1) seven intelligent electronic devices, including a tripping, a control, and a bus selector SW; and (2) three differential relays (one per phase). The scheme uses multiple zones of protection to identify and trip only the faulted bus. The zones are identified by “bus selector switch” inputs, which are used to place the breaker on bus-1 or bus-2. Internal logic places the breaker current transformer (CT) contribution in the bus-1 or bus-2 differential zone. Using this type of scheme, one bus differential scheme can protect two busses.

The “A” phase differential relay power supply capacitor started degrading, which caused the analog to digital converter to provide erroneous current and voltage values from the reference voltage used in the protection element calculations. This resulted in an “A” phase differential trip for bus-1 and bus-2; the voltage supervision was not effective since the degraded capacitor also provided erroneous voltage values used in the differential element supervision. This version of the relay does not monitor the power supply internal logic voltages, so the relay did not take itself out of service. The double bus trip resulted in a sustained loss of over 58,000 customers.
