Lesson Learned

Breaker Failure Due to Trip Coil Polarity

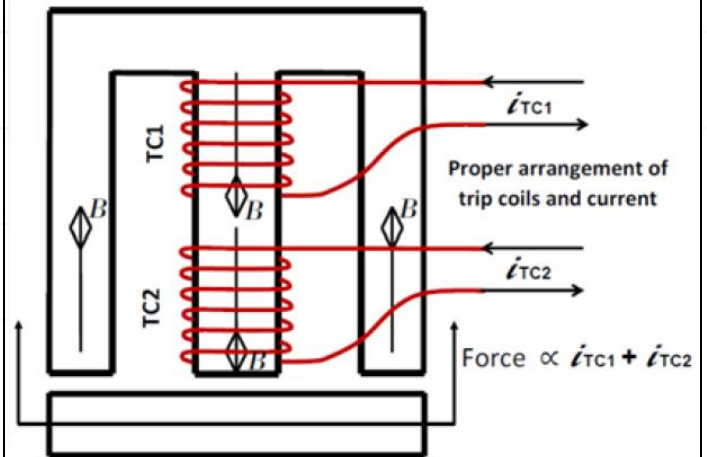
Figure 1a: Proper Arrangement

The breaker has a common trip coil assembly that had been wired such that the polarity was opposing for each trip coil. When the trip coils were energized simultaneously, cancellation of magnetic flux occurred due to the opposing trip coil polarity, causing the coil armature to remain immobile (See Figures 1a, 1b, 1c). Microprocessor relay data indicated that the trip coils were energized by separate primary and secondary relay trip contacts within a time span of less than 3 ms (Figure 2). Figures 3 and 4 show the trip coil assembly and the trip coils.

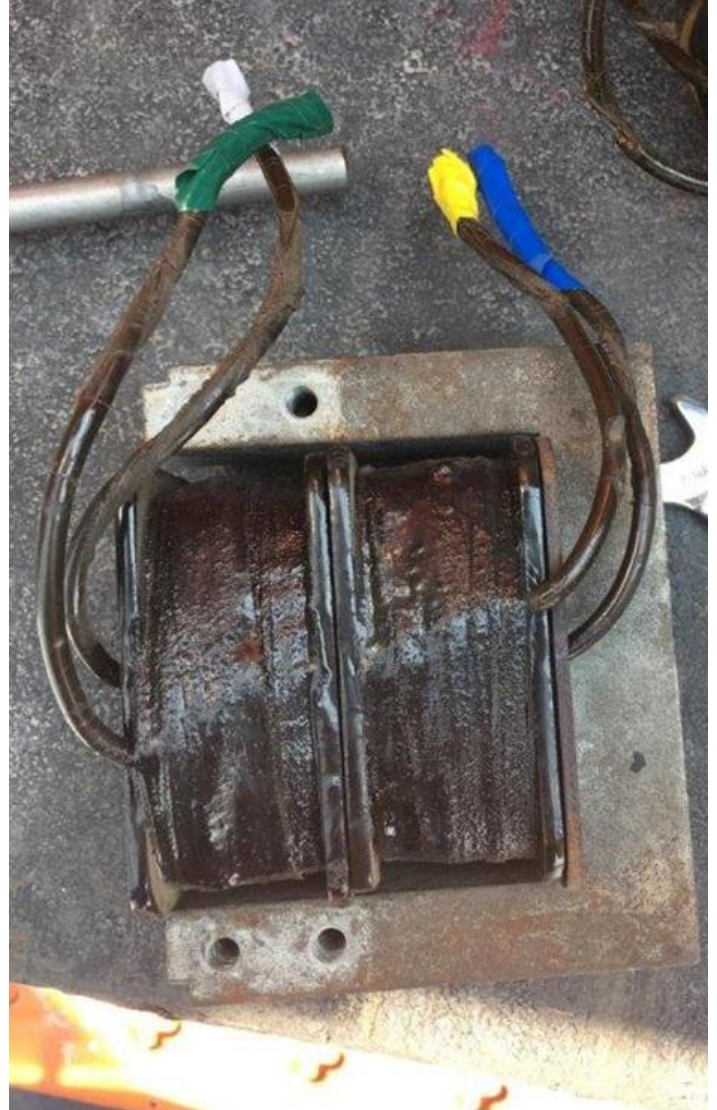
Figure 4: Burned Trip Coils

A temporary phase-phase-ground fault occurred on a 115 kV line. A 115 kV line breaker at one end of the line was slow to operate. Breaker failure protection operated, which caused the remaining two 115 kV breakers of a three-breaker switching station to open. This left the switching station de-energized. The breaker that failed to operate utilized two trip coils. Onsite investigation indicated that both trip coils had been damaged when they were energized to trip the breaker.

The trip coils were replaced and tested to verify proper operation by applying simultaneous trips to the trip coils.
