Lesson Learned

Networking Packet Broadcast Storms

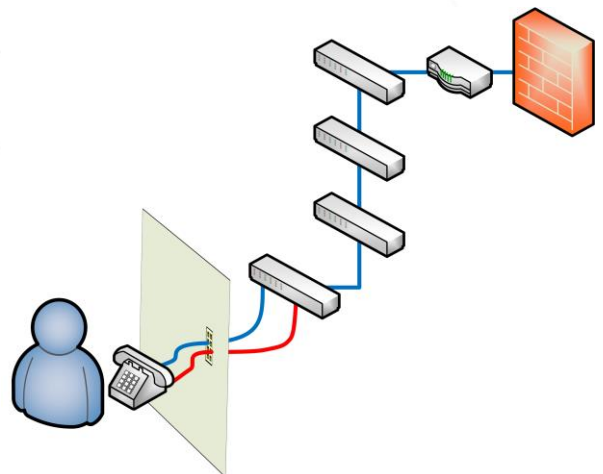
When the second network cable was connected from a VOIP phone to a network switch lacking proper settings, a switching loop resulted. Spanning tree protocol is normally used to prevent switching loops from propagating broadcast packets continuously until the network capacity is overwhelmed. A broadcast packet storm from the switching loop prevented network communications from functioning and SCADA was lost for several hours. The effects of this condition are like a self-inflicted denial of service (DoS) attack.

In the IP phone case, the entity worked to narrow down the switching loop network location by isolating network segments, pinpointing the trouble spot, and finally shutting down the device and the port it was utilizing. They worked with the network hardware vendor to help review hardware global settings and receive remediation recommendations based on this specific incident.

The vendor recommended that network port settings be set to block BPDU packet propagation from non-spanning tree protocol enabled devices unless purposely allowed.¹

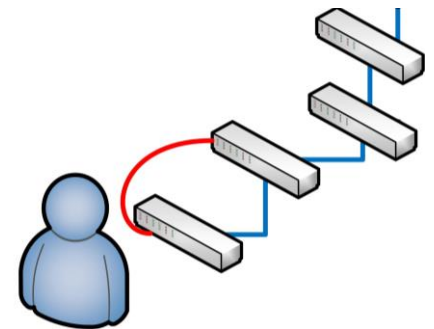
In one case, a substation technician performing routine system maintenance at a substation inadvertently connected an unused ethernet cable between two ethernet switches where an ethernet connection was already established. This created a communications loop with multiple ports seeing a duplicate MAC address. This loop created a broadcast storm that ultimately caused a loss of SCADA capability from the remote terminal units (RTUs) to the utility’s EMS. Eventually, the cable was identified as the problem and removed, and EMS capability was fully restored.

In the station cases, locating and eliminating the unintended loop was the corrective action. In some cases, incompatibilities between network device manufacturers complicates use of spanning tree protocol.

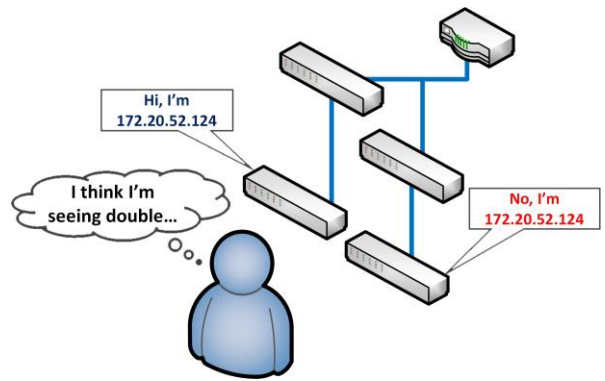
At another location, a technician copied the configuration from another switch while preparing a new network switch to ensure their configuration was similar. However, the technician neglected to change the IP address of the new switch, so the new switch duplicated the IP address of the existing network switch. The duplicate IP address caused a packet storm that blocked network traffic and the entity’s primary control center experienced a complete loss of SCADA data.

In the cloned IP case, the solution was removing one of the two switches and assigning it a different IP address.

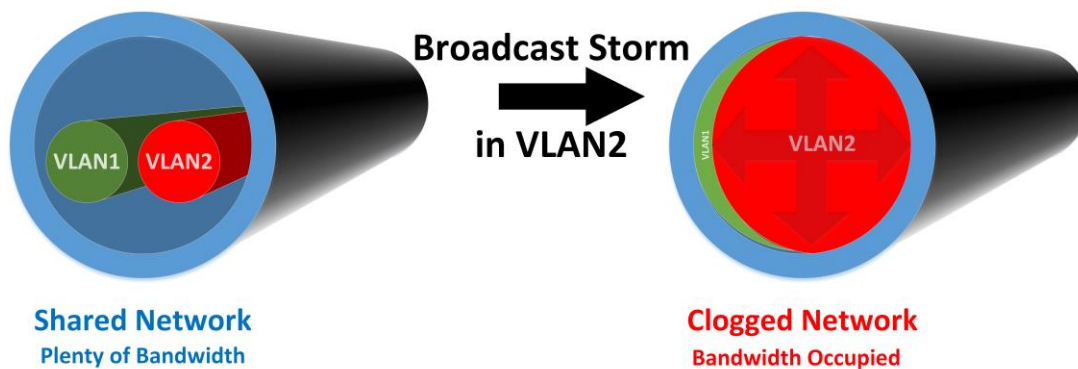
Another case involved substation data and commercial data on separate virtual local area networks (VLANs) passing through the same physical network switches. When station data was defeated by a broadcast storm due to an issue at a station under construction, the switches became overwhelmed, and the separate business traffic ceased as well.
