Lesson Learned

Incorrect Field Modification and RAS Operation Lead to Partial System Collapse

Source of Lesson Learned: Northeast Power Coordinating Council
Lesson Learned #: 20181002
Date Published: October 17, 2018
Category: Transmission Facilities

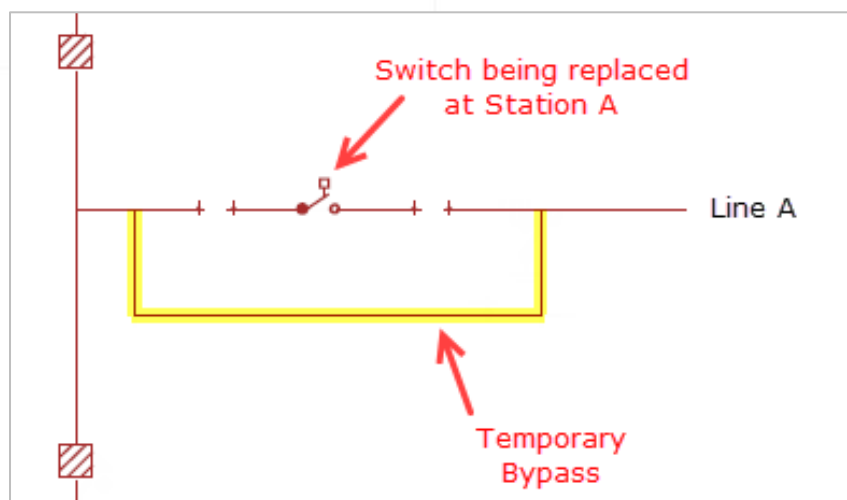
Figure 1: Schematic of Disconnect Switch and Bypass at Station A

On August 9, 2017, planned work was underway to replace the 500 kV Line A disconnect switch at Station A. As part of this project, a temporary bypass was installed to keep the circuit in-service during the replacement (see Figure 1).

Believing that the Line A disconnect switch was in the open position (as is typical for line outages), the Field Protection & Control (P&C) staff member toggled the position of an auxiliary contact multiplier relay to maintain protection adequacy of Line A with the bypass circuit in-service. The intention was to simulate the switch in the closed position to the protection relays during the month-long line disconnect replacement. The P&C personnel was not aware that the disconnect switch was requested closed during this period to facilitate its removal due to clearance issues. During this modification, the physical position of the disconnect switch was not verified and neither was the OPEN & CLOSED labeling on the auxiliary multiplier relays to confirm the current line switch position. Due to this incorrect assumption, this action resulted in the auxiliary contact multiplier being placed in the opposite position, indicating to the protective relays that the disconnect switch was open. The circuit, along with the bypass, was then placed back in-service in the early hours on August 10.

With the circuit in-service and the line disconnect switch being indicated as open to the protection relays, the line stub bus protection was enabled and the detection of a Line A contingency in the RAS became disabled as designed after one second. The TO does not normally receive any indication when a RAS contingency becomes disabled. By mid-day, as generation and flows in the region increased, the power flow on Line A exceeded the stub bus protection pickup threshold; this, combined with the perceived open disconnect switch, looked exactly like a major fault to the protection system and resulted in the undesirable trip of the Line A terminal breakers at Station A.

- The position of the auxiliary multiplier was corrected for the Line A disconnect switch.
- Although it is common practice to verify the status of equipment when performing auxiliary isolation/switching, it was not clearly stated in the process documents. These documents will be revised to clearly state that a status check (both primary and auxiliary devices) must be performed prior to operating auxiliary devices.

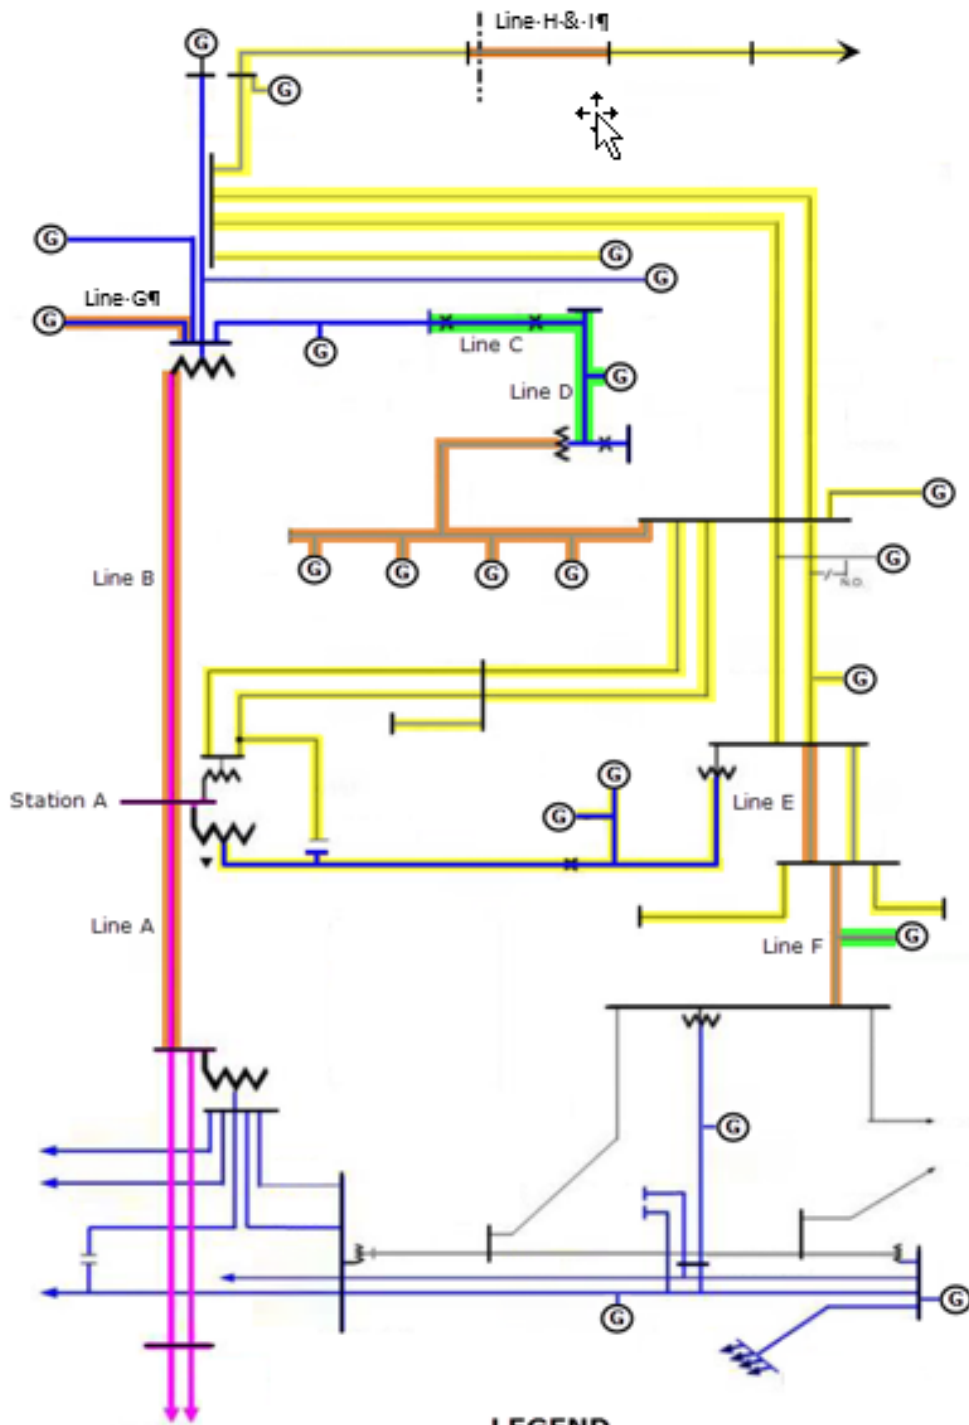
Figure 2: Single Line Diagram of the Affected Region

When the Line A contingency occurred, the RAS was armed to trip Line B, Line C, Line D, some generation, and large industrial loads in the region (see Figure 2). An assessment by the RC indicated that the arming of the RAS was correct based on the system conditions at the time. However, the RAS did not trip as expected (Line B remained in service) due to the detection of a Line A contingency being previously disabled. Instead, Line B tripped from overvoltage protection 58 seconds after the initial contingency. A security feature of the RAS prevents it from detecting the Line A contingency after one second following its initiation.

With the significant imbalance of the generation and load in the area, Line E and Line F protections operated during load swings into the relay trip settings. Line G “B” line protection was an intelligent electronic device (IED) type with an older firmware version that operated at about 61.7 hertz. Line H and I “B” line protections operated at above 65 hertz.

The actuations resulted in separation of a large portion of the entity’s system, load losses, generator trips, and islanding of a small pocket sustained by local generation as indicated on the following diagram.

- The functionality of the Line B cross-trip scheme was tested to verify that it works within acceptable timings.
- Line E and Line F protections operated during a power swing for which a study will be done to verify the possibility of improving immunity during a similar event.

- For one of the relay misoperations (Line G), the issue was determined to be a limitation of the relay design associated with an older firmware version which may cause misoperation during frequency excursions. The relay manufacturer advised that newer firmware versions provide a user settable parameter that, if set correctly, could have avoided this misoperation.

- For the other misoperation on a different relay type (Line H & I), a setting modification was suggested by the vendor and is being incorporated by the TO. This is the only location where these relays were set in this manner and new protection relay settings have been issued to the field.
