## Lesson Learned

### Misoperation of 87N Transformer Ground Differential Relays Causing Loss of Load

#### Problem Statement

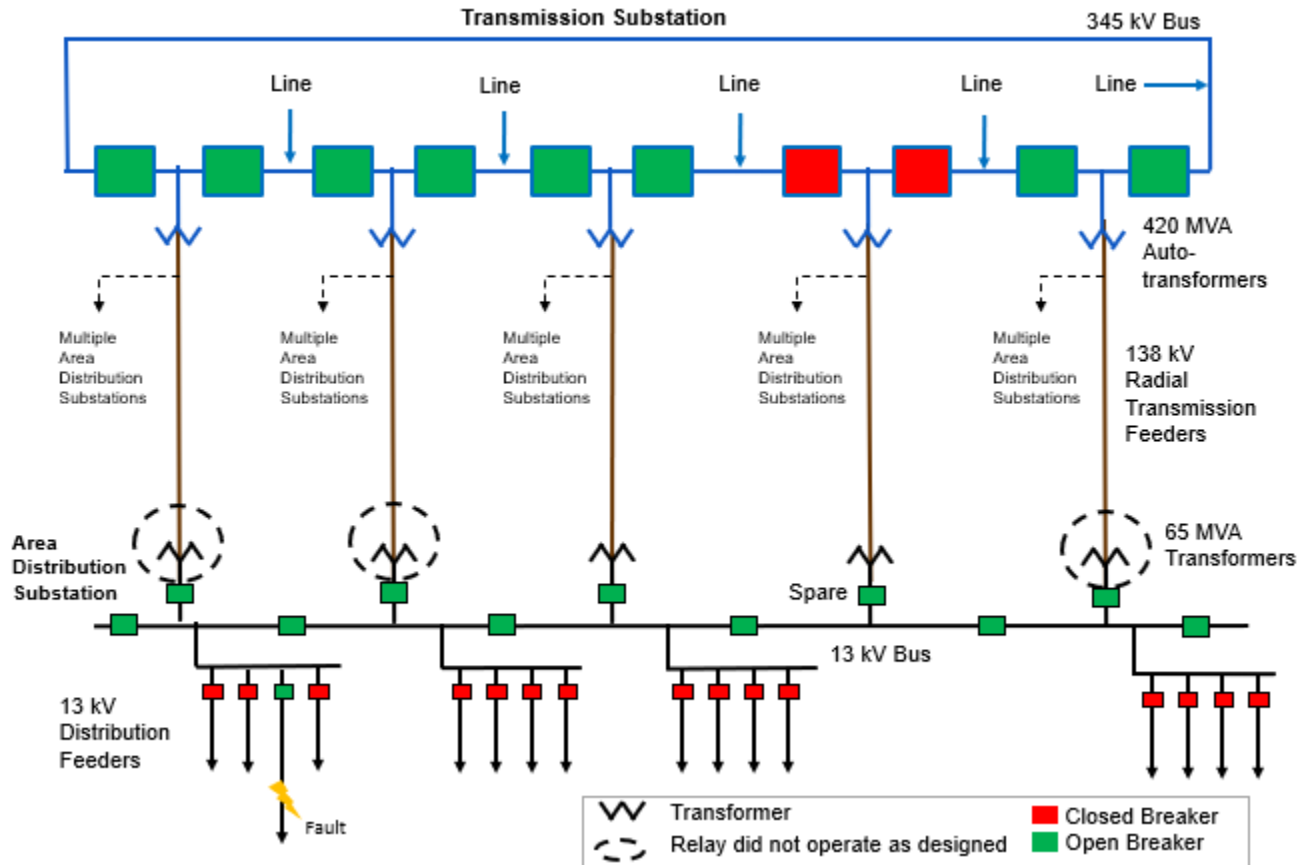
**Figure 1: One-line Diagram of Transmission and Area Substations**

A significant load area was supplied by a 345 kV transmission substation arranged in a ring bus configuration (see Figure 1) with 10 bus sections tied to one another by 10 circuit breakers. Five 345 kV transmission lines and five 345 to 138 kV auto-transformers were connected in an alternating supply-load arrangement wherein the lines serve as the supply and the auto-transformers draw load from the transmission system. The auto-transformers, rated at 420 MVA each, supply multiple area distribution substations via 138 kV radial transmission feeders. The area substations contained 65 MVA transformers that step down the voltage onto a common 13 kV bus that supplies many distribution load feeders. One of the multiple area substations is depicted in Figure 1.

The loss of load event was initiated by a routine single-line-to-ground fault on one of the 13 kV distribution feeders. The protective relays on the feeder detected the fault and were in the process of clearing it by tripping the 13 kV feeder breaker connected to the area substation. Just prior to the completion of this tripping action, neutral or ground differential relays (ANSI/IEEE device designation: 87N) simultaneously misoperated on three of the four in-service transformers at the area substation.

The relays protecting the 65 MVA transformers at the area substations need to transfer trip the 345 kV ring bus breakers at the transmission substation in order to clear the source. Thus, the associated 420 MVA auto-transformer and 138 kV radial transmission feeder are tripped in tandem with the area substation transformer by design. The misoperations of 3 87N relays at the area substation therefore resulted in tripping 3 420 MVA autotransformers at the upstream transmission substation and the opening of 6 of the 10 ring bus breakers.

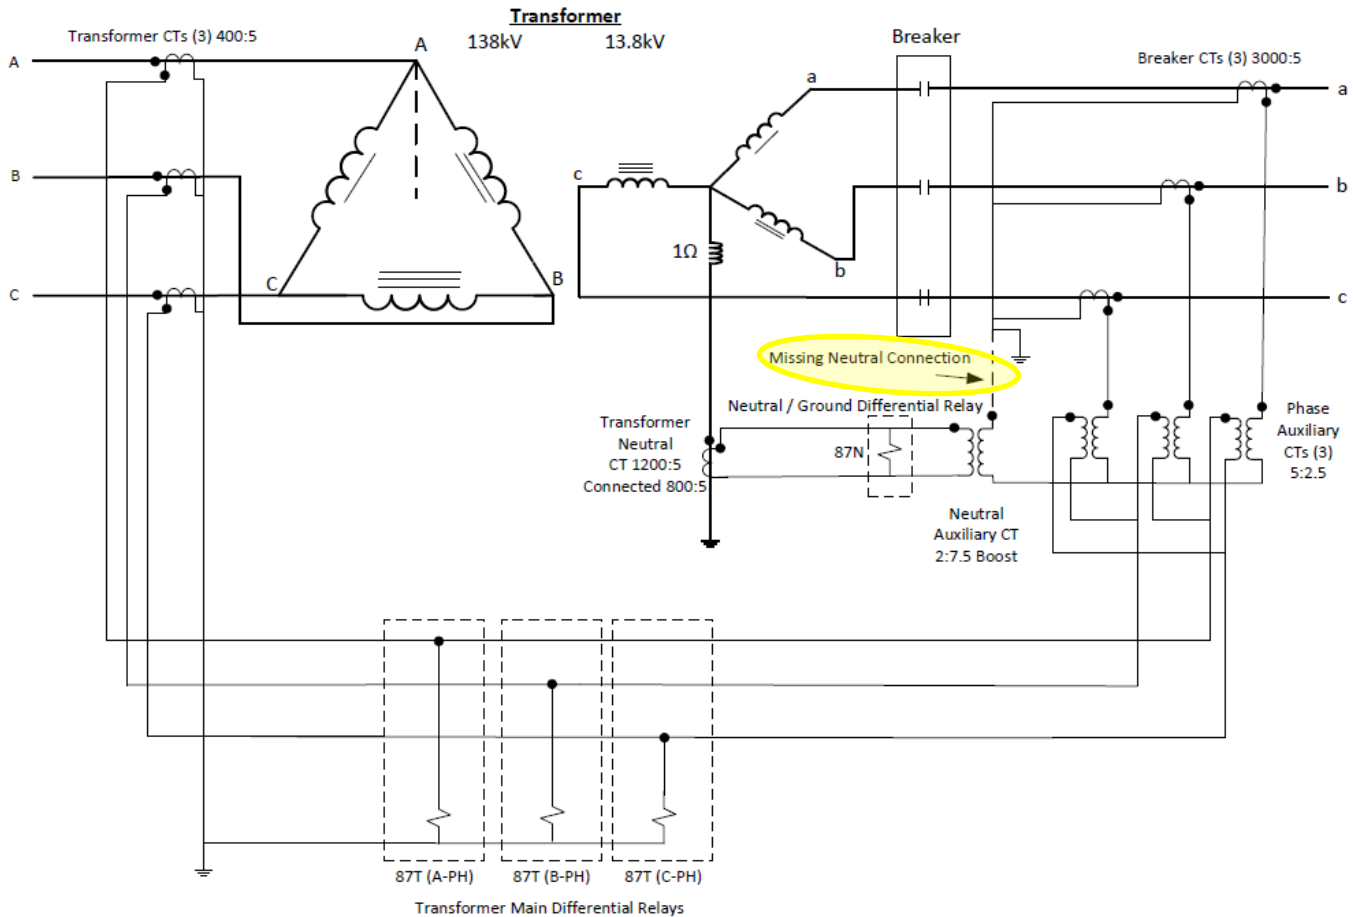
**Figure 2: Schematic Diagram of Transformer Differential Relay Protection**

Event analysis and trouble-shooting determined that the three 87N relays on the area substation transformers misoperated due to an open or missing connection in the wiring between the 13 kV transformer secondary breaker current transformers (CTs) and the neutral auxiliary CT that supplies each 87N relay. This is depicted in schematic form in Figure 2. To function properly, the 87N relay requires inputs to compare the current through the transformer neutral itself to the ground current flowing through the secondary breaker as seen by the residual of the three phase currents. This missing connection unbalances the differential configuration.

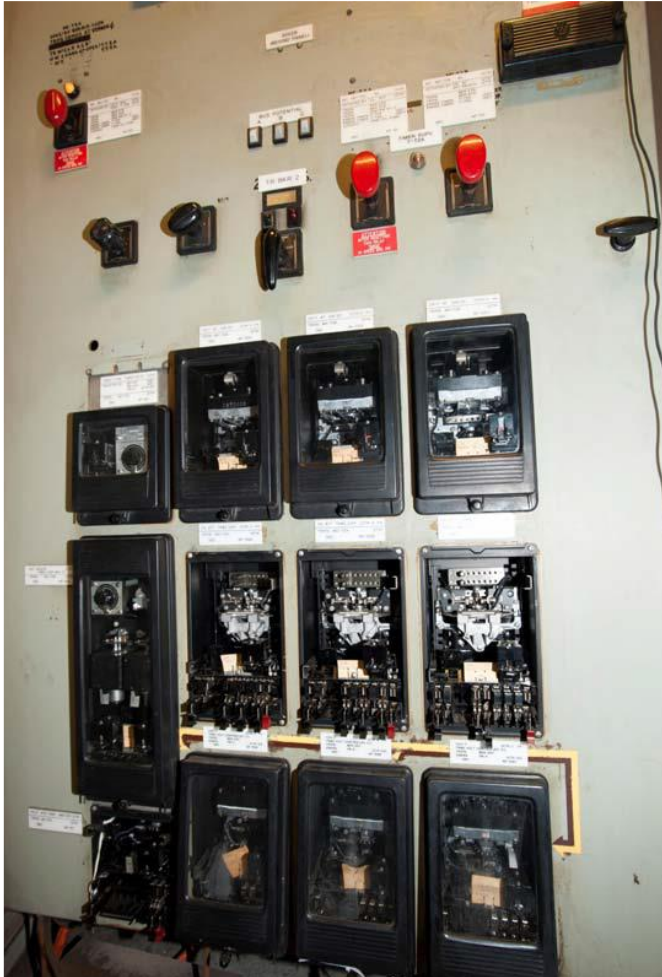
**Figure 3: Relay Panel Under Test Following the Event (87N In Lower Left Hand Corner)**

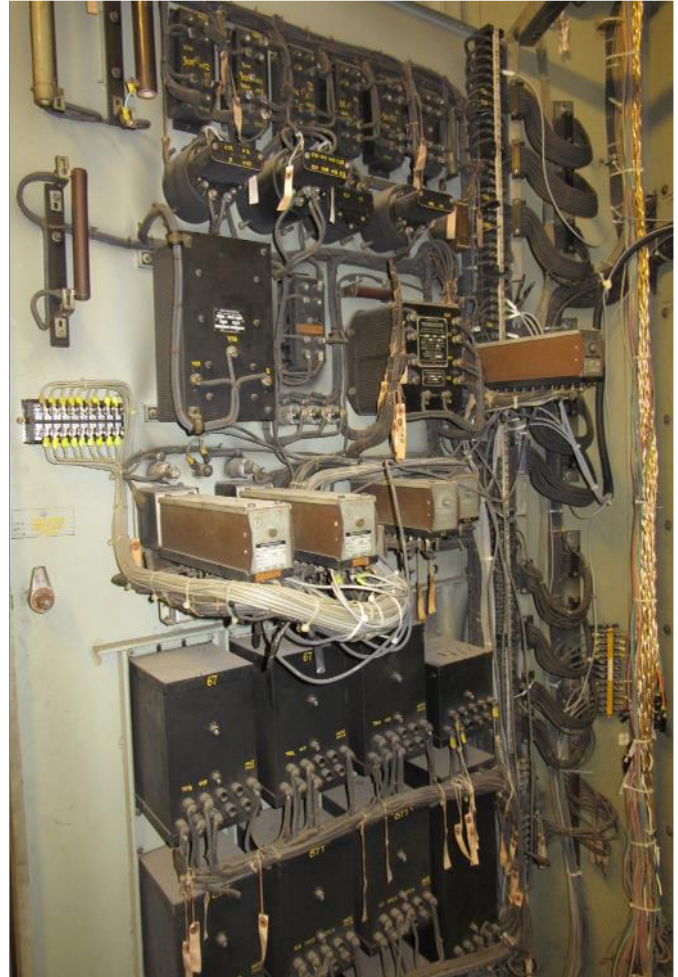
Investigation found that the missing neutral connection occurred during a 13 kV breaker retrofit program undertaken many years after the substation was originally built. The vendor who performed the work opted to create a separate wiring diagram for the protective relay circuits that focused only on those portions of

the circuits being affected by the retrofit work. This separate diagram essentially took an excerpt of the overall transformer relaying circuit schematic and modified it to show connections to the upgraded breaker cabinet. It was intended to be used in conjunction with the original overall schematic, but it is believed that the wiring crew relied on it exclusively. This separate diagram lacked detailed terminal designations for the neutral-to-ground connection, thus one wire was landed on a termination where two were required.

**Figure 4: Wiring in Rear of Relay Panel**

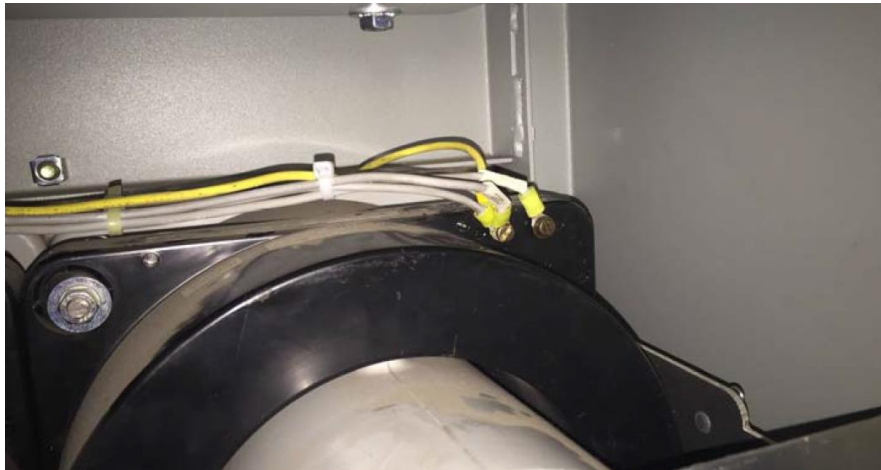
**Figure 5: Added Neutral CT Connection to Complete 87N Circuit Post-Event**

The missing wiring was corrected (see Figure 5).
