Lesson Learned

Protracted Fault in a Transmission Substation

Lesson Learned #: 20200402

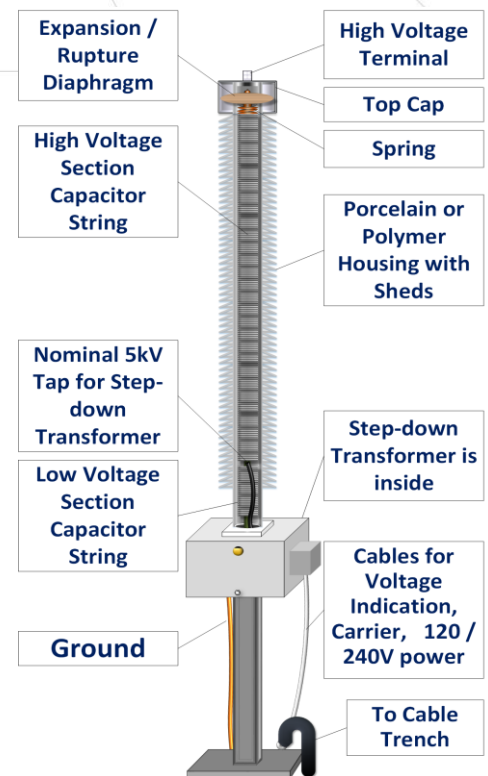
Figure 1: Typical CCVT

A single-phase-to-ground fault occurred on an instrument voltage transformer connected to the bus section that serves as the transmission line's terminal at Substation 1. The instrument voltage transformer was a capacitive coupling voltage transformer (CCVT)¹, comprised of a stack of coupling capacitors that form a voltage divider that supplies approximately 5 kV to a small potential device that in turn steps down the voltage to 120 volts for utilization by metering and back-up protective relaying. (See **Figure 1**). This instrument voltage transformer had exhibited low, out-of-tolerance output prior to the event. Low output voltage is often thought to be a benign condition for coupling capacitor devices.² The output to metering and back-up relaying had been temporarily isolated prior to the event to preclude false readings and avoid the risk of relay misoperation, but the coupling capacitors remained connected³ to the transmission bus.

² When capacitors begin to fail in a CCVT, it is usually by shorting out of individual capacitor packs in the string. If packs short out above the CCVT's "low voltage tap," the output voltage rises. If packs below the 'low voltage tap' short out, the output voltage would lower. In either case, there would be increased voltage stress across all the remaining capacitors in the string, accelerating their failure. As long as the string remains energized, this leads to a continuous sequence of shorting packs out and eventual catastrophic failure. Monitoring the output for "stair steps" can warn of a developing failure.

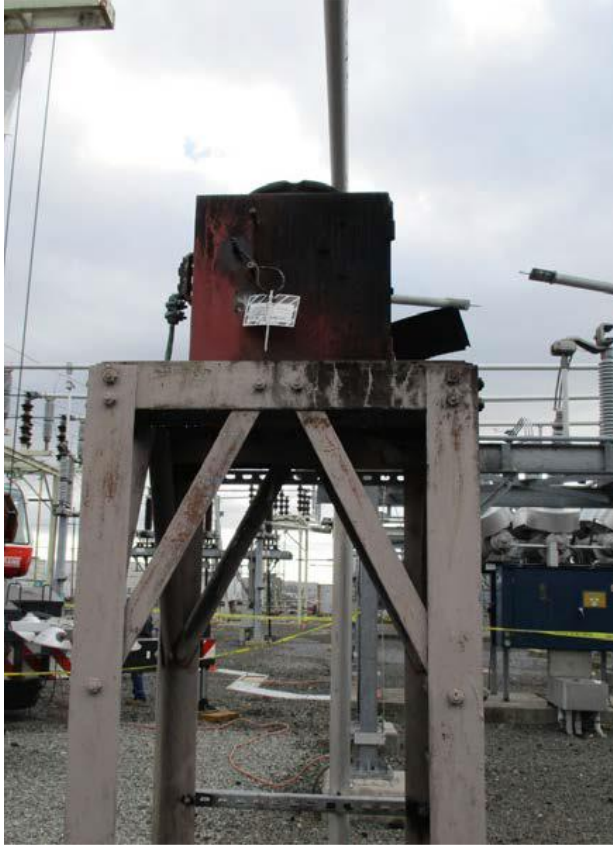
Figure 4: Failed C Phase CCPD

All equipment damaged at Substation 1 during the fault was replaced. This included the instrument voltage transformer for the stand-alone back-up relaying that had been temporarily out of service.

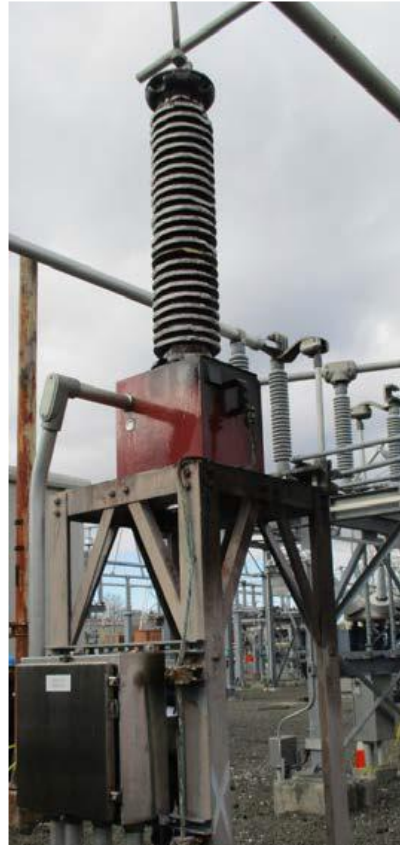
Figure 5: Damaged B Phase CCPD

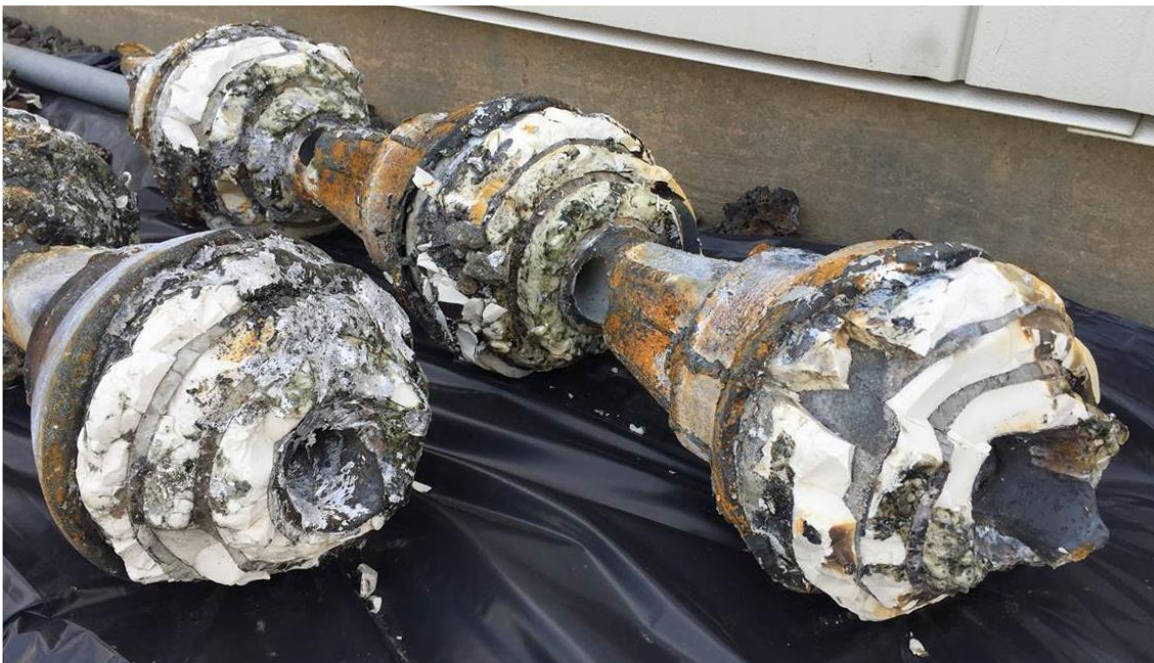
Figure 6: Remnants of Bus Insulators

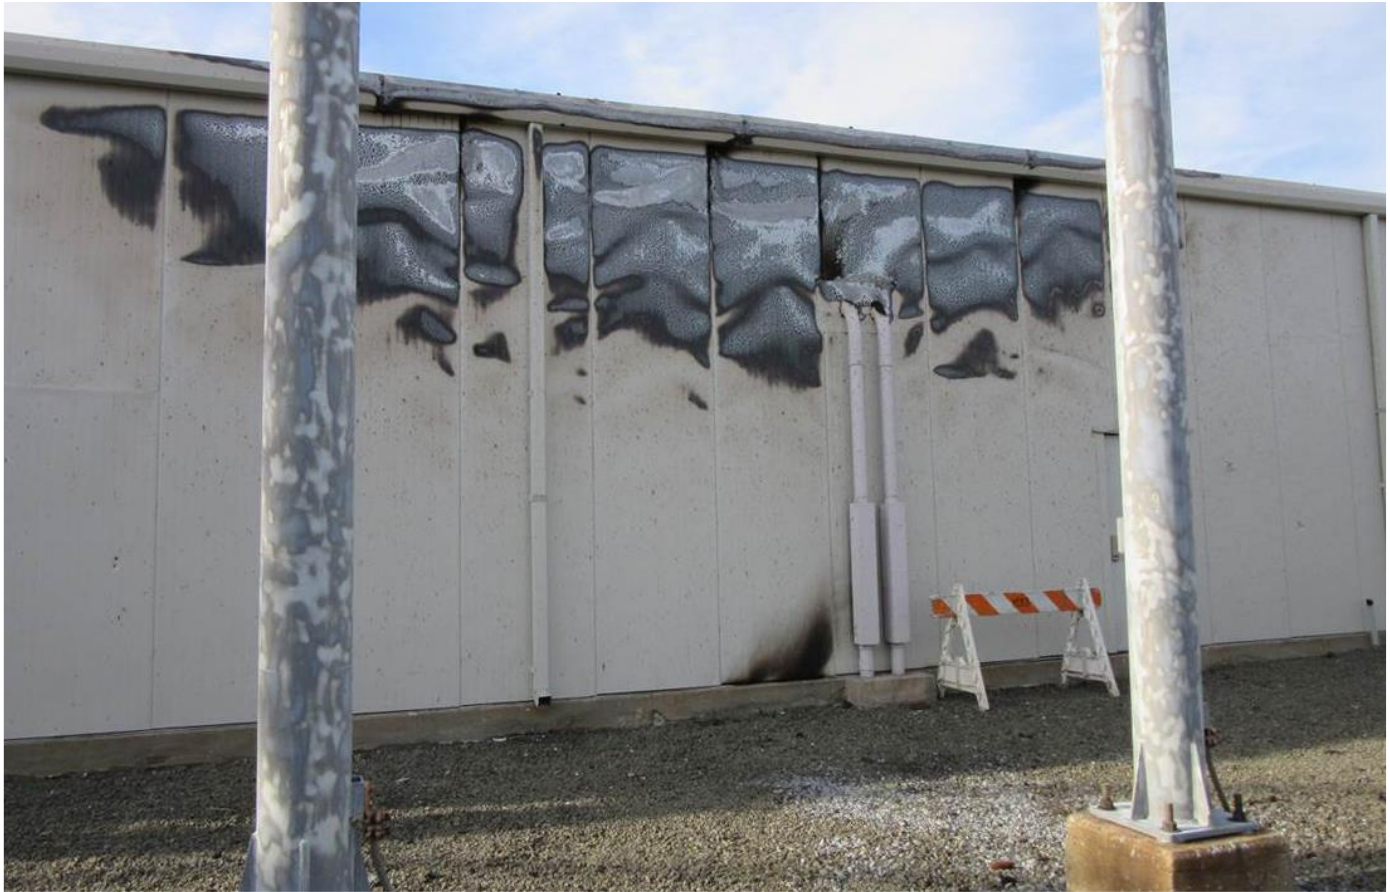
Figure 7: Exterior of Relay House Singed by Protracted Fault
