Lesson Learned

Preventing Energy Emergency Alerts

Lesson Learned #: 20200602
Date Published: June 11, 2020
Category: Bulk Power System Operations

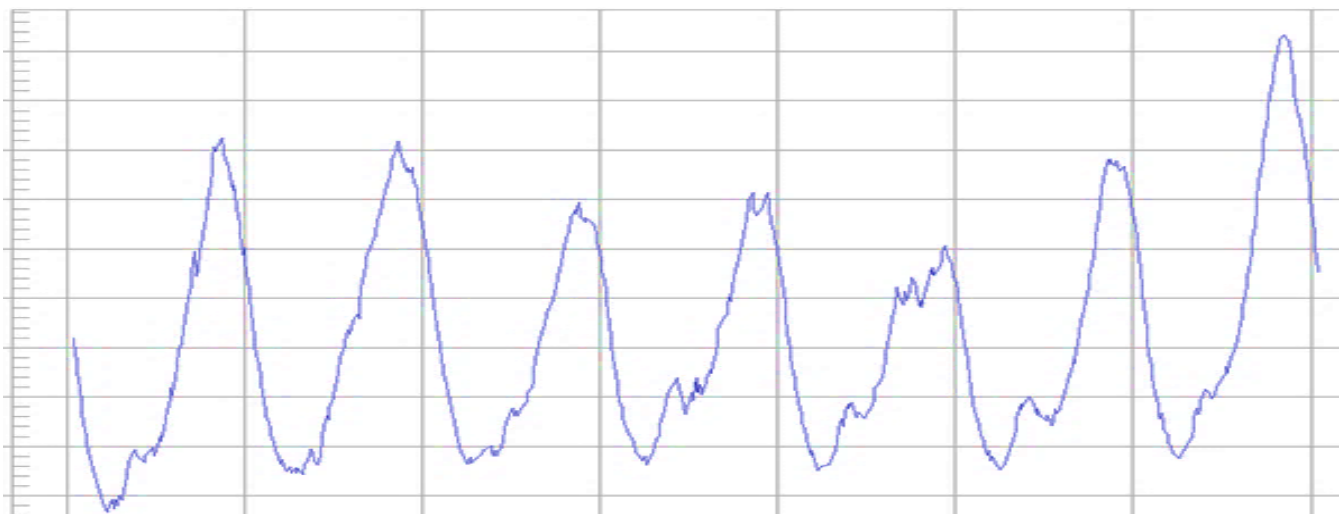
When temperatures were hotter than forecast and photovoltaic renewable resources were declining during the evening time frame, the RC declared an EEA-1 for BA 1 upon BA 1's request (see Figure 1). Around the same time, two generating units tripped off-line, totaling about 530 MW of generation.² This caused the RC to place BA 1 and another BA (BA 2) within the same RSG in an EEA-3. Since both BAs were a part of an RSG, they requested contingency reserve assistance from the other RSG members.

Figure 1: BA seven-day loading trend showing the demand on this day was higher than normal
