Lesson Learned

Lockout Relay Component Failure Causes Misoperation and Reportable Event

Lesson Learned #: LL20200703

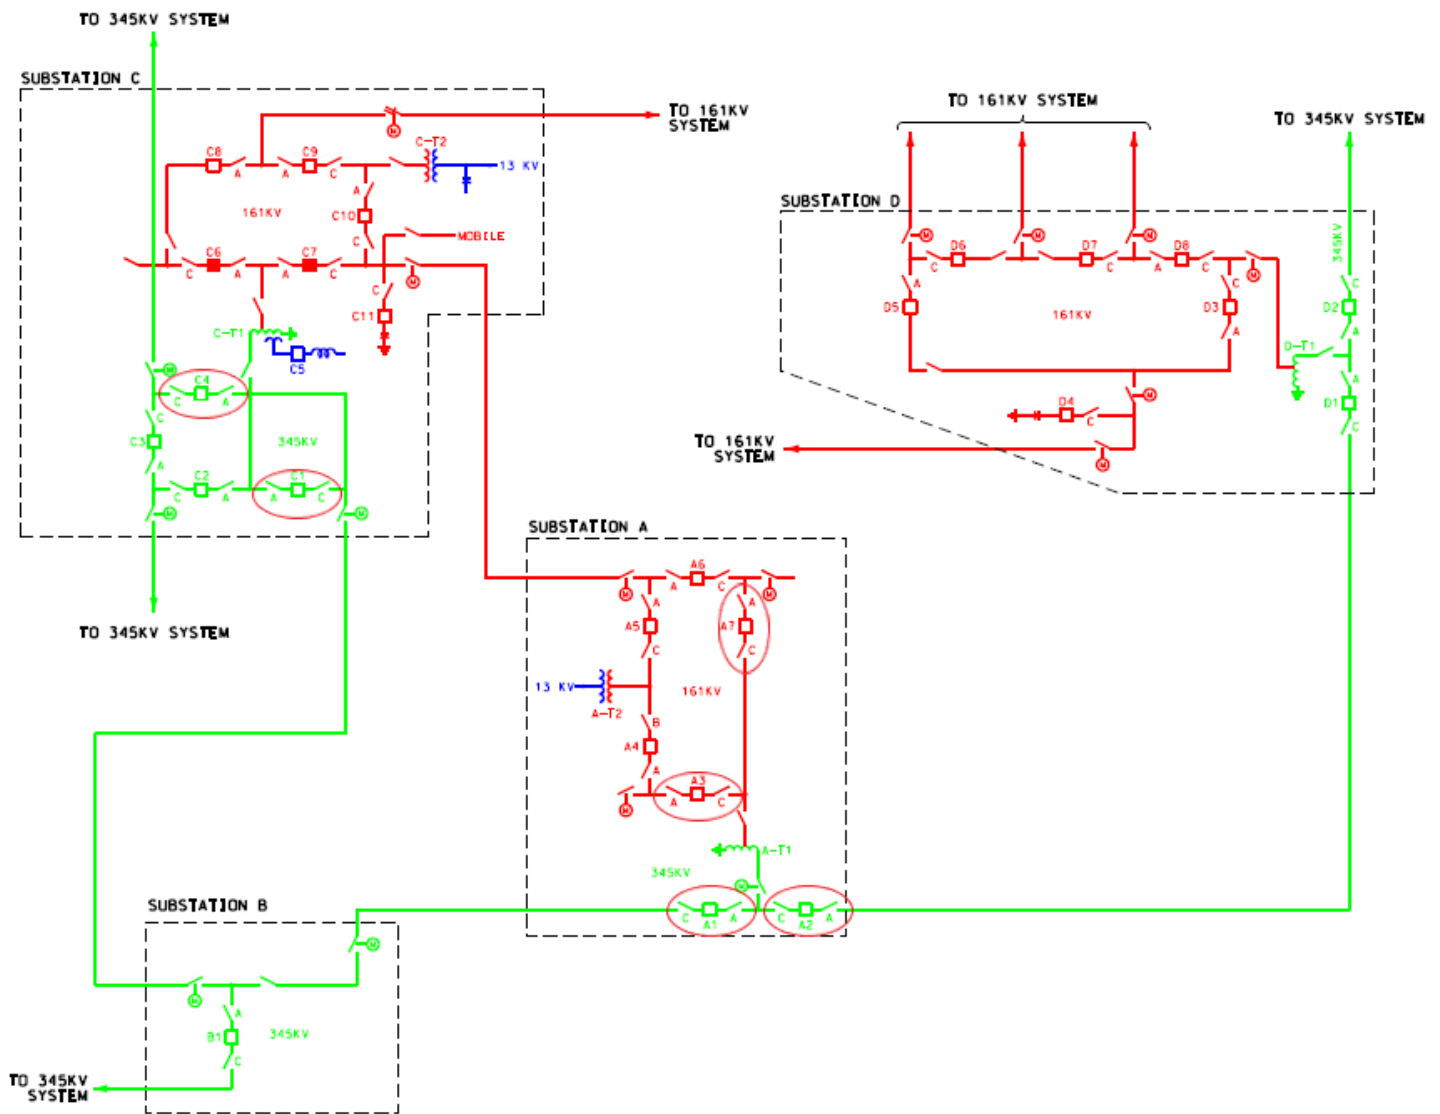
Figure 1 illustrates a recent example of a lockout relay misoperation. The lockout relay associated with 345 kV BKR A1 at Substation A misoperated during a nonfault condition, resulting in the trip of the circuit breakers circled in the figure. 345 kV BKR B1 at Substation B was out of service as part of a planned outage prior to the event.

The breaker operations removed the following BES equipment from service as a result of the misoperation of this lockout relay:

- 345 kV transmission line for Substation A–Substation B–Substation C
- 345 kV transmission line for Substation A–Substation D
- 345/161 kV transformer A-T1 at Substation A

Figure 1: Breaker Operations Resulting from Lockout Relay Misoperation

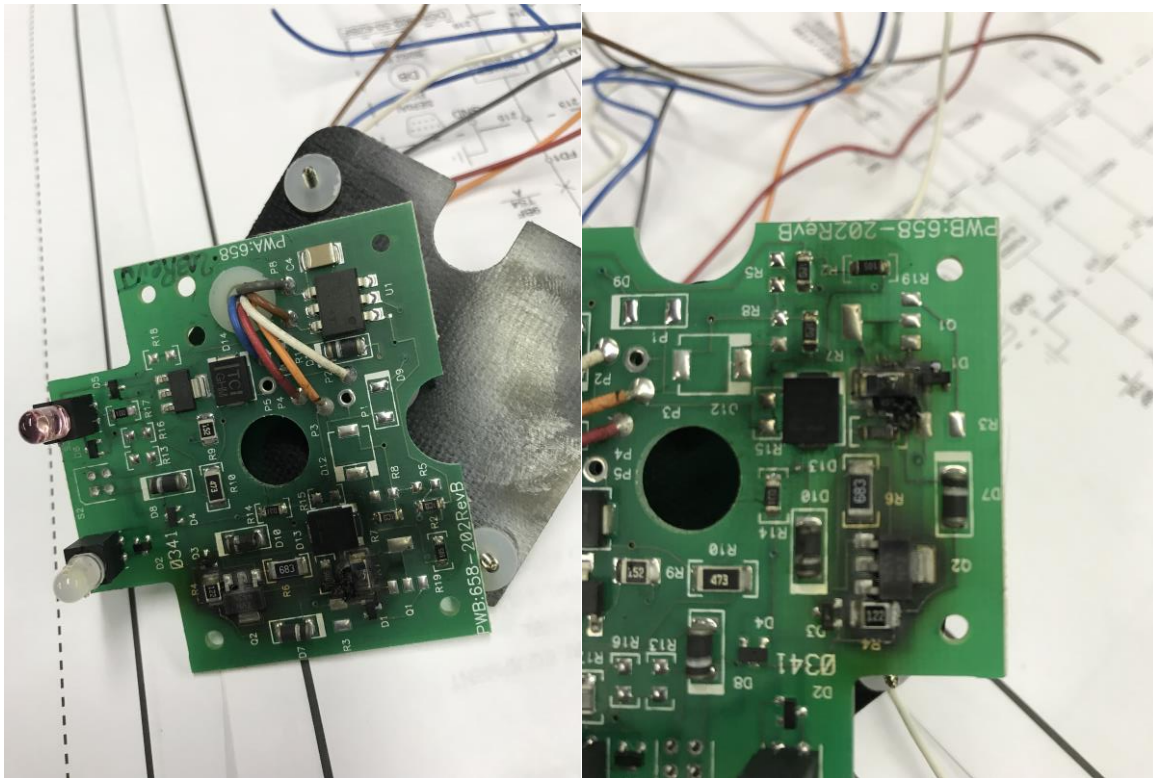
It was determined the misoperation was due to a faulty lighted nameplate control circuit board within the lockout relay. A detailed investigation uncovered a 2014 product advisory note from the lockout relay manufacturer. The note documented a potential problem with the lighted nameplate circuit board on their lockout relays manufactured between 2000 and 2008. The note stated “...symptoms have included the nameplate LEDs not lit or flashing, the SCADA contact alarm on or intermittent and in a very few reported instances, failures resulting in an unintended breaker “trip/open” operation.” [Figure 2](#) below contains photos of the failed circuit board that illustrate the circuit discoloration mentioned in the product advisory note.

Figure 2: Failed Lighted Nameplate Circuit Board from Lockout Relay

This event seems to indicate that the insulating material and electrical clearances used within the lighted nameplate controls may be less than adequate, resulting in dielectric breakdown and undesired breaker trip and lockout operations. The entity believed that this lockout relay had been operated within normal device specifications (i.e. control voltage and temperature). Lighted nameplate circuit boards have been replaced on a few other lockout relays that exhibited symptoms discovered after the event. Further research has revealed more entities have experienced similar lighted nameplate circuit board failures that had also caused unintended operations.

Conduct a system-wide survey to determine locations of lockout relays affected by the product advisory note. Work with the manufacturer to determine a corrective action that best fits constraints of the user.

- Replacement of the lighted nameplate circuit board with manufacturer recommended model on individual lockout relays.
- Replacement of individual lockout relays with lighted nameplate circuit boards affected by the product advisory note with lockout relays of a different model.
