Lesson Learned

Single Phase Fault Precipitates Loss of Generation and Load

Lesson Learned #: 20201001
Date Published: October 6, 2020
Category: Transmission Facilities

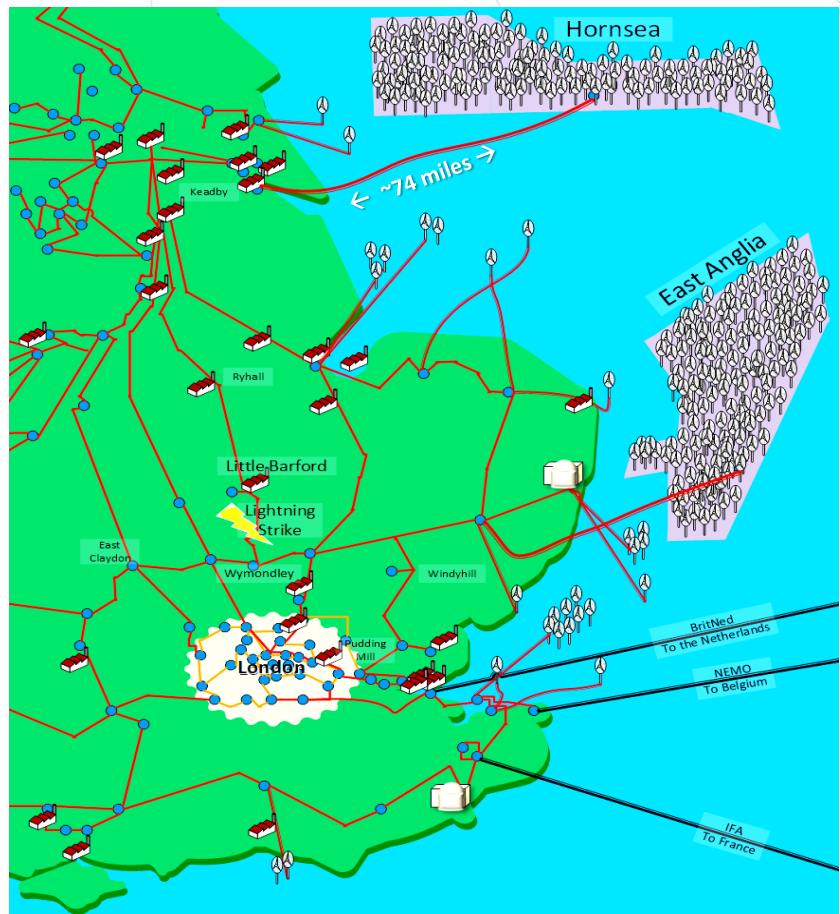
Figure 1: Simplified Transmission Map for SE Britain

A lightning-initiated single phase-to-ground fault on a 400 kV transmission line north of London was detected and isolated within its design parameters (refer to [Figure 1](#)). The line was successfully reclosed 20 seconds later.

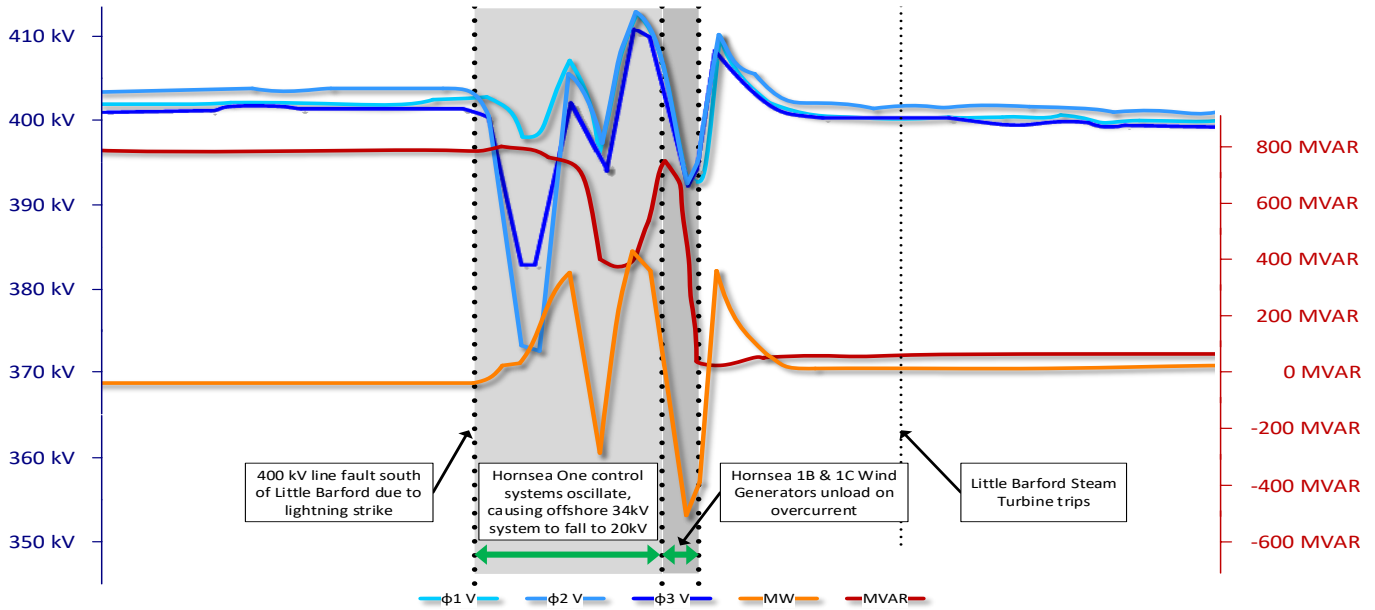
Figure 2: Parameters Measured at Hornsea Onshore Station – MW and MVAR

During the fault, Hornsea 1's output dropped from 799 MW to 62 MW. This occurred due to an oscillation that began when the reactive output of the offshore wind farm increased to support voltage during the fault. The wind farm was operating in a "weak" system condition with an undersea cable out of service. This weak configuration resulted in an oscillation when the voltage control algorithm increased var output. High var and watt output resulted in overcurrent protection operating and reducing output of the wind farm. Analysis of the event resulted in the wind farm operator making control algorithm changes.

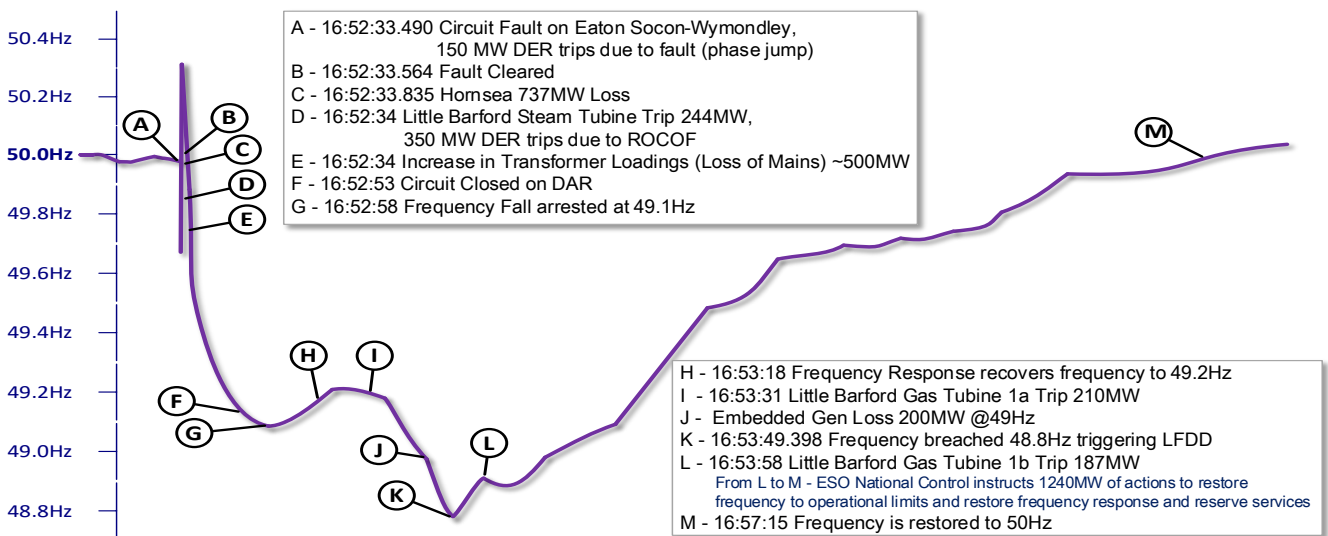
Figure 3: Frequency

generation within approximately one second of the fault. This resulted in a frequency decline from the European standard of 50.0 Hz to 49.1 Hz (see **Figure 2** and **Figure 3**).

As frequency began to recover 58 seconds into the event, one combustion turbine of the Little Barford plant tripped (210 MW), resulting in further frequency decline. When frequency dropped below 49 Hz, more DERs tripped.

Approximately 85 seconds into the event, a second combustion turbine was taken off-line at Little Barford by plant operators (187 MW), which made the cumulative generation loss of 1,878 MW, resulting in a frequency decline to 48.8 Hz. Underfrequency load shedding (UFLS) schemes operated at 48.8 Hz, disconnecting 931 MW of load. At this point, frequency stabilized at 48.9 Hz and began to recover as system operators dispatched resources.

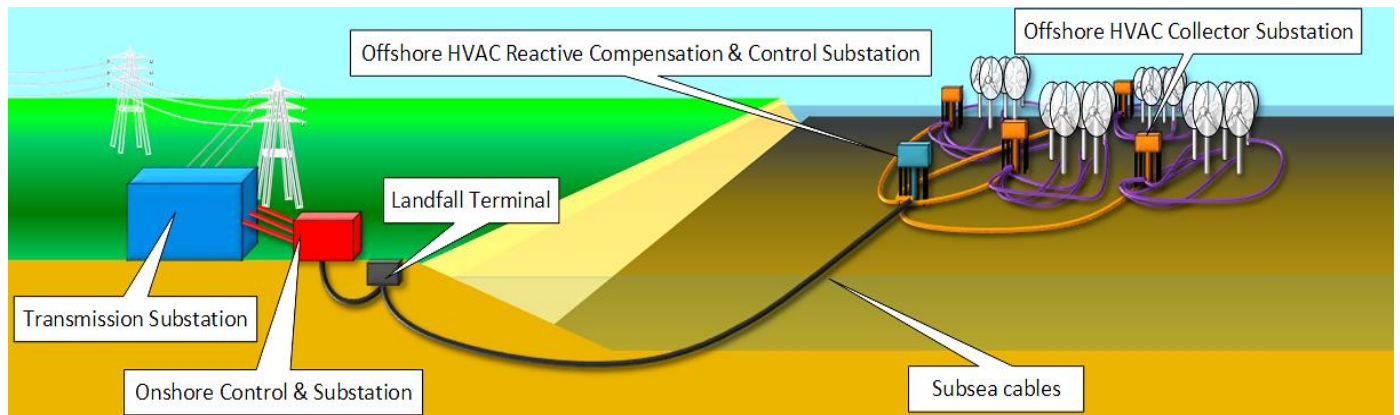
Figure 4: Typical Offshore Wind Farm Arrangement

There were limitations in the entity's knowledge of Hornsea 1's control system and the interaction between its onshore and offshore arrangements (See [Figure 4](#)). This impaired the understanding of Hornsea 1's performance during this event. The wind farm's onshore control system operated as expected when the system voltage dipped concurrently with the lightning strike. The offshore wind turbine controllers, however, reacted incorrectly to voltage fluctuations on the offshore network following the fault. This caused an instability between the onshore control system and the individual wind turbines. The instability triggered two modules to automatically shut down. In investigating the issues internally, the wind farm's developer identified that Hornsea 1's systems identified a "weak grid" condition at the time in question. The wind farm's developer identified the disturbance that resulted in the unloading was caused by an unexpected control system response due to an insufficiently damped electrical resonance in the sub-synchronous frequency range that was triggered by the event. The developer also identified that this stability issue with its voltage control system had occurred approximately 10 minutes prior to the incident on August 9 but did not cause unloading at that time. This may have been related to the trip of the Blyth – Eccles – Stella West 1 400 kV circuit trip at 16:43:25. At the time of the event, there were a number of transmission facility outages. Transmission facility outages (and less synchronous generator dispatch) reduces short circuit strength and contributes to creating a "weak grid" condition. The power electronics that inverter-based resources use require a minimum short circuit strength relative to their capability, often referred to as the "short circuit ratio," for stable operation. These outages contributed to the "weak grid" condition that Hornsea 1's systems identified and resultant unloading.

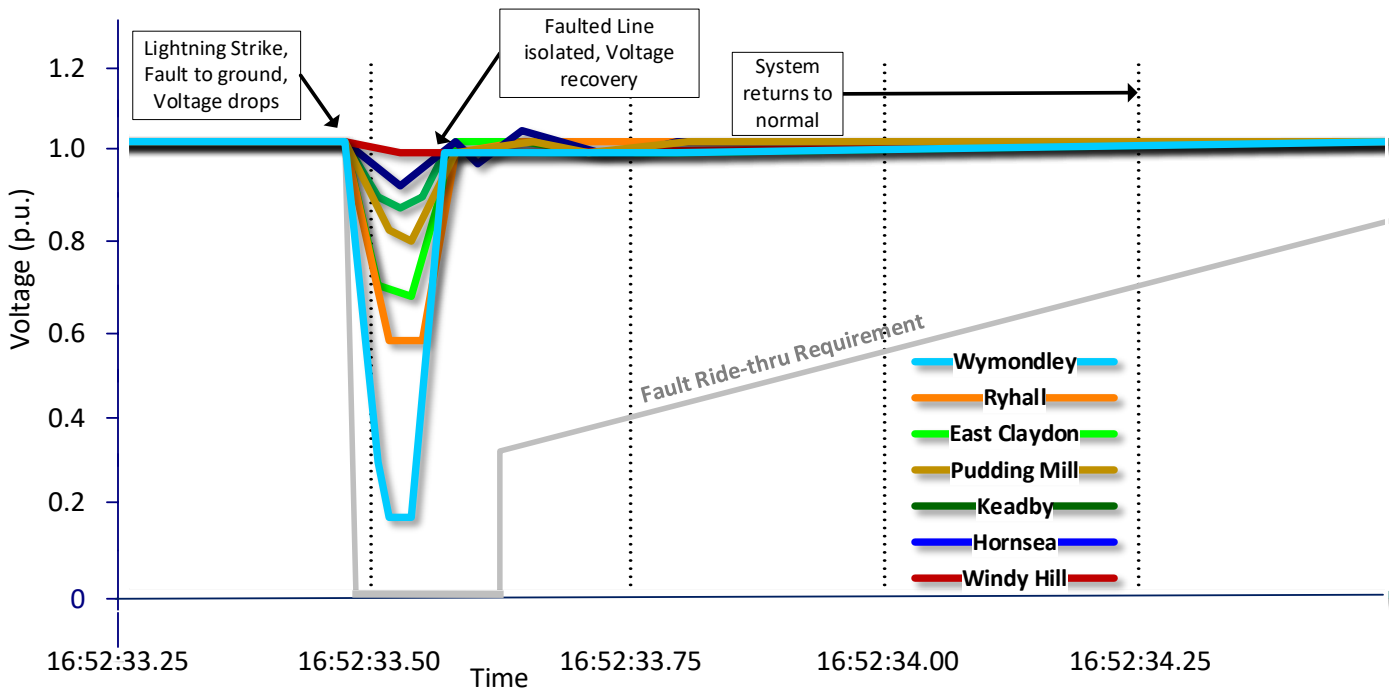
Figure 5: Voltage (p.u.) Profile at Various Locations During the Event

System voltages did not exceed the ride-through requirement. **Figure 5** shows single phase voltage profiles at various locations.
