## Lesson Learned

### Transient Induced Misoperation: Approach I (Control Circuit Transient Misoperation of Microprocessor Relay)

Lesson Learned #: 20210203

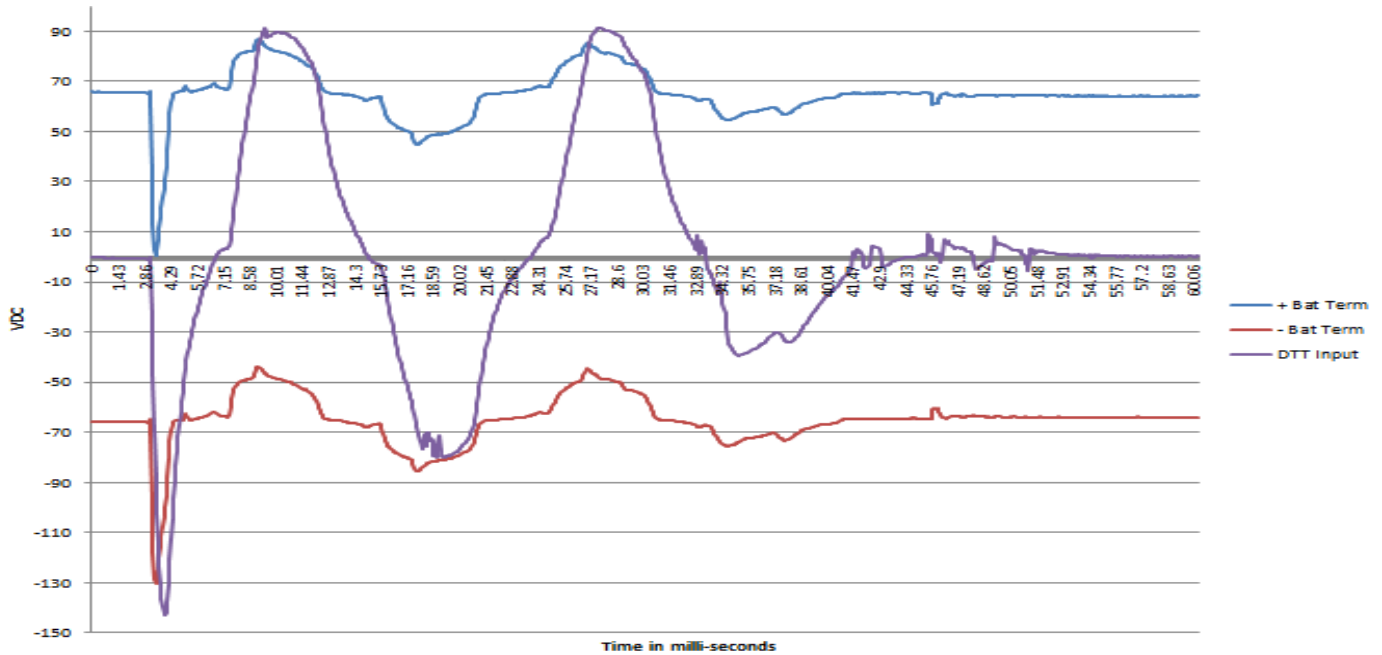
In 2020, a similar event from a single phase line fault occurred on a 500 kV line in close proximity to the powerhouse. The fault resulted in a misoperation of the same two powerhouse lines causing 315 MW of hydro generation to be tripped. The 15 kHz continuous recorder captured a brief full positive shift of the dc control power with respect to ground. A voltage pulse was seen across the DTT input of the monitored relay followed by a 60Hz AC voltage component lasting the same duration as the transmission line fault (approximately 2.5 cycles); see [Figure 1](#) and [Figure 2](#). The transient ac signal was comparable to the previously conducted lab tests that showed an ac signal was capable of initiating the relay input without the DTT LED trip target. The conditions that the relay is expected to operate at (above 70 V for 4 ms) occurred too briefly in the 2020 event. Unfortunately, the transmitting relay did not log an event, and the receiving relay that did trigger an event masked the actual duration with a time delay dropout of the trip signal (e.g. "min trip duration").

**Figure 1: 15 kHz continuous recorder data measuring relay supply voltage (Blue and Red) and the DTT input voltage across the installed resistor (Purple)**

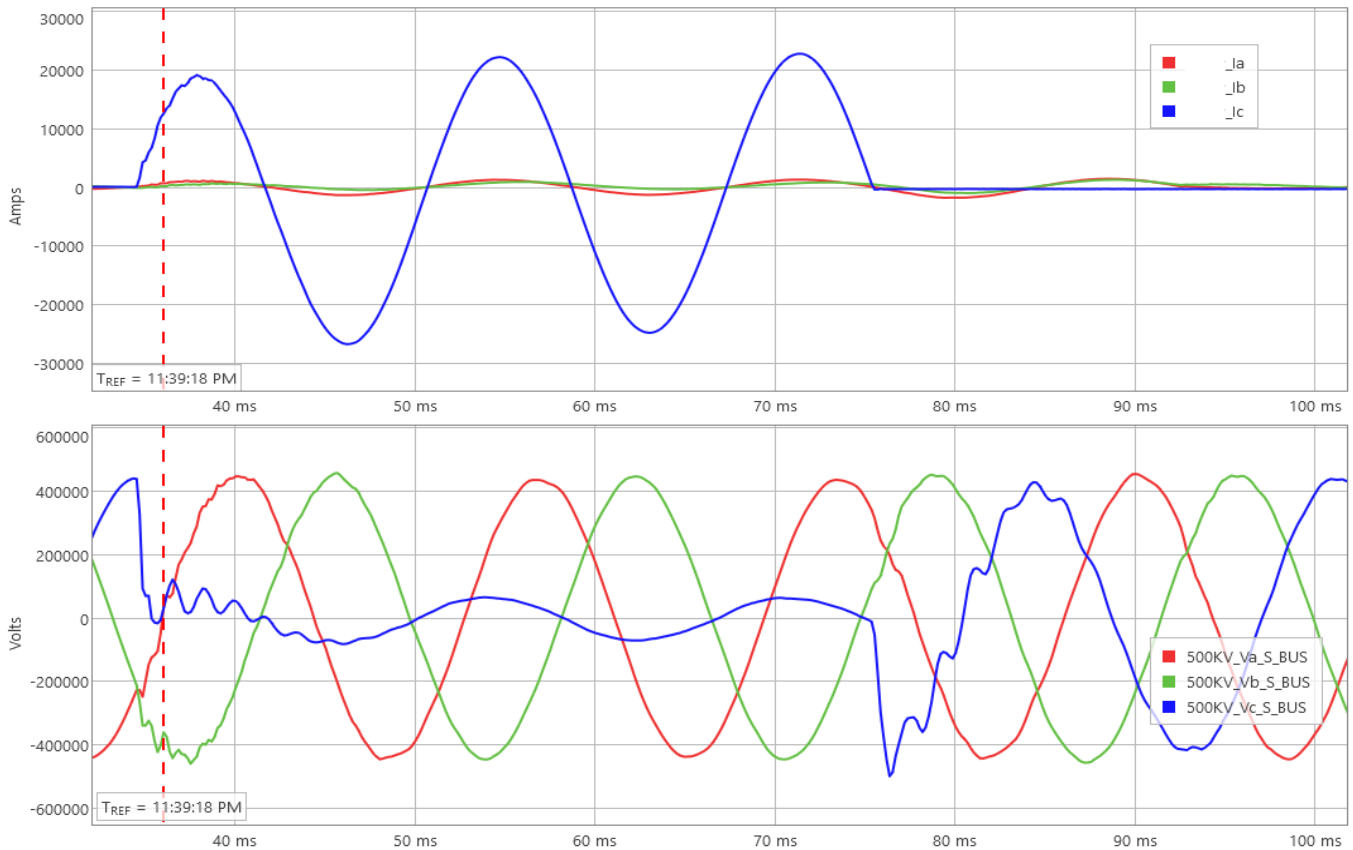
**Figure 2: Event from digital fault recorder, located at the substation adjacent to the powerhouse, showing line current (top) and bus voltage (bottom) during the 2020 500 kV line fault.**

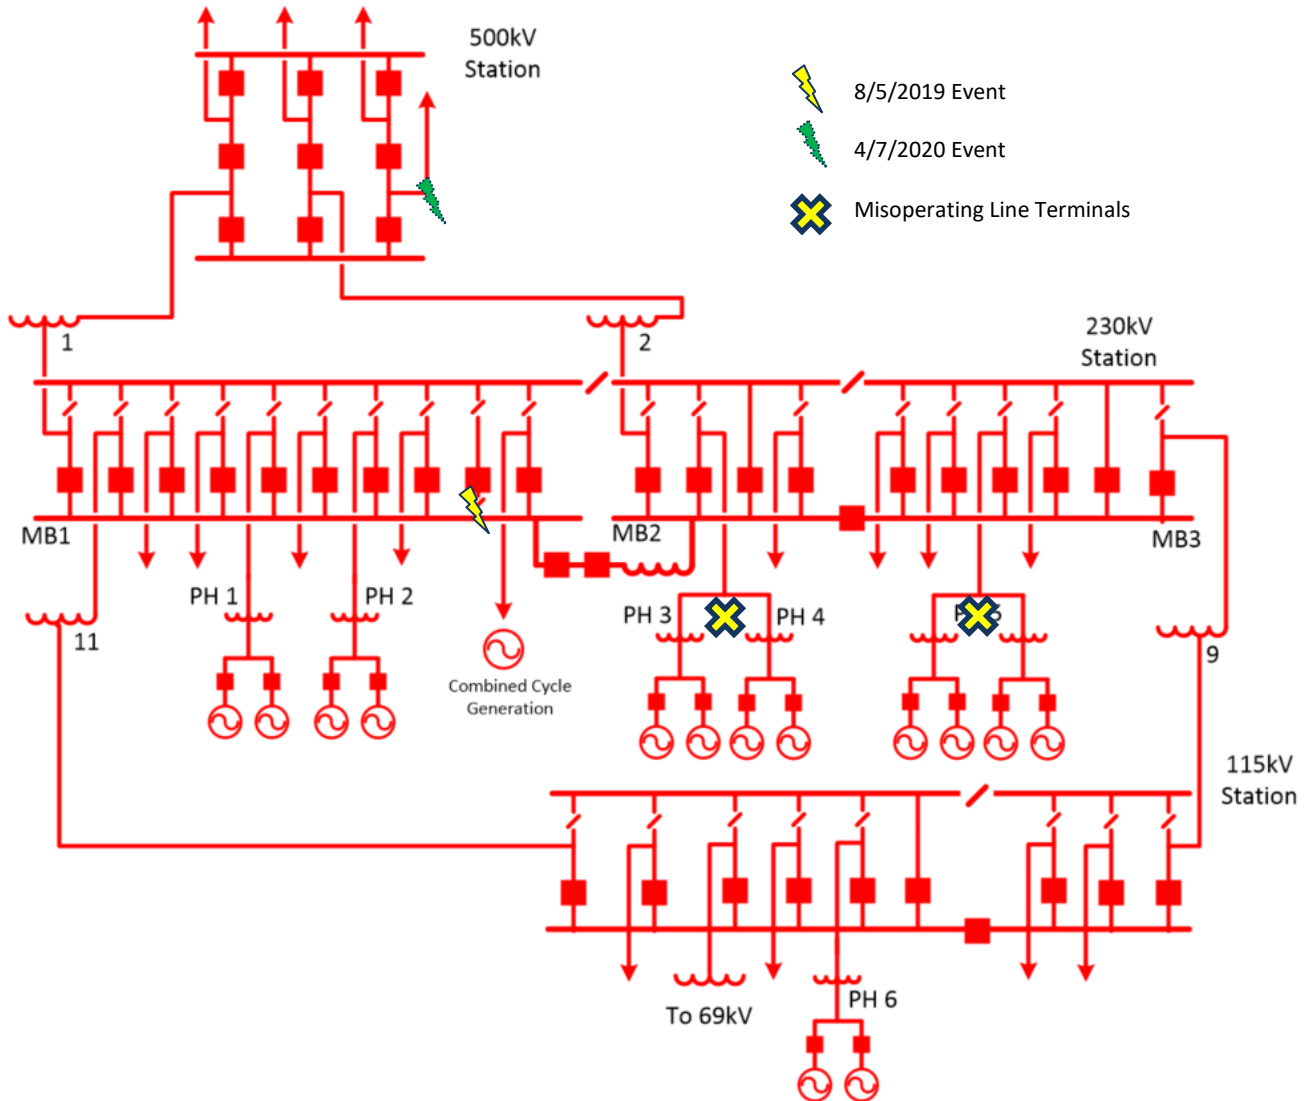
The generator step-up (GSU) transformers at the powerhouse rely on the line breaker at the substation to clear for transformer faults (see [Figure 3](#)). The powerhouse line relay DTT input is used to transmit operator control and transformer protection trips to the substation. The two powerhouse lines with a history of misoperation have two GSUs per line relay and consequently more control cabling than a line with only one GSU (GSU transformer relays misoperated in 2017 for a similar close in fault). The remaining four lines that had only one GSU per line have not misoperated.

**Figure 3: One line diagram of the impacted station.  
Line relay misoperations occurred on powerhouse lines 3/4 and 5.**

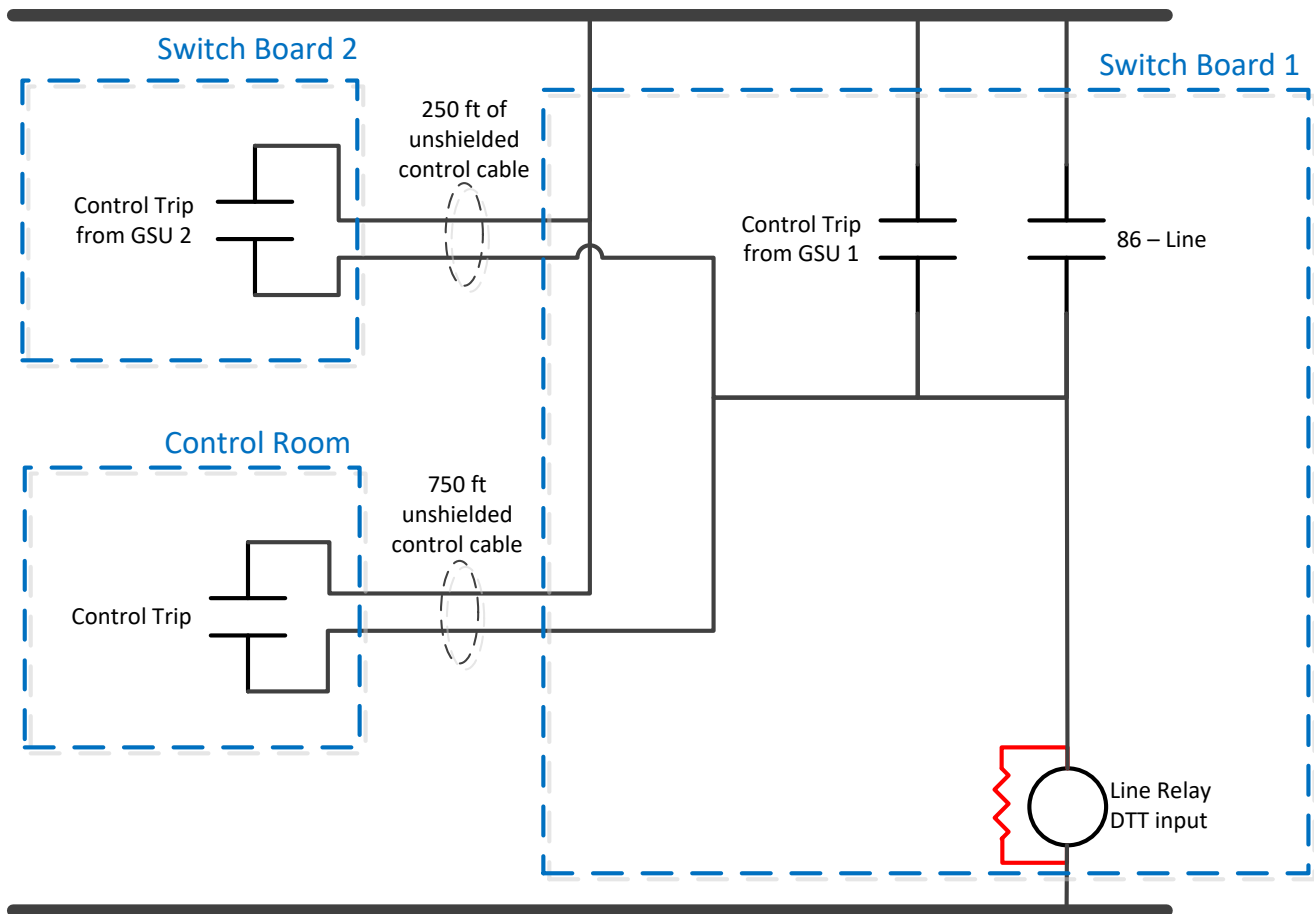
- The long cable that carried the control room trip back to the line protection sat in the same cable tray as the unshielded current transformer (CT) cable for the control room board meter (see [Figure 4](#)). It was theorized that the large current flowing through the CT cable during a close-in fault could have been the cause of the DTT transient in conjunction with improper CT grounding. CT grounds were checked, and secondary injection testing was performed in an attempt to rule out coupling between the CT and DTT control circuit during faults. A 100A AC signal designed to look like a single-line-to-ground fault was simulated into the board meter CT circuit while monitoring the DTT input of the associated line relay. CTs were found to be properly grounded and no corresponding transient was measured during secondary injection.

**Figure 4: Original DTT circuit for two GSU Transformer per line protection package. Single GSU lines do not have a Control Trip from GSU 2.**

- The control handle trip circuits run for several hundred feet from the protection cabinet to the control room at the powerhouse. The length of the cable resulted in higher cable capacitance and an increased likelihood of ac coupling during high magnitude ground faults. The GOP rewired the control trip circuits to terminate into the GSU protection, a more advanced microprocessor relay. The redesign of the circuit allowed for the implementation of a 100 ms (6 cycle) delay of the control trip signal for transient ride through during normal clearing faults. A longer delay has been requested by the TOP to ride through potential stuck-breaker fault events.

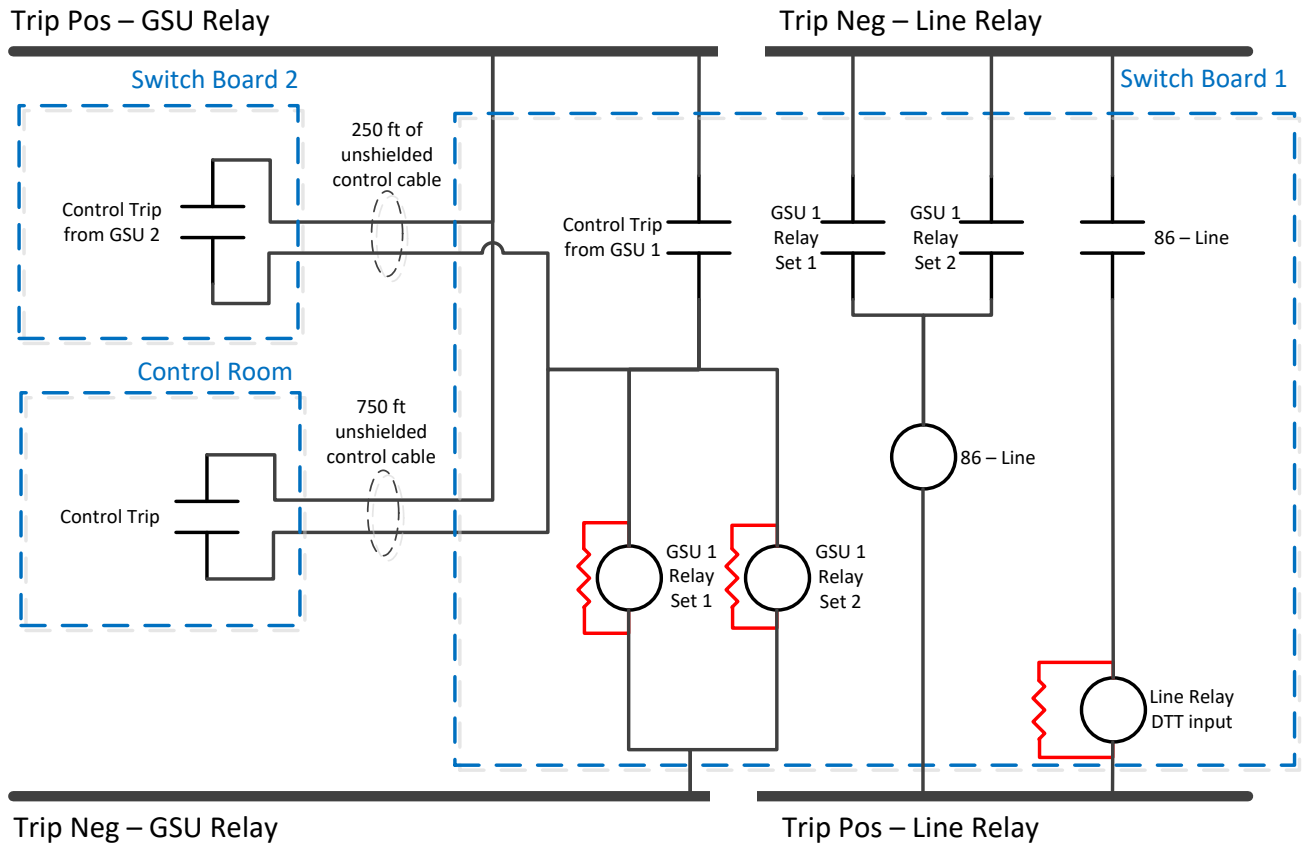
**Figure 5: Modified protection and control trip circuit used to trip substation breaker. Both Set 1 and 2 GSU relays trip 86-line lockout relay.**

- The powerhouse line protection will be replaced in the near future with more sophisticated microprocessor relays with the DTT circuit divided across multiple inputs (control and protection) on the new line relays. The electrically smaller protection signal of the DTT circuit can be passed through to the substation with no intentional delay to maintain fast clearing times for GSU faults. The electrically larger control signal of the DTT circuit will be time delayed for transient ride through. Additionally, the new design will address the single point of protection failure vulnerability that the 86-line lockout represents in the present design (see [Figure 5](#)).

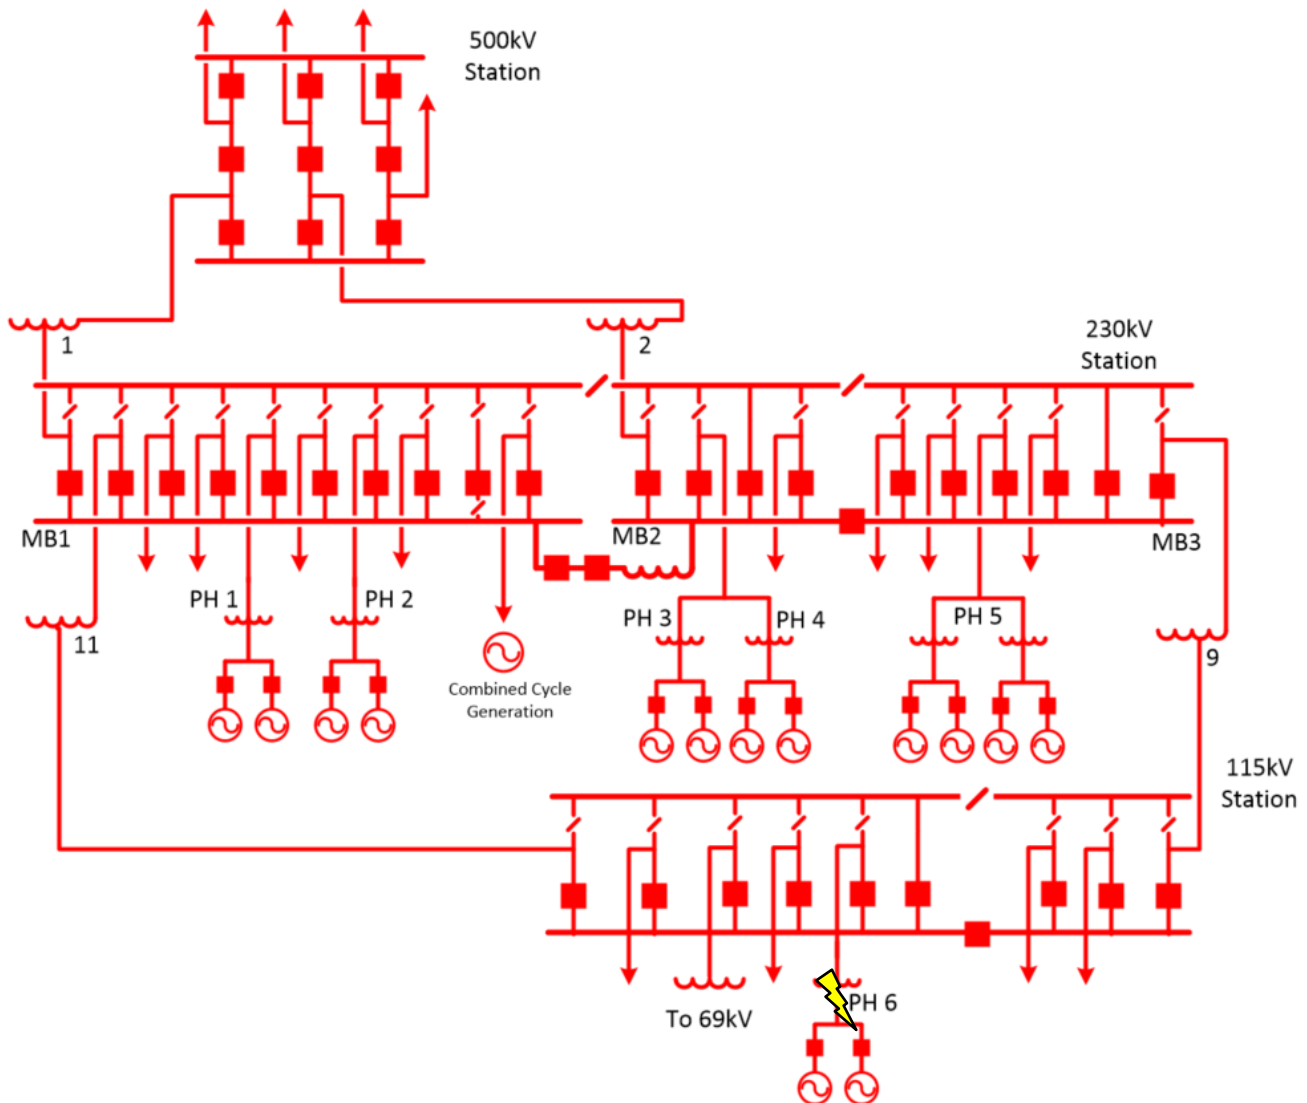
Later in 2020, a thunderstorm resulted in multiple faults in the vicinity of the powerhouse. A 115 kV PH line fault was observed during this storm (see [Figure 6](#)). The fault was smaller in magnitude than the 500 kV single phase fault observed during the earlier 2020 misoperation, but a transient was observed and the relays did not false trip. At that time, the only corrective action fully implemented was the updated

resistor sizing on the DTT input. While more events will need to occur to verify the success of the corrective actions, this was a positive indication of the effectiveness of the corrective actions.

**Figure 6: One-line diagram of substation showing the 115 kV Bus and powerhouse line impacted by the later 2020 close-in fault**
