Lesson Learned

Transient Induced Misoperation: Approach II (Loss of Protection during Severe Lightning Event)

Lesson Learned #: 20210204

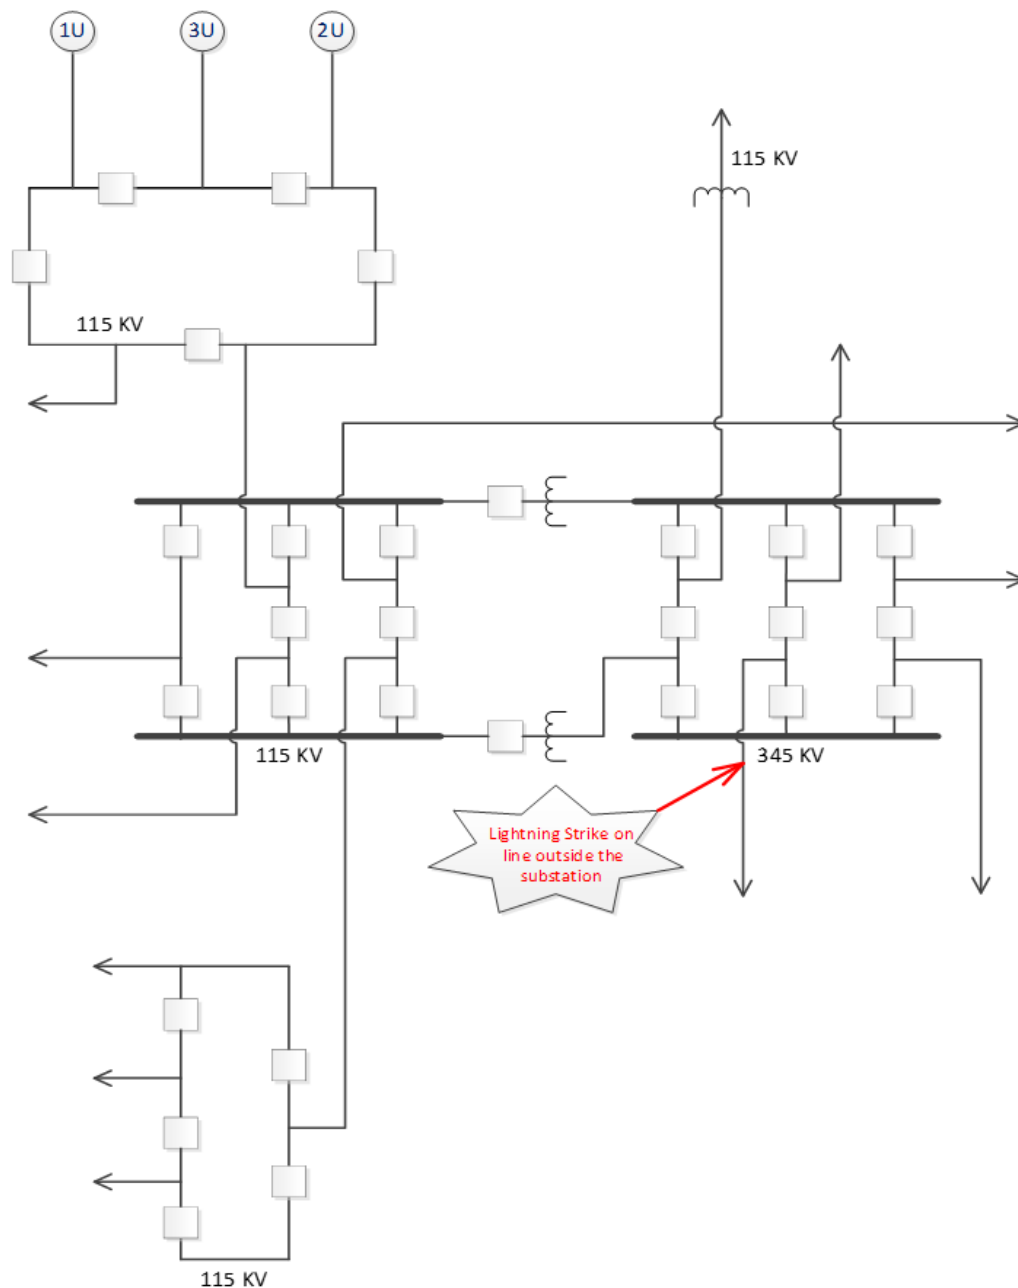
Figure 1: One Line Diagram

A 146 kA magnitude lightning strike¹ occurred near a 345 kV line and terminated at a 345/115/13.8 kV substation. This strike caused a backflash on a 345 kV line structure just outside the station, resulting in a B phase-to-ground fault.

This fault was not cleared by the local station System 1 or System 2 line protection relays as they both powered off and rebooted seemingly simultaneously with this strike. The System 1 protection scheme uses directional comparison blocking (DCB) via power line carrier, and the System 2 uses line current differential via optical ground wire (OPGW). The protection systems utilize different relay manufacturers and are supplied by separate DC systems. The System 1 protection at the remote terminal of the faulted line operated via the DCB communication-assisted elements in 4.5 cycles. The remote System 2 line current differential did not operate due to the loss of communication with the powered off relay.

However, since the fault was left uncleared at the local station, 14 remote 345 kV and 115 kV terminals operated for the fault via neutral time overcurrent (TOC) or over-reaching step distance protection elements to clear the fault. Total clearing time for this 345 kV Single Line to Ground fault was approximately 1.5 seconds. All lines reclosed as designed. A one-line diagram is included on the following page ([Figure 1](#)).

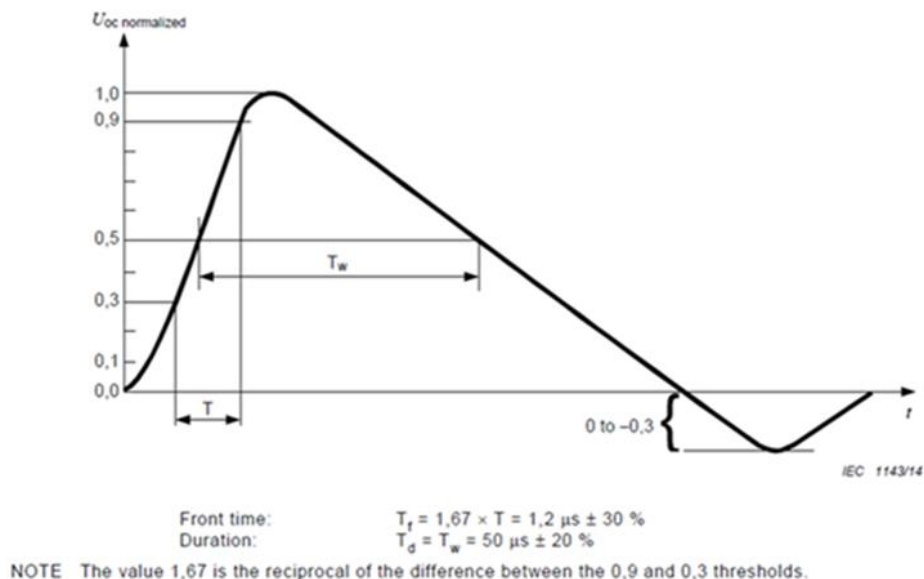
Figure 2: IEEE Surge Withstand

Each manufacturer maintained that their product was built and tested to the latest IEC 60255-26 (2005) and IEC 61000-4-5 (2005) standard at the time of manufacture. The surge withstand test consists of 50 μ s pulses of various high voltages and of positive and negative polarity to the terminals of the power supply. The power supply under test was originally designed for up to 2.0 kV surge withstand. The standard was updated in 2013 increasing the surge withstand to 4.0kV.

Relay Manufacturer B (System 2) was able to recreate the failures in their lab during surge withstand testing on both the actual System 2 relay and a replica when the relay was subjected to a 4.0 kV surge (see [Figure 2](#)). Manufacturer B concluded that the ground potential difference exceeded the surge withstand capability of the relay, resulting in a reboot.

The protection relays that rebooted as a result of this event were installed in 2011 and therefore met the 2005 standard.
