## Lesson Learned

### Battery Energy Storage System Cascading Thermal Runaway

Lesson Learned #: 20210301

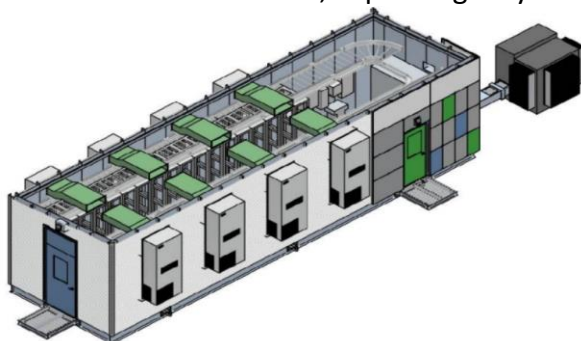
Figure 1 shows the general layout of the BESS. Figure 2 shows how a single cell failure propagated through one Module and consumed the whole rack, releasing a large plume of explosive gases. This could have occurred without a flame, explaining why the gases were not burned as they were emitted.

**Figure 2: General layout of the BESS**  
(Image credit: APS)

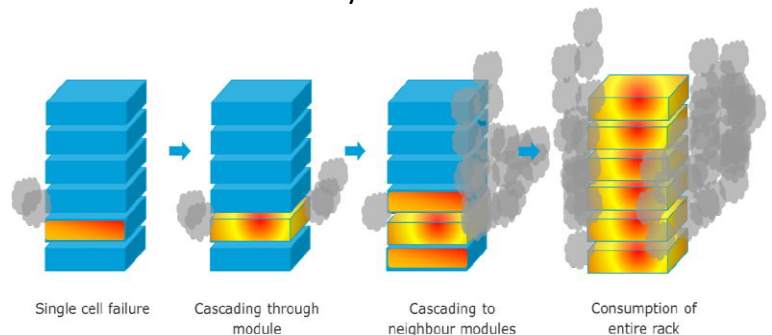
At approximately 16:54 PST, a battery cell in the BESS experienced a sudden drop in voltage during a charging cycle. Moments after, the voltage dropped and a battery cell went into thermal runaway. This event generated off-gassing and smoke that activated the smoke detection system, leading to the discharge of the fire suppression system. The initial cell's thermal runaway cascaded into neighboring cells and subsequently into the batteries contained within neighboring modules.

**Figure 1: A single cell failure propagated through one Module** (Image credit: APS).

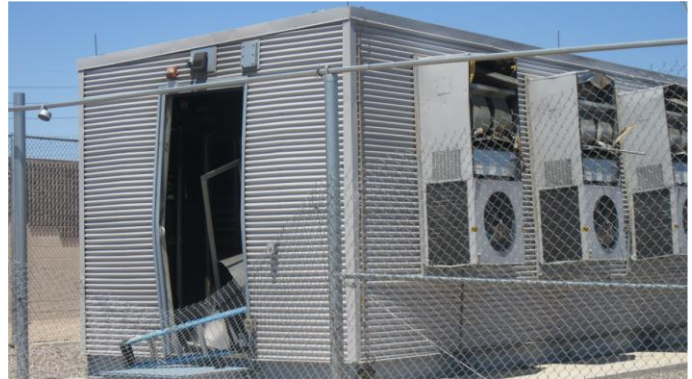
Approximately three hours after initiation of the event, emergency responders opened the BESS side container door and approximately two minutes later, an explosion occurred.

**Figure 3: BESS Exterior after event (image credit: APS)**

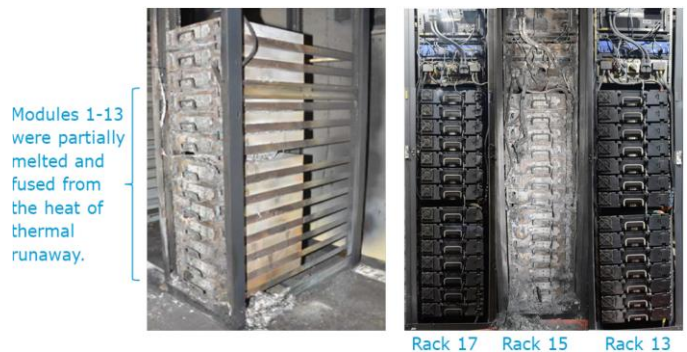
- Internal failure in a battery cell initiated thermal runaway
- Lack of thermal barriers between cells led to cascading thermal runaway
- The fire suppression system was incapable of stopping thermal runaway
- Flammable off-gases concentrated without a means to ventilate
- Emergency response plan did not have an extinguishing, ventilation, and entry procedure

**Figure 4: All modules in Rack 15 were severely damaged by thermal runaway while leaving nearby racks mostly intact (image credit: APS)**

- Improve training, emergency response planning, and procedures for first responders, operations, and maintenance personnel that account for the risks and hazards of cascading thermal runaway, including flammable gases and how to enter systems after a failure.
- Work with suppliers, industry experts, and standards bodies to improve battery safety and limit potential risk in the following areas:
  - Minimize or eliminate cell-to-cell and module-to-module heat transfer to stop thermal runaway.
  - Implement fire detection and suppression system designs that will fully manage a thermal runaway.
  - Implement design changes incorporating monitoring and remote reporting of flammable gas concentrations and implement ventilation systems to mitigate.
