Lesson Learned

Multiple Faults in Rapid Succession Contribute to Relay Misoperations Leading to Loss of Load

Lesson Learned #: 20210802

Category: Relaying and Protection Systems

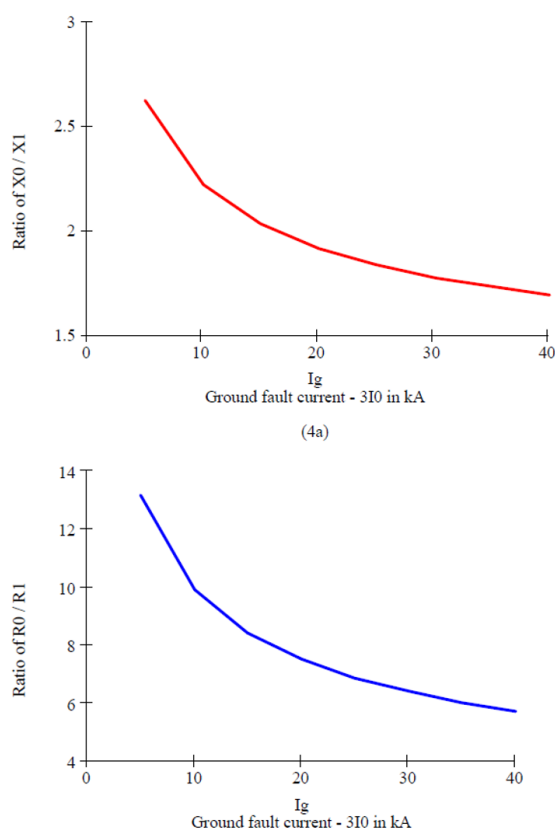
Figure 1: Ratios of Zero to Positive Sequence Reactance (top, red) and Resistance (bottom, blue)

Two additional transmission line trips associated with the four faults occurred due to relay misoperations at the remote terminals of the lines at a substation several miles away. After analysis, these have both been attributed to overreaching of the Zone 1 ground distance elements in the stepped distance relaying scheme that serve as backups to the line current differential relaying. The Zone 1 elements were set for 80% of the line impedance, yet they operated for faults at the substation at the remote ends of the lines, fully 100% away in terms of line impedance. It has been determined that the relays overreached because of the dynamic nature of the zero-sequence impedance of the transmission lines. These are underground lines housed in steel pipe-type cables. Magnetic saturation of the steel pipe in the presence of high fault current levels is a known phenomenon that results in changes in the impedance of the return path of ground fault currents. This is depicted in **Figure 1**, showing both the reactive and the resistive components with the latter exhibiting much wider variation.

The resistance (R0) is actually affected significantly more than the reactance (X0).

Saturation was accounted for in the zero-sequence impedance model used to determine the relay settings, and appropriate compensation factors were applied. However, multiple faults in rapid succession, compounded by the transmission line trips previously described, fragmented the transmission system in the vicinity during this event, altering the fault current flows anticipated in short circuit studies. The impedance of the ground current return paths used in the modeling no longer matched the evolving conditions. Exacerbating the situation was the complex nature of the return current paths, including underground steel infrastructure such as water pipes, structural steel in tunnels and building foundations, etc.

- The zone one elements of the stepped distance back-up relaying on the underground pipe-type cables have been put on standby to be armed only when the communications used by the line current differential relaying are unavailable. This will be done automatically so that if communications are suddenly and unexpectedly lost, the zone one elements will immediately begin protecting the lines.
