900 MW Fault Induced Solar Photovoltaic Resource Interruption Disturbance Report

Southern California Event: October 9, 2017
Joint NERC and WECC Staff Report

February 2018

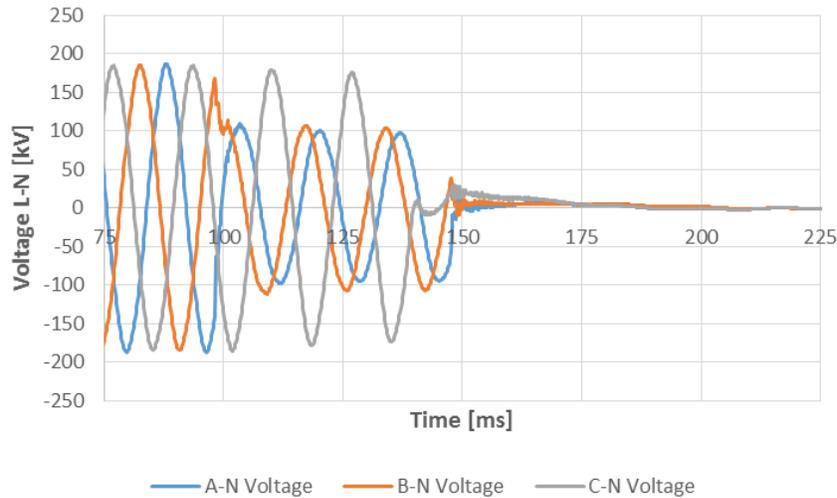
Figure 1.2: DFR Data from 220 kV A-B Phase Fault at 12:12:16 PST [Source: SCE]

Figures 1.2 and 1.3 show digital fault recorder (DFR) point-on-wave data from the fault locations⁸ and demonstrate that both the 220 kV and 500 kV phase-to-phase faults cleared normally with no irregular transient behavior. Both faults resulted in tripping or momentary reduction of a significant amount of solar PV resources affected by these faults. No solar PV generation was de-energized as a direct consequence of the protective relaying removing the faulted element(s) from service; rather, the solar PV inverter controls tripped in response to the measured conditions at their point of measurement (POM) or terminals.

⁸ The 220 kV measurement is on the line side, hence why measured voltage goes to zero upon fault clearing. The 500 kV measurement is on the bus side and measured voltage recovers after fault clearing.

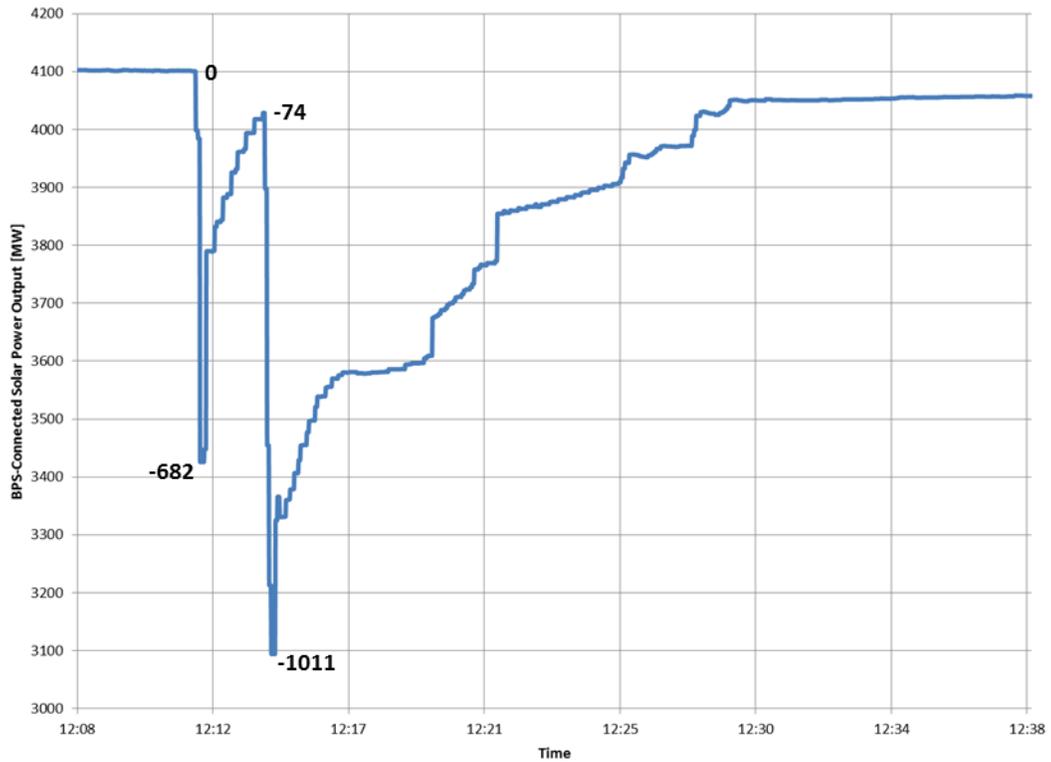
Figure 1.4: Solar PV Response during Canyon 2 Fire [Source: SCE]

The first fault resulted in a reduction of 682 MW of solar PV resources, and the second fault resulted in a reduction of 937 MW. These amounts were determined using supervisory control and data acquisition (SCADA) data supplied by SCE at a resolution of one sample every four seconds. Data of this resolution is able to capture the general response of the solar PV plants over a longer period of time; however, the data cannot differentiate between momentary cessation and tripping in some cases.⁶ Based on data requested for this event (e.g., sequence of events alarms, high resolution measurements, etc.) from Generator Owners (GOs) and Generator Operators (GOPs) for this event, it was confirmed that most of the affected solar PV inverters that did not trip entered momentary cessation. Some plants restored output within five seconds, as recommended in the Blue Cut Fire disturbance report, while others took longer to fully restore power output.

Figure 1.4 shows the aggregate solar PV fleet response during the two events, Figure 1.5 shows the aggregated response of solar PV resources separated by region (to match Figure 1.1), and Figure 1.6 shows the response of the six solar PV plants that accounted for most of the reduction in generation. These plots were generated using SCADA data from Southern California Edison.

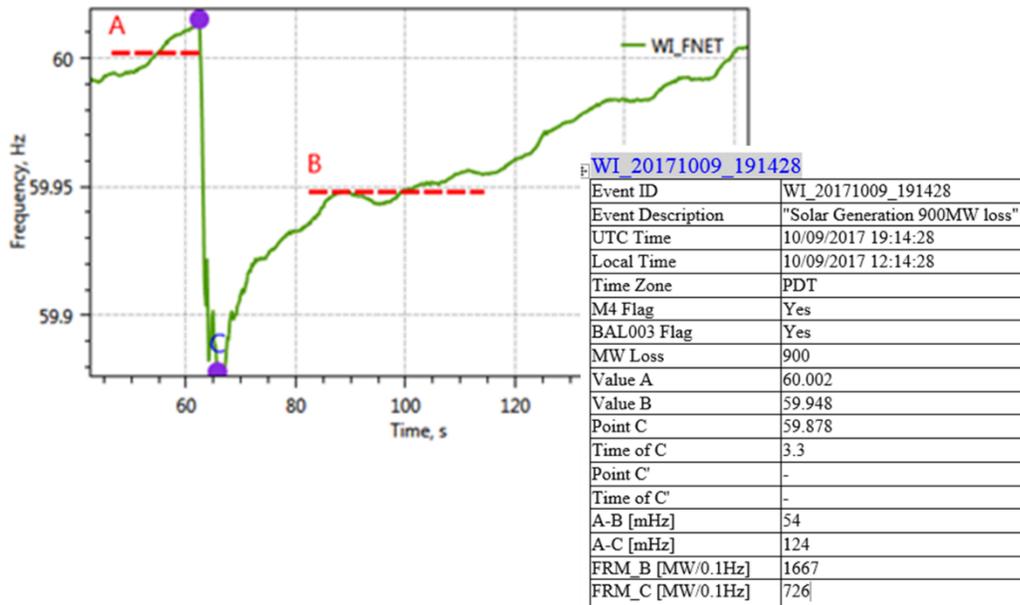
Figure 1.7: Western Interconnection Frequency during Second Fault

The 500 kV fault that resulted in over 900 MW solar PV resource loss caused a frequency excursion in the Western Interconnection with system frequency reaching a frequency nadir of 59.878 Hz about 3.3 seconds after the fault (see Figure 1.7). Frequency recovered to nominal in roughly 100 seconds. The NERC IRPTF is performing stability studies to determine if the momentary loss of inverter-based resources caused by momentary cessation poses any significant risk to frequency stability and if this should be considered in the resource loss protection criteria (RLPC) for the Western Interconnection (i.e., currently the loss of 2 Palo Verde generating units).

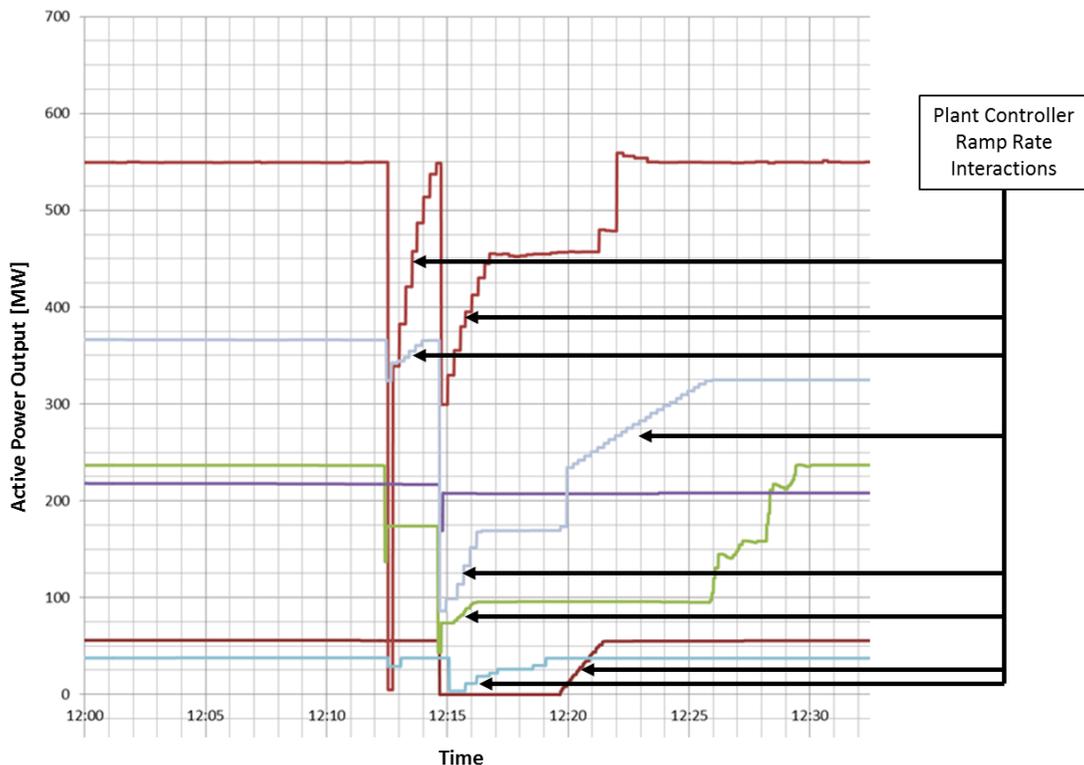
Figure 2.1: Plant Controller Ramp Rate Interactions

During the Canyon 2 Fire disturbance, multiple plants experienced ramp rate limiter interactions that impeded the inverters from recovering to precontingency active current injection quickly. Figure 2.1 shows identified conditions where the plant-level controller imposed ramp rates on the inverters following momentary cessation. This is not the intended operation of inverter-based resources and these interactions following fault conditions need to be remediated to ensure BPS transient and frequency stability (these ramp rates are typically imposed on active power, not reactive power).

Ramp rate limits are typically implemented at the plant-level controller to ensure that the overall plant active power output meets any BA ramping requirements.¹³ This controller is relatively slow, operating around a resolution of 100 ms (10 times per second) or slower. However, when voltage at the plant controller falls below a predetermined level (e.g., 0.9 pu), the plant controller freezes, sending commands based on when the inverters enter ride-through mode or momentary cessation where command values from the plant controller are ignored and each inverter uses its terminal conditions for control. If the inverter enters momentary cessation, it recovers active current injection to predisturbance levels within a programmable amount of time (e.g., within 0.5 seconds). Once voltage recovers to above the predetermined level, the plant controller will again begin sending commands for the inverters to follow. Ramp rates then become controlled by the plant controller again. The plant controller and inverter controls should be coordinated to ensure that active current injection returns to predisturbance levels unimpeded by any interaction with the ramp rate limits of the plant controller.

Inverter-based resources are returning to predisturbance outputs slower than desired because plant-level controller ramp rate limits used for balancing generation and load are being applied to inverter-based resources following momentary cessation. During ride-through conditions, the inverter controls its output and ignores signals sent by the plant-level controller. After voltage recovers and the inverter enters a normal operating range, it again responds to signals from the plant controller. The plant controller then applies its ramp rate limits to the remaining recovery of current injections, restraining the inverter from recovering quickly to its predisturbance current injection.

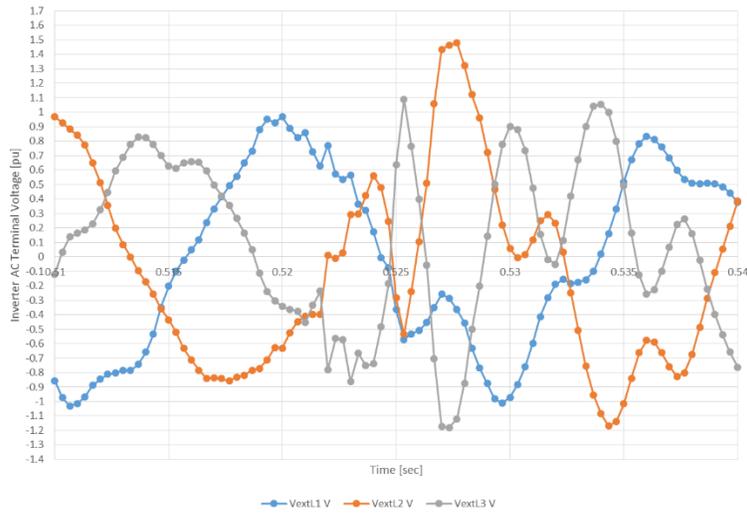
Figure 2.3: Phase Voltages during On-Fault Conditions

In the Canyon 2 Fire disturbance, inverters tripped due to a sub-cycle (less than quarter cycle) measured voltage above the overvoltage protective setting for the inverter (see Figure 2.3¹⁴ and Table 2.2). However, root-mean-square (RMS) trip settings should not be applied to instantaneously sampled voltage measurements. RMS trip settings should be applied to the fundamental frequency component of a filtered ac voltage waveform to avoid spurious tripping on transient overvoltages.

A large percentage of existing inverters on the BPS are configured with instantaneous overvoltage protection at the PRC-024-2 high voltage ride-through curve that does not use any form of filtering. Any instantaneous, sub-cycle transient overvoltage may trip the inverter off-line, making these resources susceptible to tripping on transients caused by faults and other switching actions.

Inverter protective functions should use a filtered, fundamental frequency voltage input for overvoltage protection when compared with the PRC-024-2 ride-through curve. Any sub-cycle transient overvoltage protection, if applicable, should use voltage levels based on equipment limitation that are substantially higher than the PRC-024-2 curve.

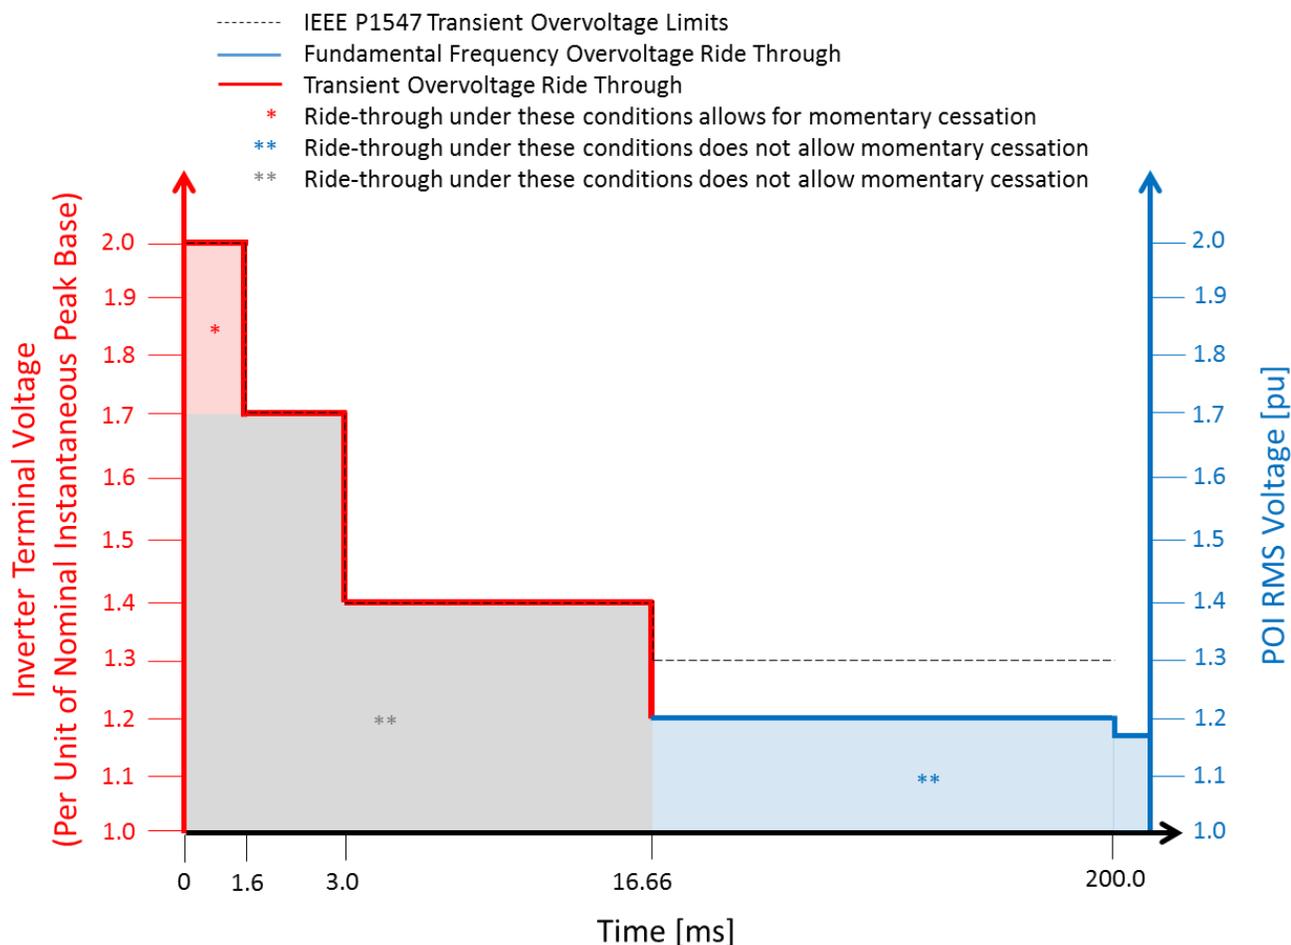
Figure 2.4: Recommended Overvoltage Ride-Through Curve

The NERC IRPTF has drafted the recommended transient overvoltage ride-through curve shown in Figure 2.4. Further details will be provided in the Reliability Guideline under development by the IRPTF. This curve differentiates between sub-cycle overvoltage that uses an instantaneously measured ac voltage value and RMS overvoltage that should use a well filtered, fundamental frequency RMS voltage measurement. The overvoltage ride-through limits on the RMS portion of the curve mirror PRC-024-2 while the limits on the sub-cycle instantaneous portion of the curve are based on new technology inverter capabilities, historical overvoltage events, known equipment limitations, and simulations of potential overvoltage conditions that can be expected at inverters on the BPS. Note that the RMS portion of the waveform applies to the POI of the inverter-based resources while the sub-cycle portion is a recommended specification for the inverters themselves.

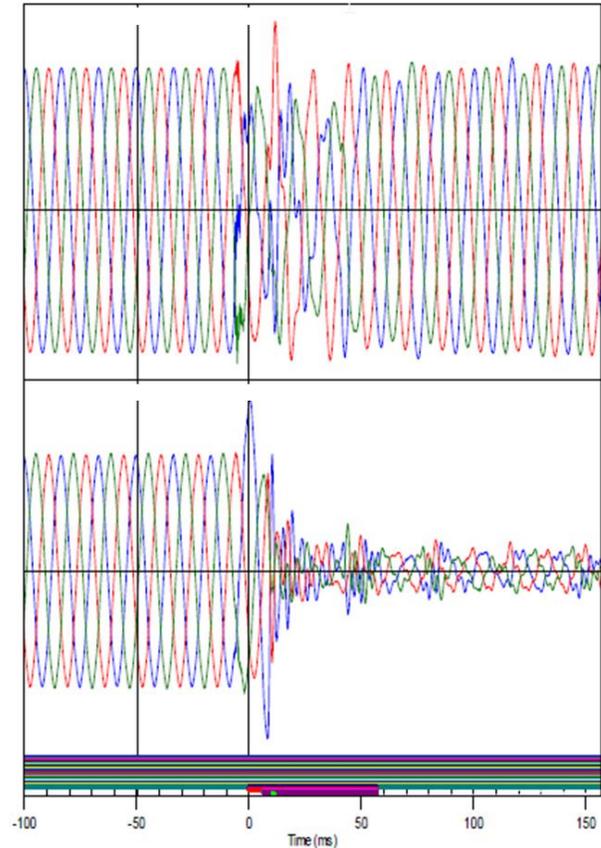
Figure 2.6: DFR Data at Plant POM

Faults on the BPS result in depressed voltages across the BPS and can also cause significant voltage waveform distortion. Distortion in the voltage waveform can cause the inverter PLL to lose synchronism if severe enough. Inverter controls need to be robust enough to handle distorted waveform periods, particularly during fault conditions. Figure 2.6 shows the voltage (top) and current (bottom) at the point of measurement (POM) of an

inverter-based resource during the Canyon 2 Fire disturbance. The voltage waveform is significantly distorted during the on-fault conditions, and the inverter enters momentary cessation. Historically, inverters have used momentary cessation to ride through the grid disturbance. However, this is not the intended response of inverters since they are expected to ride through these disturbances and continue injecting current to the grid.

This particular solar PV facility entered into momentary cessation during the disturbance and subsequently tripped following fault clearing (as can be seen in the prolonged reduction in current in Figure 2.6) on “ac grid overvoltage” that occurred for less than a single electrical cycle. Plant operator(s) noted that many of the solar PV plants affected by the disturbance have shunt capacitor banks within the plant and that further study is needed to understand the interactions between shunt compensation, momentary cessation, and inverter tripping.

The potential interaction of in-plant shunt capacitors with the response of inverters during and after the fault conditions has been identified in this event as a potential cause for transient overvoltage and warrants further study. Prior to the disturbance, shunt compensation is in-service to support collector system voltages while the inverters are producing active power. When the fault occurs, grid voltages are depressed and most inverters enter into momentary cessation (cease injection of current to the BPS). Upon fault clearing, the inverters take a cycle or two to either ramp back up to predisturbance output or regain synchronism with the grid. During this time, the shunt capacitors are discharging on very low grid voltage. The combination of the inverter momentary cessation and response of the shunt compensation within the plant may be causing a large overshoot in plant voltages for a very short time (less than an electrical cycle). These voltage are not observed at the POM, as reported by TOs for these plants. However, the inverters are observing significantly higher voltage at their terminals, causing them to trip.

During fault events, there appears to be an interrelationship between momentary cessation, in-plant shunt compensation, and transient overvoltage conditions that result in inverter tripping. While this has been observed at multiple locations for multiple events, the causes and effects are not well understood and require detailed EMT simulations for further investigation.

EMT studies should be performed by the affected GOPs, in coordination with their TO(s), to better understand the cause of transient overvoltages resulting in inverter tripping. These studies should also identify why the observed inverter terminal voltages are much higher than the voltage at the point of measurement (POM), and any protection coordination needed to ride through these types of voltage conditions.
