1998 System Disturbances

Review of Selected
Electric System Disturbances in
North America

May 2001

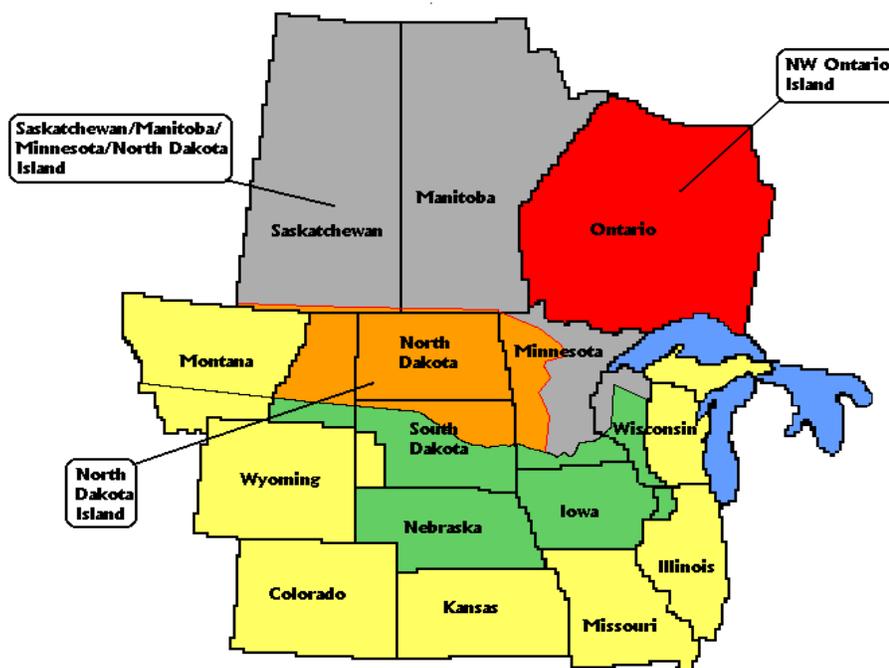
Figure 1

Islands Formed

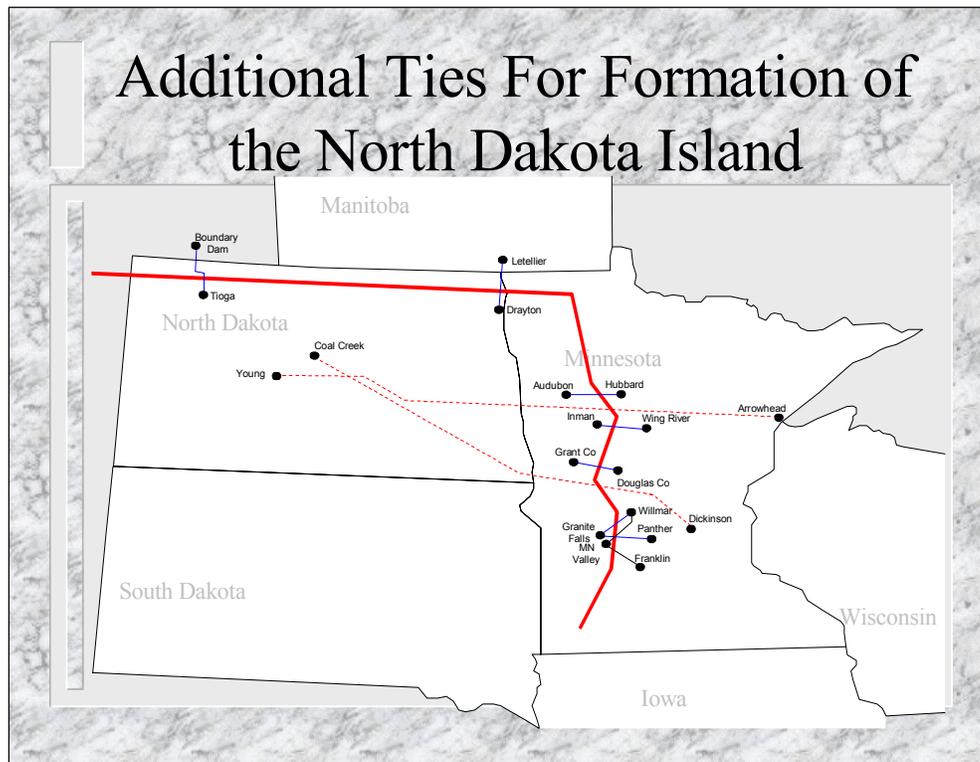
Figure 2

North Dakota/South Dakota/Montana “Smaller Island”

Prior to the disturbance, electricity from generating plants in the North Dakota coal fields was being transferred to the east on various alternating current (ac) lines and two HVDC lines, the Cooperative Power Association-Units Power Association (CU) HVDC (at 810 MW) and the “Square Butte” HVDC (at 300 MW). Generation at the CU source-end was operating at 840 MW and the differential amount of energy flowed into the associated ac lines. When the initial large island was formed, the 61 Hz frequency caused the governors on the generating units to lower their output to 540 MW (300 MW drop). However, the HVDC facility has a frequency controller that allows the HVDC facility output to be increased, thus, increasing demand and reducing the frequency when the generators are operated isolated from the ac system. In this case, the controls responded to the high frequency (even though the generators were not isolated) by increasing the HVDC facility output to 1,090 MW (280 MW gain) in an effort to reduce the frequency. The result of the two actions by the generators and HVDC controllers was 580 MW of unscheduled flow entering the HVDC terminal from the ac system. With the dc power oscillating and the controls not responding to commands, the HVDC operator removed one pole of the HVDC (0226 hours) from service to reduce the facility’s flow closer to the scheduled 810 MW level. On doing this, the bus voltage rose and system protection removed the second pole from service 28 seconds later due to over voltage. Complete loss of the CU HVDC transferred the flows onto the parallel ac lines, which overloaded and were removed from service in the next five seconds to complete the isolation of the smaller island (Figure 2). Frequency

rose to 62.2 Hz in this island, causing system protection to remove one pole of the Square Butte HVDC from service on over-frequency protection, but the flow on the remaining pole ramped up to maintain the power flow. One 115 kV line equipped with out-of-step blocking relays was prevented from opening, keeping the island tied to the outside and causing voltage oscillations in the island as it slipped past the Eastern Interconnection every 0.6 second. About five minutes later, this line was removed from service when a wave trap faulted due to thermal breakdown caused by the out-of-synchronism currents. Frequency ran at 61.3 Hz for 30 minutes before being reduced to allow synchronization at 0304 hours.

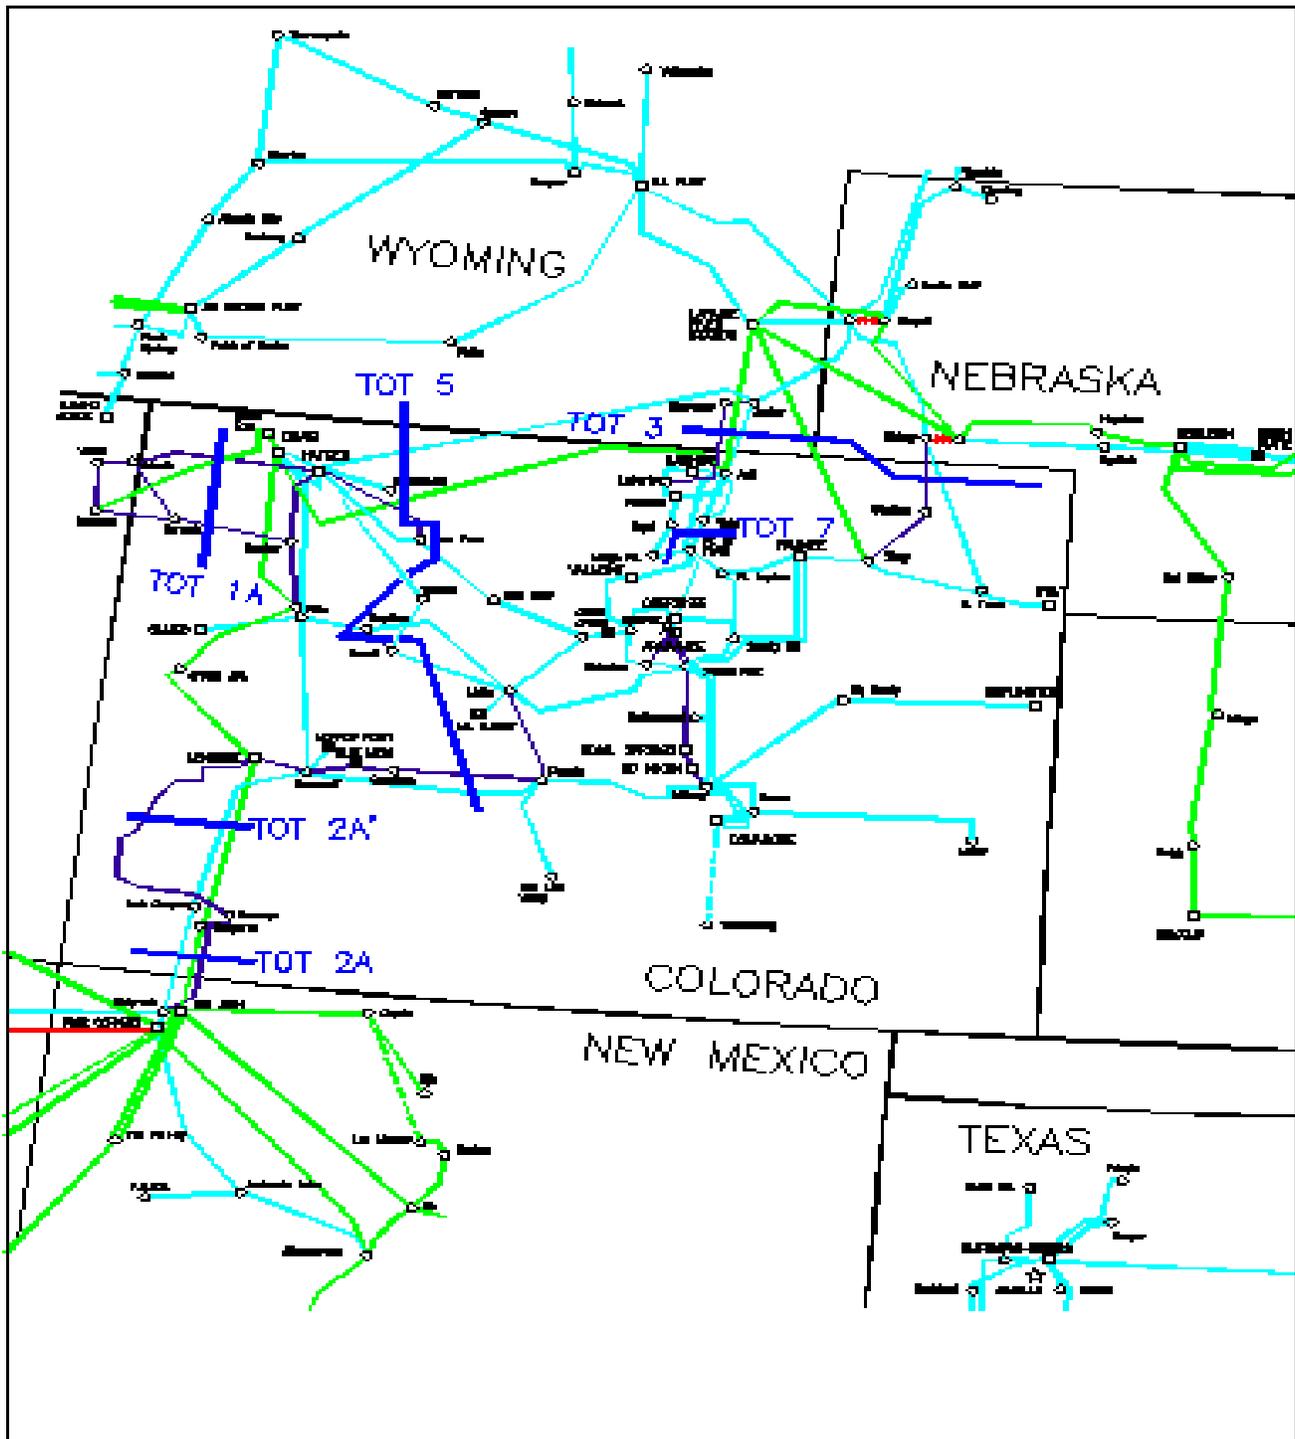
Figure 1

In Colorado, there are four defined transfer paths referred to as TOTs (Figure 1), short for total, over which power moves into or out of the state. Of the four TOTs, two of them, TOT 3 and TOT 5 are the highest rated and move the majority of the power required to the primary demand center, referred to as the Front Range. This geographical area runs from Ft. Collins in the north to Pueblo in the south, and includes the Denver metropolitan area.

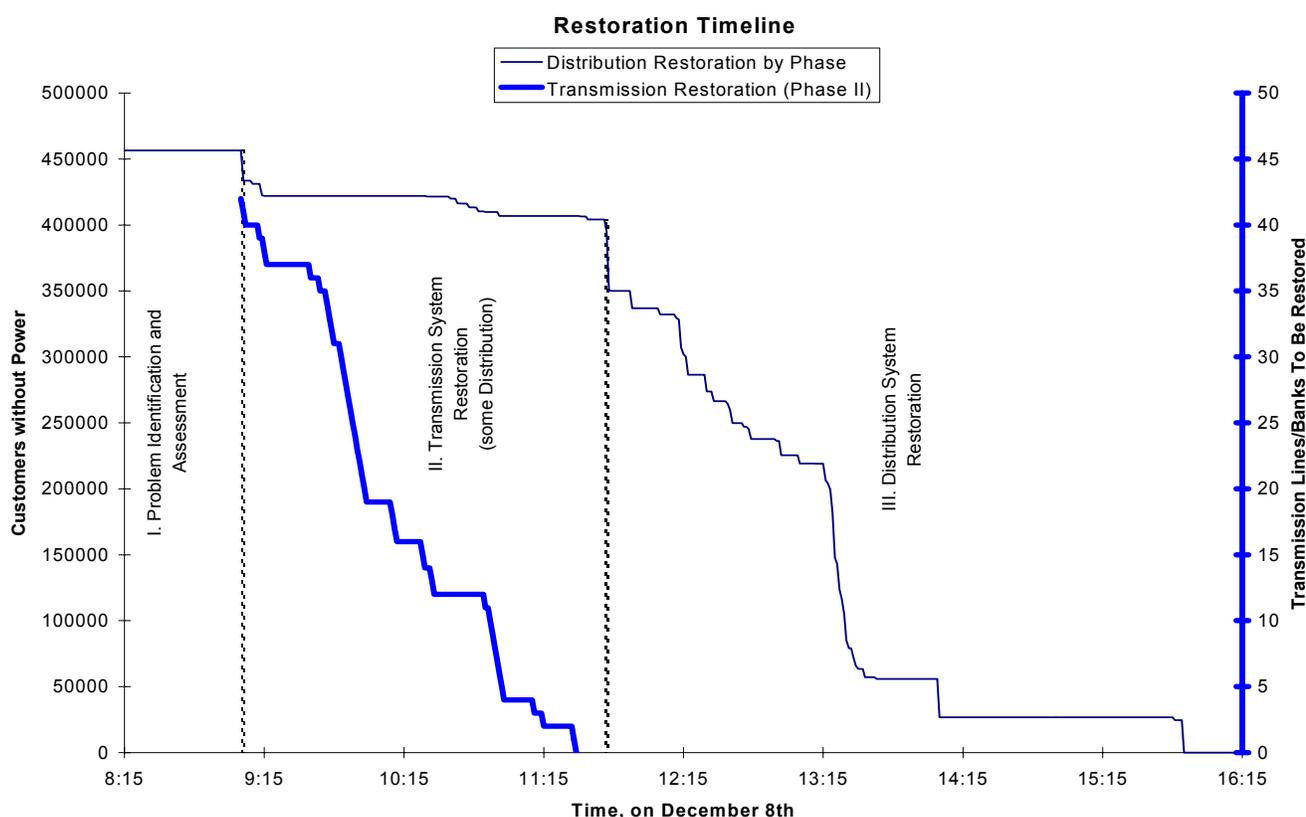
FIGURE 2

As shown in Figure 2, the transmission system was fully restored at 11:30 a.m. and all customers were restored by 4 p.m. on December 8.
