# 5. How and Why the Blackout Began in Ohio

## Summary

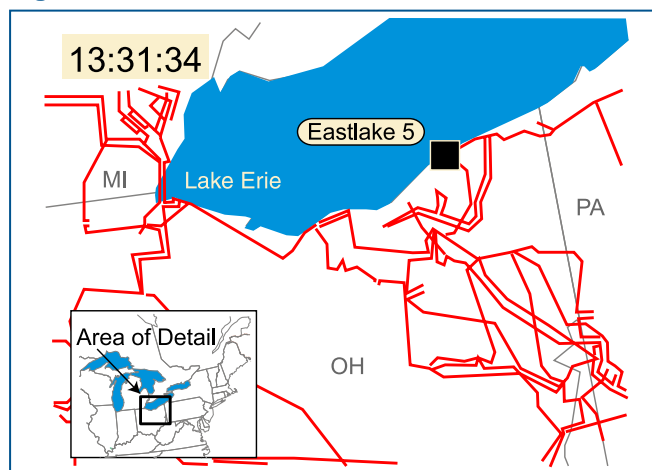
Figure 5.3. Eastlake Unit 5

When Eastlake 5 dropped off-line, replacement power transfers and the associated reactive power to support the imports to the local area contributed to the additional line loadings in the region. At 15:00 EDT on August 14, FE's load was approximately 12,080 MW, and they were importing about 2,575 MW, 21% of their total. FE's system reactive power needs rose further.

The investigation team's system simulations indicate that the loss of Eastlake 5 was a critical step in the sequence of events. Contingency analysis simulation of the conditions following the loss of the Harding-Chamberlin 345-kV circuit at 15:05 EDT showed that the system would be unable to sustain some contingencies without line overloads above emergency ratings. However, when Eastlake 5 was modeled as in service and fully available in those simulations, all overloads above emergency limits were eliminated, even with the loss of Harding-Chamberlin.

**Recommendation**  
23, page 160

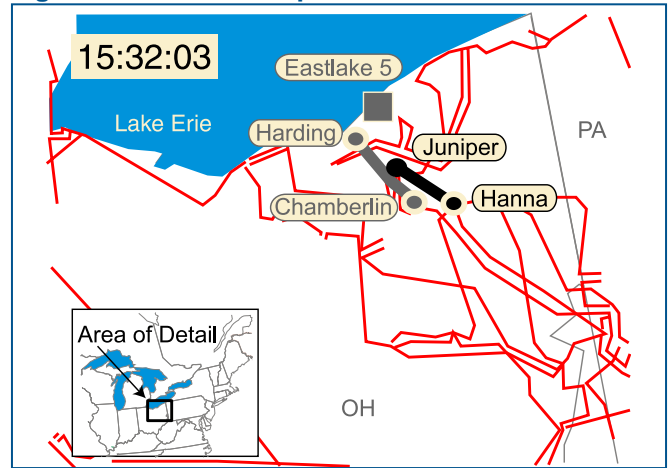
**Figure 5.9. Hanna-Juniper 345-kV Line**

Hanna-Juniper was loaded at 88% of its normal and emergency rating when it tripped. With this line open, over 1,200 MVA of power flow had to find a new path to reach its load in Cleveland. Loading on the remaining two 345-kV lines increased, with Star-Juniper taking the bulk of the power. This caused Star-South Canton's loading to rise above its normal but within its emergency rating and pushed more power onto the 138-kV system. Flows west into Michigan decreased slightly and voltages declined somewhat in the Cleveland area.

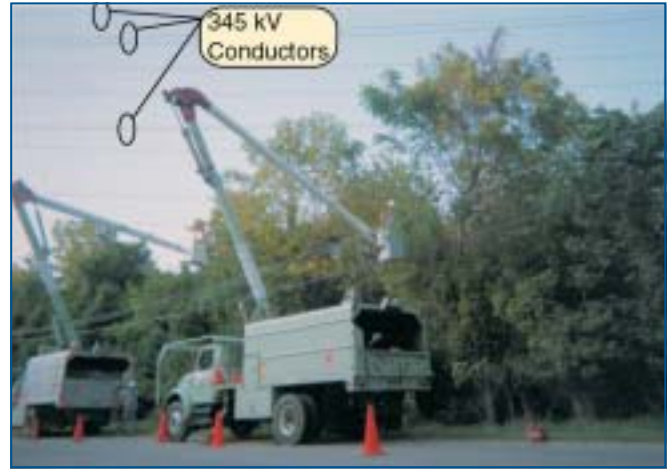
Figure 5.10. Cause of the Hanna-Juniper Line Loss

This August 14 photo shows the tree that caused the loss of the Hanna-Juniper line (tallest tree in photo). Other 345-kV conductors and shield wires can be seen in the background. Photo by Nelson Tree.

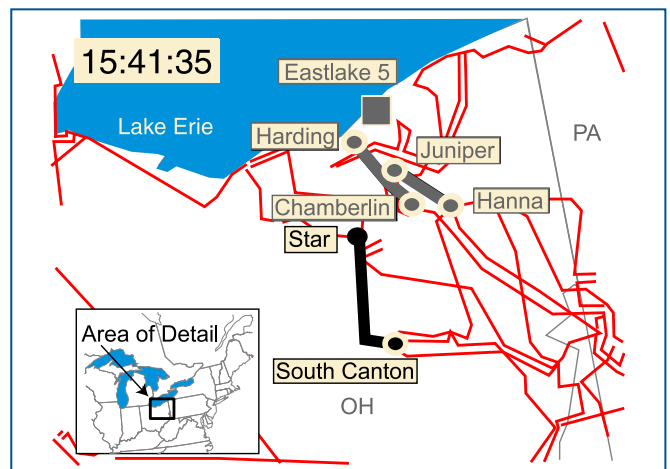
**Figure 5.11. Star-South Canton 345-kV Line**

contacted a tree three times between 14:27:15 EDT and 15:41:33 EDT, opening and reclosing each time before finally locking out while loaded at 93% of its emergency rating at 15:41:35 EDT. Each of these three lines tripped not because of excessive sag due to overloading or high conductor temperature, but because it hit an overgrown, untrimmed tree.<sup>22</sup>

The investigation’s field team inspected the right of way in the location indicated by the relay digital fault recorders, in the FE portion of the line. They found debris from trees and vegetation that had been felled. At this location the conductor height was 44 feet 9 inches (13.6 meters). The identifiable tree remains measured 30 feet (9.1 meters) in height, although the team could not verify the location of the stump, nor find all sections of the tree. A nearby cluster of trees showed significant fault damage, including charred limbs and de-barking from fault current. Further, topsoil in

the area of the tree trunk was disturbed, discolored and broken up, a common indication of a higher magnitude fault or multiple faults. Analysis of another stump showed that a fourteen year-old tree had recently been removed from the middle of the right-of-way.<sup>28</sup>

**Recommendations**  
16, page 154; 27, page 162
