Transmission Facility Outages During the Northeast Snowstorm of October 29–30, 2011

Causes and Recommendations

Federal Energy Regulatory Commission *and* the North American Electric Reliability Corporation

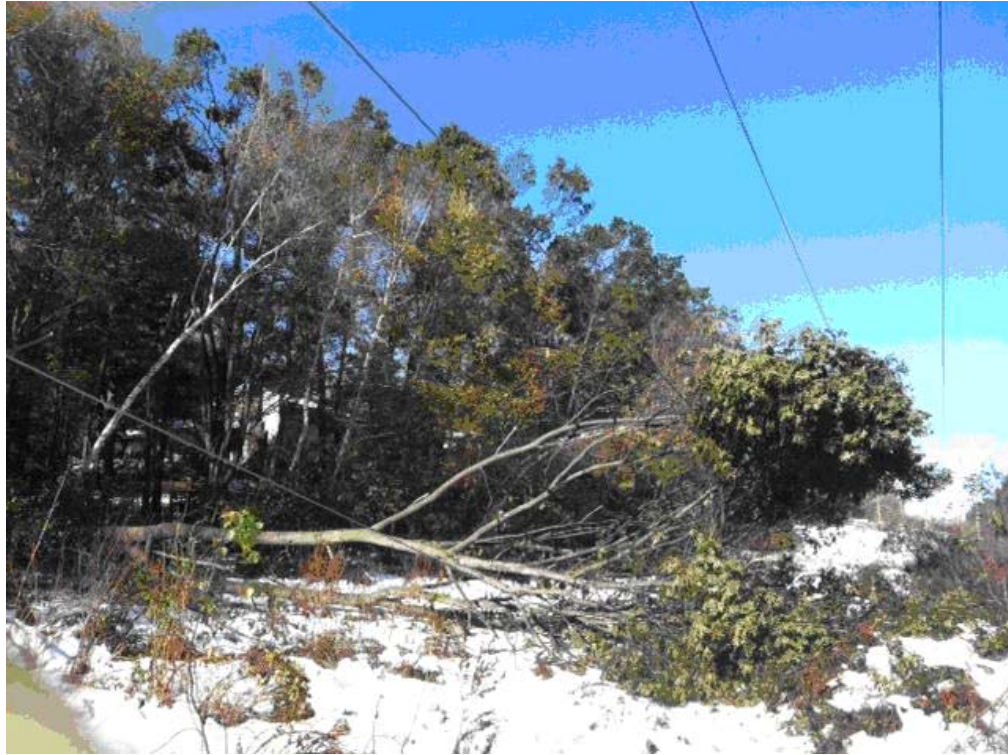
Figure 13: Trees Fallen on 115kV Line in Connecticut

The 115 kV line in the photograph below was forced out of service when several trees, each over sixty feet tall and located twenty to thirty feet outside of the utility's full right-of-way, uprooted and fell onto three separate spans of the line. Transmission lines are not always located in the middle of a right-of-way, but instead often are closer to an edge of the right-of-way. Thus, as is the case here, a tree may be outside the boundaries of a 130 foot wide right-of-way but still less than sixty-five feet from a conductor.
