# Arizona-Southern California Outages on September 8, 2011

## Causes and Recommendations

Prepared by the Staffs of the  
Federal Energy Regulatory Commission  
*and the*  
North American Electric Reliability Corporation

**April 2012**

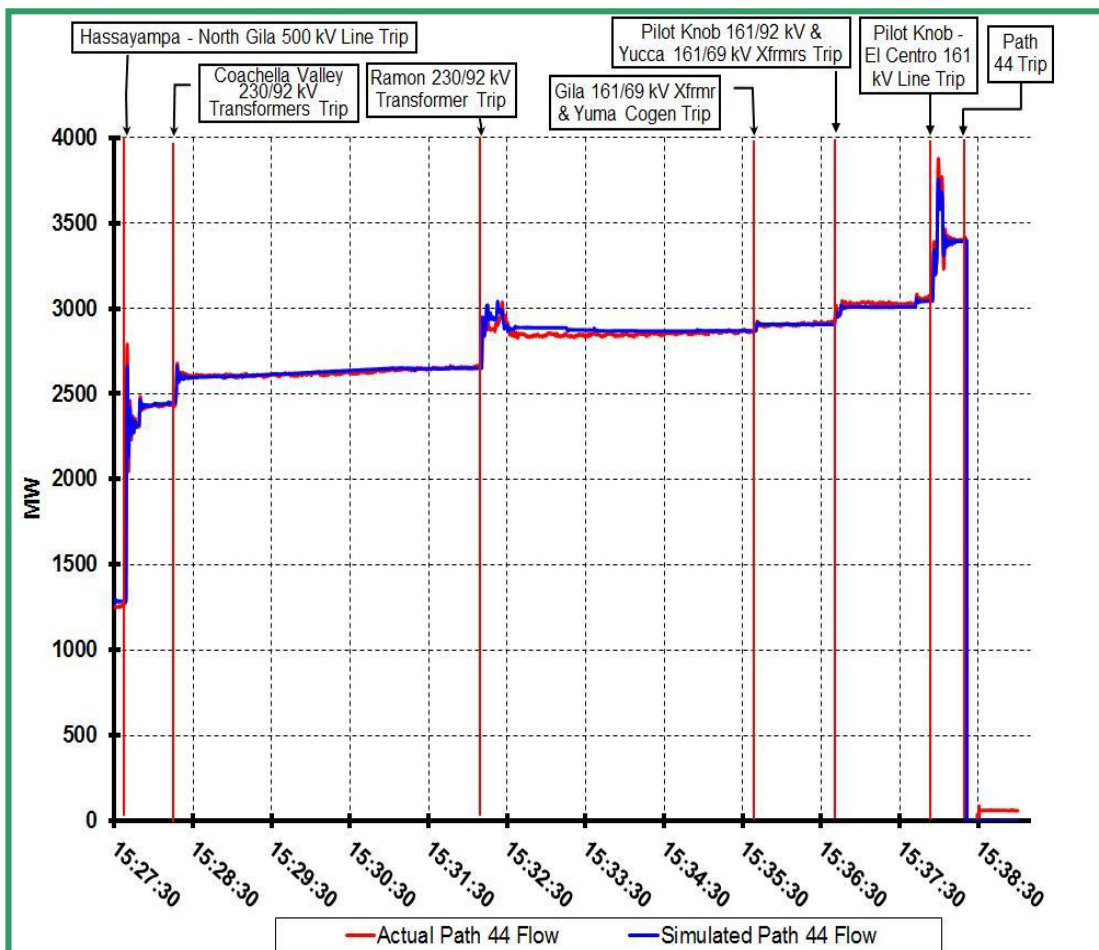
**Figure 1: Comparison of Actual and Simulated Path 44 Flows**

As the first step in performing power flow and dynamic stability analyses, the Modeling and Simulation team developed and benchmarked a modeling case of system conditions prior to the event. The team started with the WECC heavy summer base case and made adjustments based on State Estimator snapshots, EMS data, actual generation and schedules, PMU data, and a base case prepared by a separate team (led by CAISO) that studied the event. The team further adjusted and benchmarked the base case using SCADA and PMU data to match the system conditions for the entire event. The team devoted considerable time and effort to resolving discrepancies between the various sources of data to best calibrate the modeling case to actual measured data. As illustrated by **Figure 1**, on the next page, and described in more detail in Appendix D, the Modeling and Simulation team achieved a significant degree of accuracy. This figure compares Path 44 flows simulated by the Modeling and Simulation team to actual Path 44 PMU data.

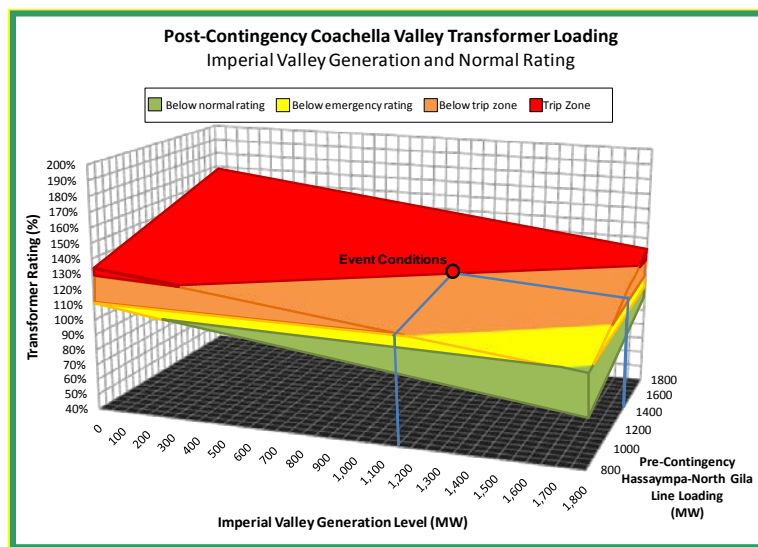
**Figure 7 : Post-Contingency CV Transformer Loading Based on Imperial Valley Generation**

In general, adding generation in San Diego, CFE, or Imperial Valley and backing down generation in APS’s system (east of Path 49) would reduce the loading on IID’s 92 kV system for the loss of H-NG. For example, an additional 600 MW of generation at Imperial Valley and a reduction of generation in APS’s system by the same amount would have reduced the pre-contingency loading on H-NG by 20% and improved the post-contingency voltage in WALC’s Blythe area by approximately 4%. Under this condition, the loading on the CV transformers for the loss of H-NG would be approximately 111% of their normal rating (166 MVA), well below their trip setting of 127%. This is a further demonstration of the importance of including all facilities when deriving SOLs.

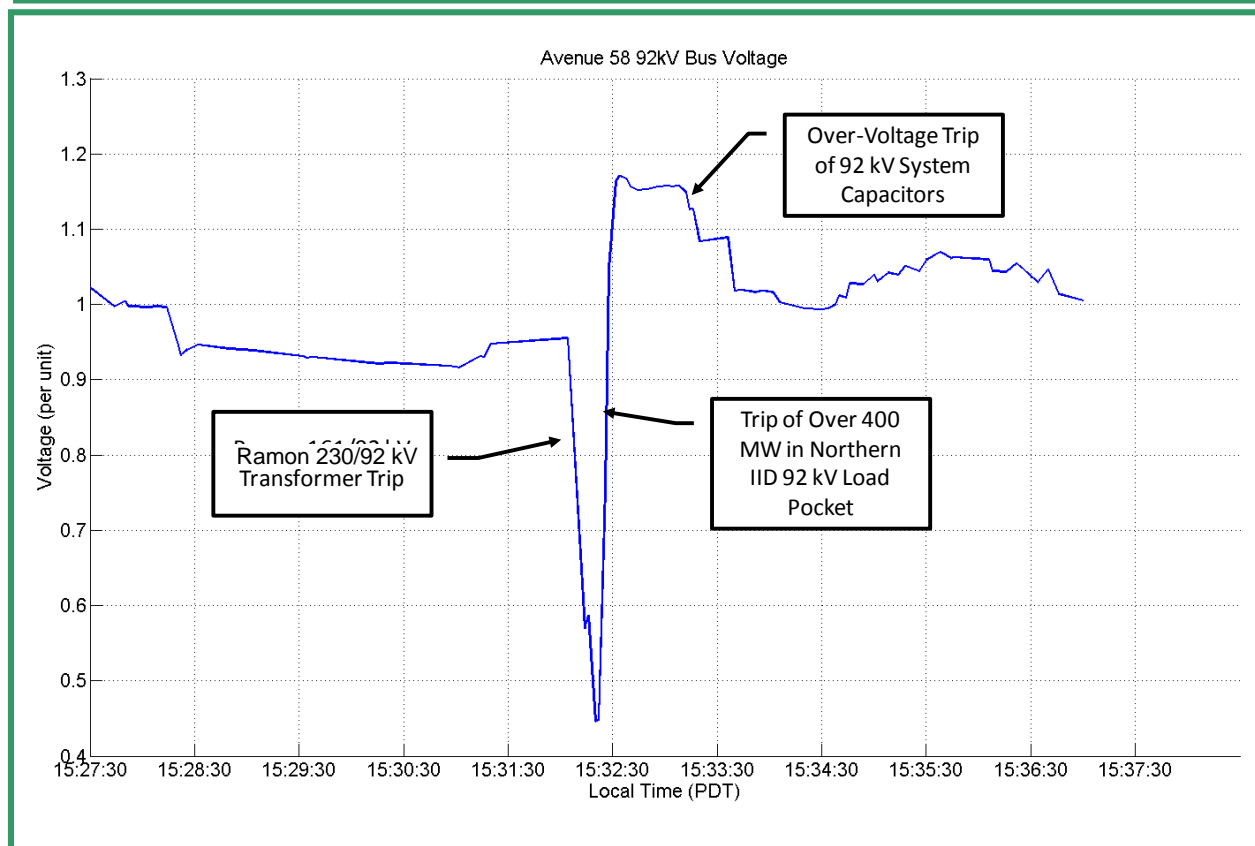
**Figure 9: 92kV Voltage (per unit) at Avenue 58**

The loss of IID's northern resources and subsequent system response caused IID to lose multiple generators connected to its 92 kV system, including IID's Niland Gas Turbine 2 (generating 45 MW), IID's CV Gas Turbine 4 (generating 20 MW), independent power producer Colmac's unit (generating 46 MW), and IID's Drop 4 Unit 2 Hydro Generator (generating 10.3 MW).

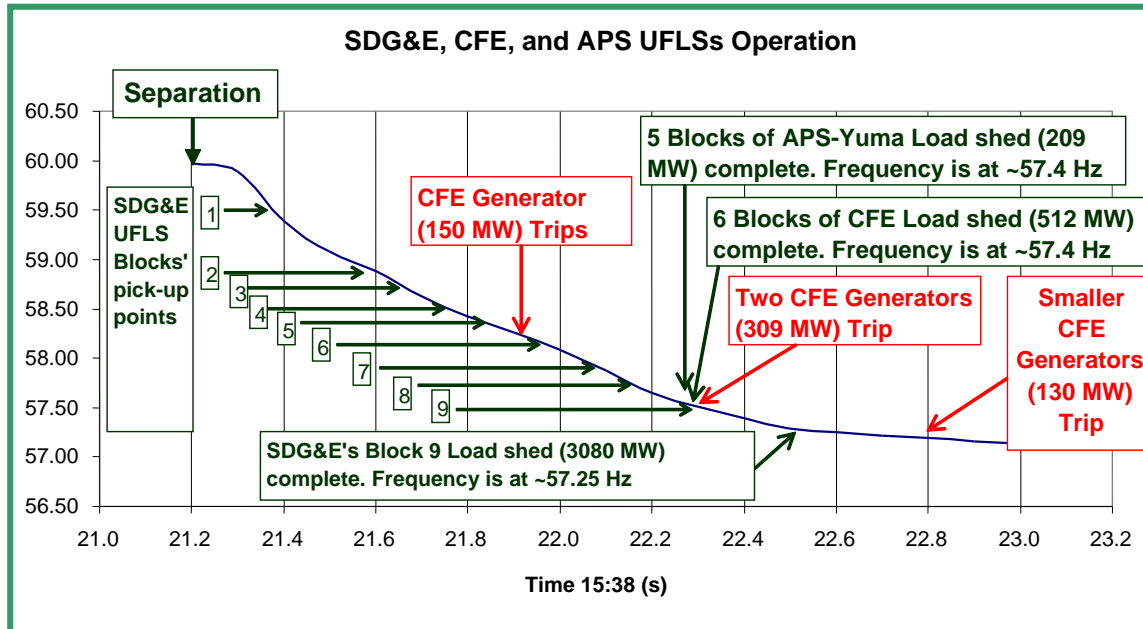
**Figure 11: Frequency Performance in the SDG&E/Yuma/CFE Island**

The CFE island separated from SDG&E after their only two remaining ties tripped in rapid succession. At 15:38:22.2, the Otay Mesa-Tijuana 230 kV transmission line open-ended at Tijuana in CFE's territory due to underfrequency protection.<sup>55</sup> Less than a second later, at 15:38:23.13, the Imperial Valley-La Rosita 230 kV transmission line open-ended at Imperial Valley in SDG&E's territory by underfrequency protection.<sup>56</sup> According to CFE, its UFLS program was not designed for the operation of a SDG&E/CFE/Yuma island, but for the operation of a "southern WECC island."

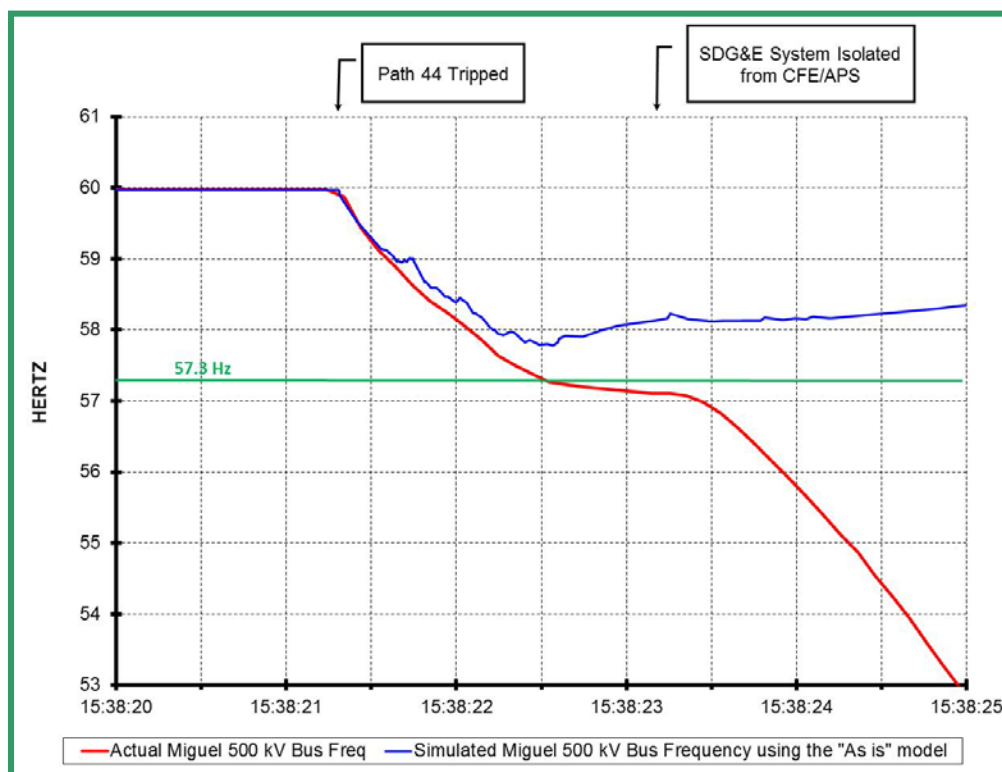
**Figure 14: Actual and Simulated Frequency at Miguel 500 kV Bus**

The inquiry’s Modeling and Simulation team was able to obtain a simulation more closely aligned with actual measured performance by performing several sensitivity

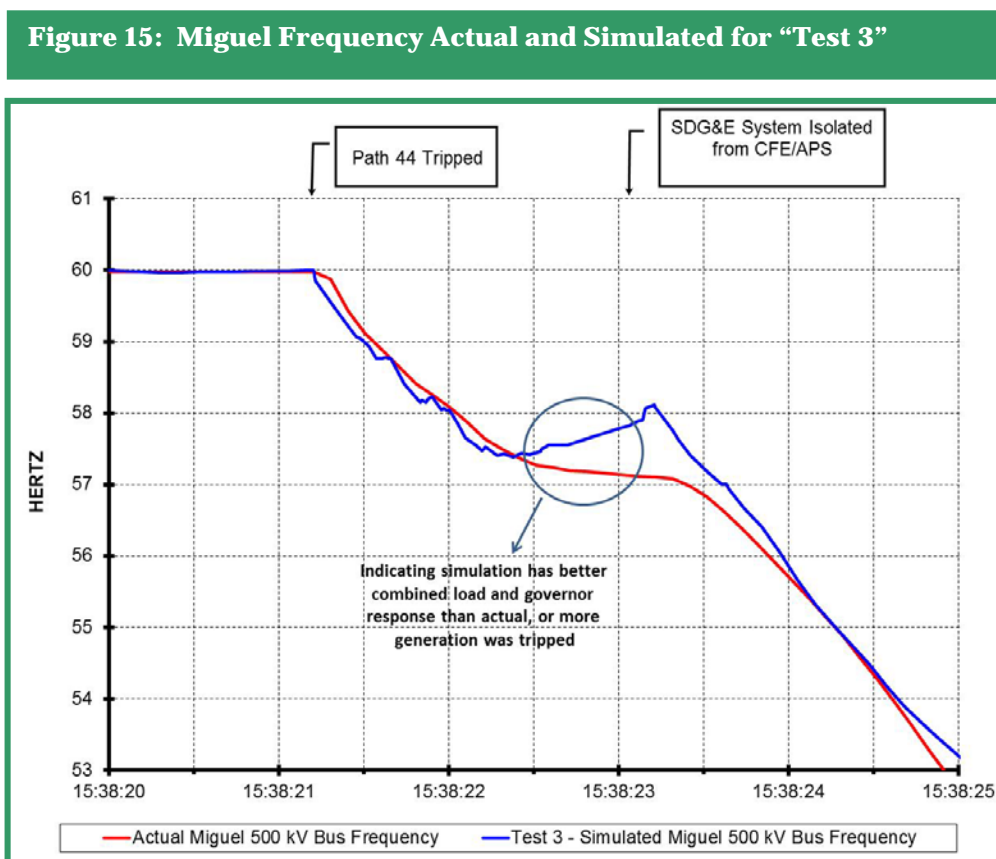
**Figure 15**, below, shows results of “Test 3.” As can be seen, this simulation more closely follows the actual event than the “as-is” model used in Figure 14.

The simulation studies explain the ineffectiveness of the UFLS program, despite up to 75% of SDG&E load that was shed within 1.3 seconds of the SONGS separation scheme operating. The simulation analysis confirmed findings in the inquiry’s SOE that the frequency collapse was caused by generation trips and UFLS misoperations within

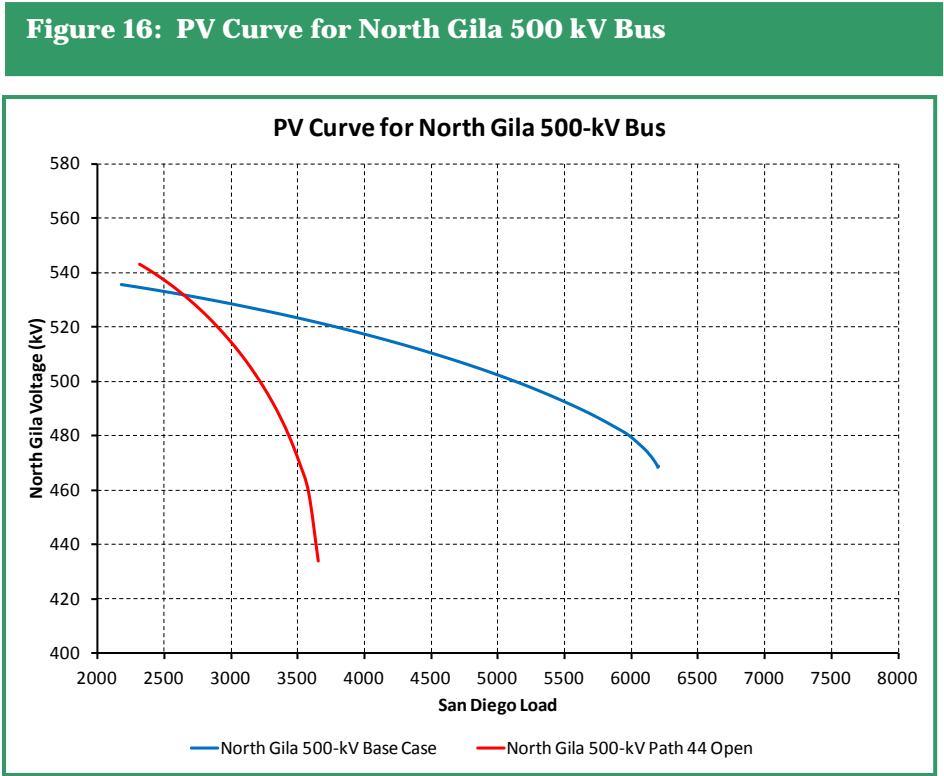
The inquiry conducted a simulation to evaluate what would happen if the SONGS separation scheme inadvertently operated during normal system operations (e.g., in the absence of any outages, overloads, or SOL violations). Based on this simulation, the inquiry determined that under certain high load conditions, the operation of the scheme could result in voltage collapse and a blackout in SDG&E’s and CFE’s territories. The inquiry conducted a voltage stability study using a Power-Voltage (P-V) curve to estimate the amount of SDG&E load that could reliably be supplied after an inadvertent operation of the SONGS separation scheme. The P-V curve below in **Figure 16** demonstrates that such operation would lead to a voltage collapse and a blackout in the SDG&E and CFE territories under certain high load conditions.

Specifically, the system is most likely to collapse when the SDG&E load exceeds 3,500 MW. In 2010, SDG&E's load exceeded this amount for 851 hours,<sup>97</sup> meaning that the system was exposed to a potential blackout for approximately 10% of the year. This shows the potential risk to BPS reliability during normal system operations as a result of the inadvertent operation of the SONGS separation scheme. Accordingly, given the lack of studies done on the scheme, the inquiry recommends that the inadvertent operation of the SONGS separation scheme be reviewed promptly to ensure it does not pose an unacceptable risk to BPS reliability. Until this verification can be completed, CAISO and SCE should consider all actions needed to minimize this risk, up to and including temporarily removing the scheme from service.

Moreover, if SCE and CAISO were to decide to temporarily remove the scheme from the service, the inquiry does not believe that BPS reliability would be jeopardized. Indeed, inquiry simulations conducted for the day of the event show that if the scheme had not operated, the system, with the exception of collapses in the IID and Yuma areas, would have stabilized with minor overloads in the area around SONGS, acceptable voltages in the SDG&E area, and sufficient reactive margins in the critical portion of SCE's system.

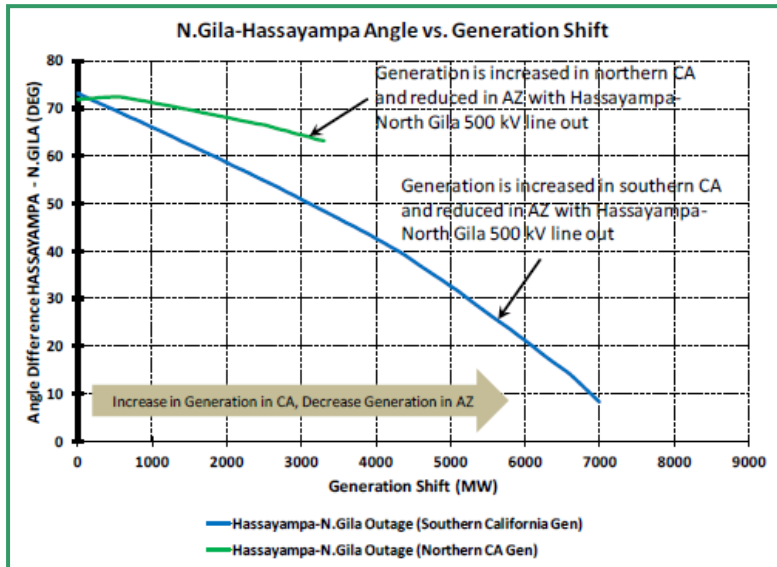
**Figure 17: Phase Angle of H-NG vs. Generation Shift**

The blue line in Figure 17 illustrates that with the particular conditions of the September 8th event, approximately 1,800 MW needed to be redispatched on both ends of H-NG (and close to the terminals, in Southern California and Arizona) in order to close the voltage phase angle from 72 degrees to 60 degrees (i.e., to within the permissive 60 degree setting of the synchro-check relay). The green line shows that more generation—more than twice as much—must be redispatched if units are chosen in Northern California to close the angle between Hassayampa and North Gila.

While system operators could redispatch generation from available spinning reserves or commit units in the Southern and/or Northern California area, it is questionable how quickly 1,800 MW could be dispatched.
