“Transmission Incident”

The Whole Story!

Jeff White
HP Coordinator
Southern Company Operations

Actual Case Study

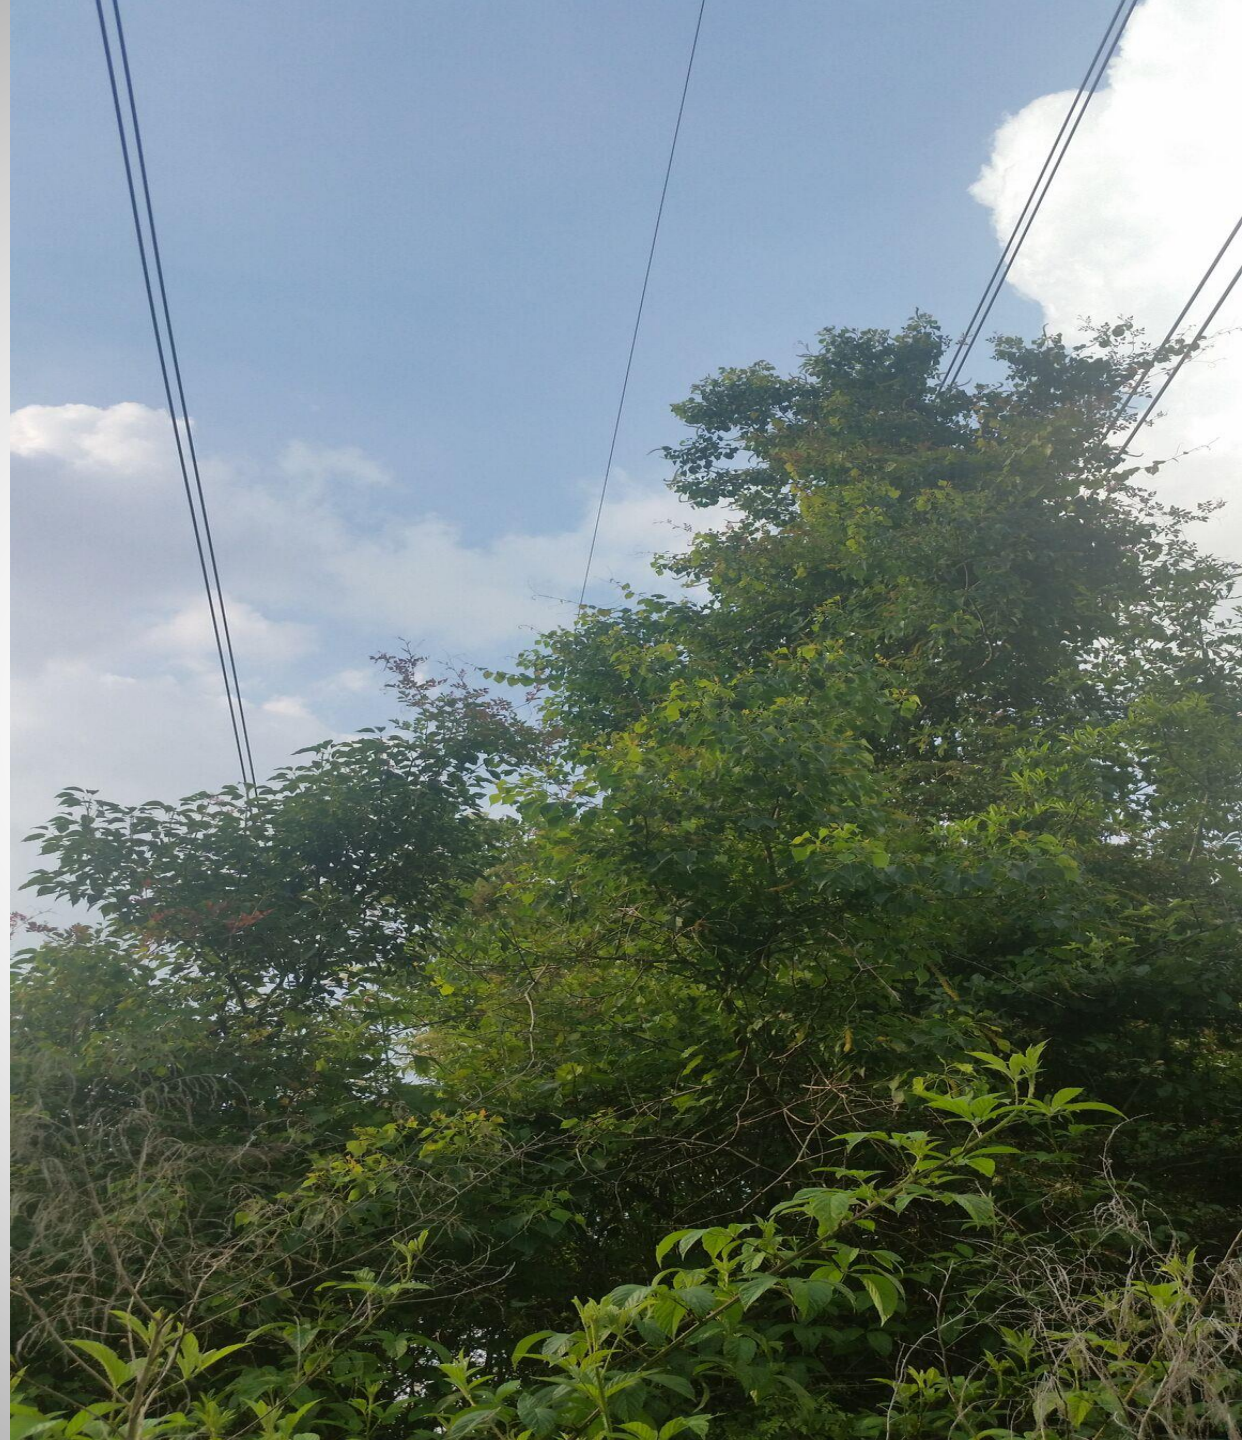
The tree measured 31'11"

**Located in a backyard,
inside of a chain-link fence
and surrounded by junk
cars.**

**This section of line is
ground patrolled because
it is in a "No Fly Zone."
(Cannot fly below 1000' in
residential areas-FAA)**

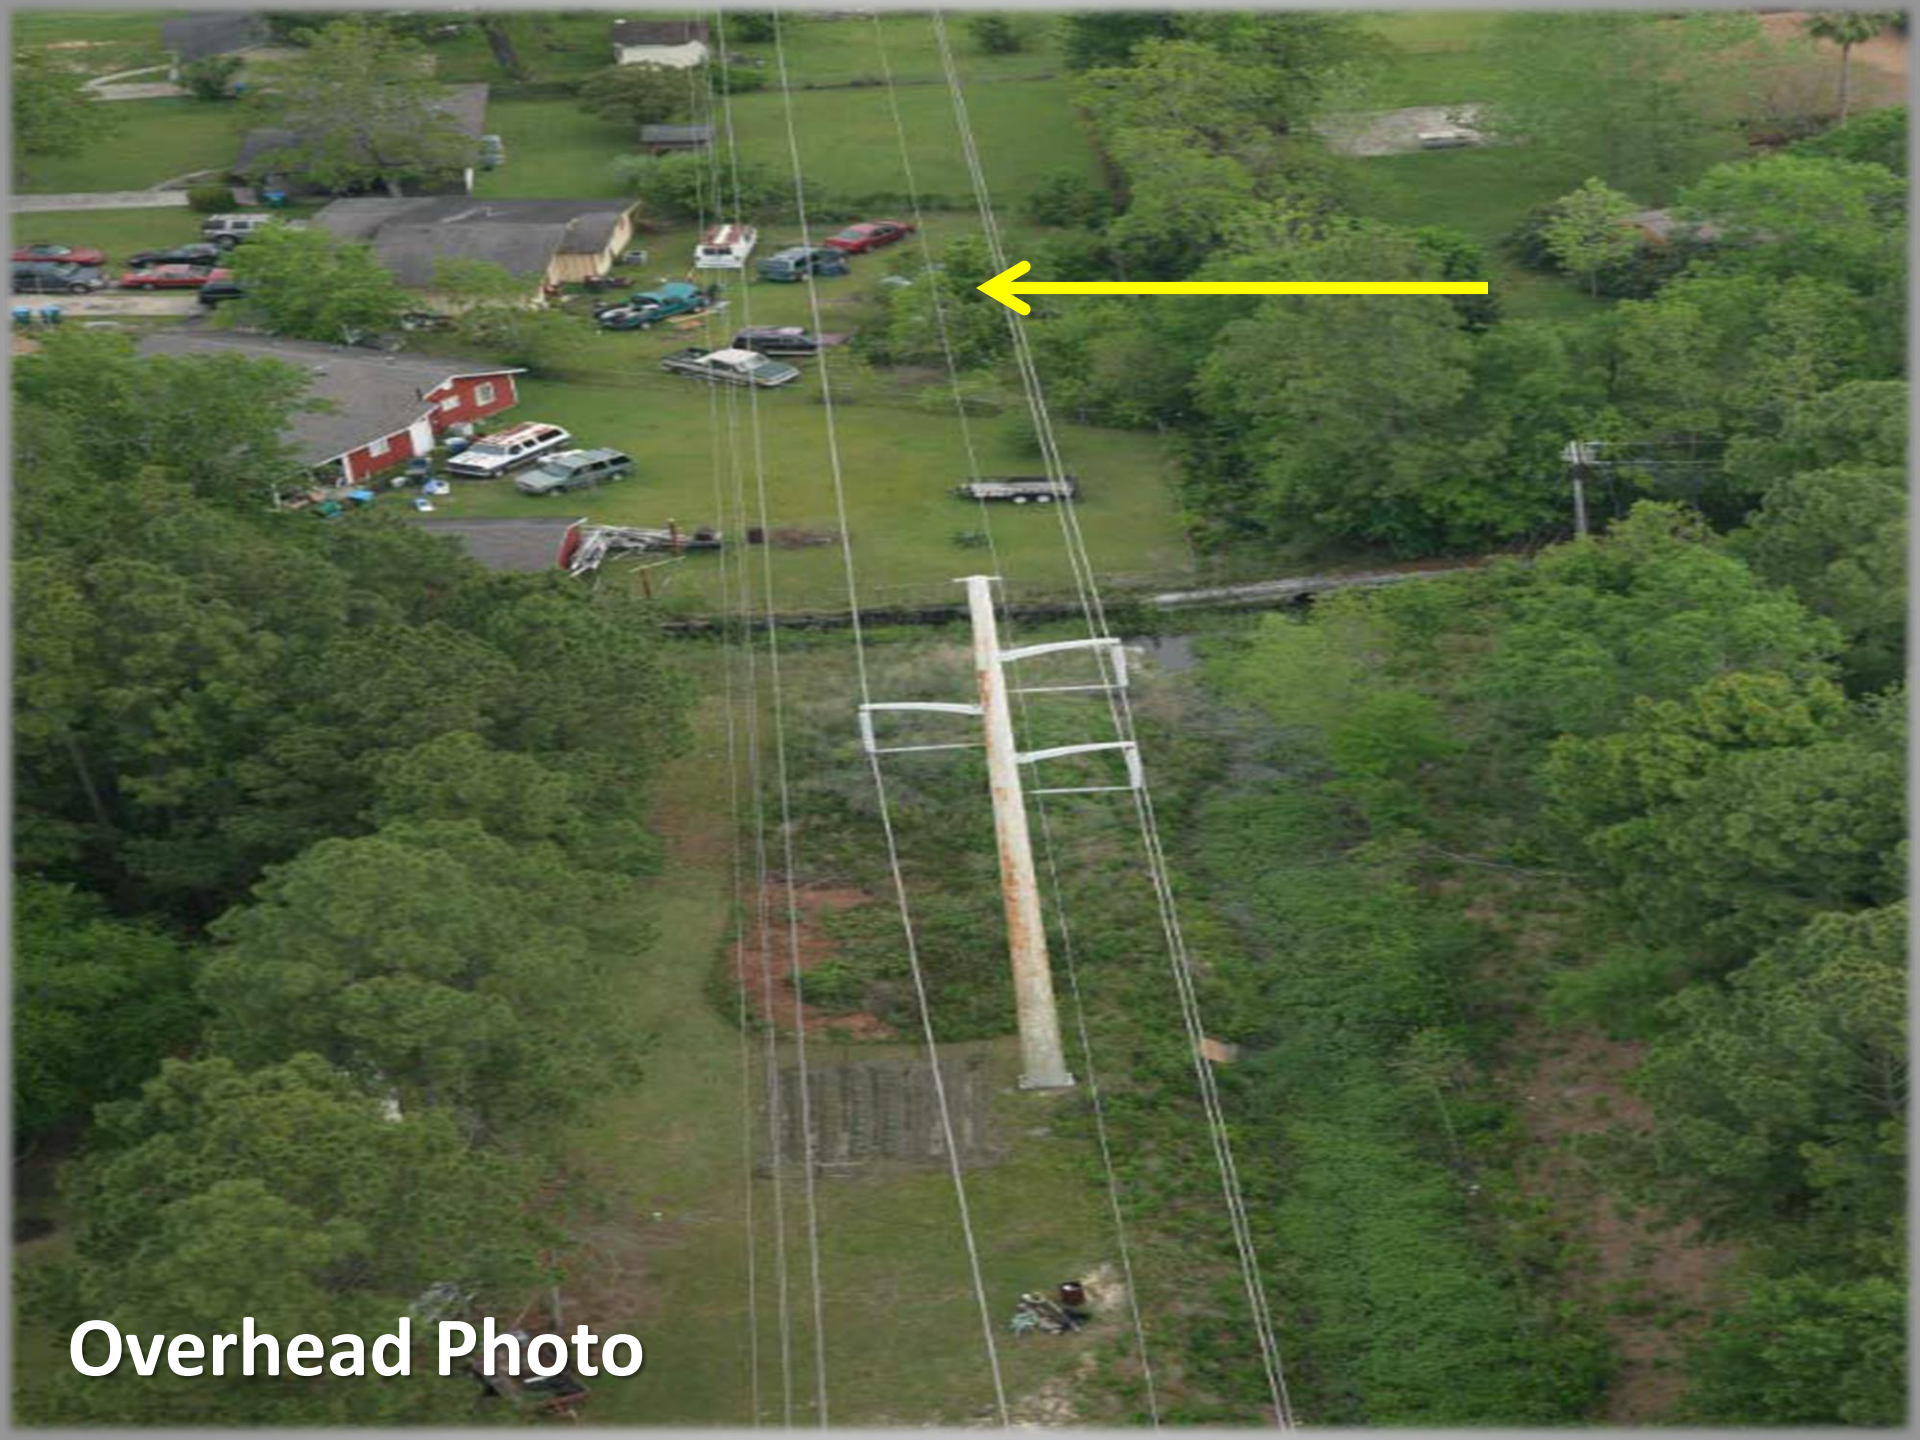
Overhead Photo

The employee inspected the tree while sitting in his pickup truck from the street, approximately 150' from the tree.

A three-phase distribution line was in the same right-of-way.

The inspector identified the top four wires as the shield wire and three conductors.

Those below he identified as distribution conductors.

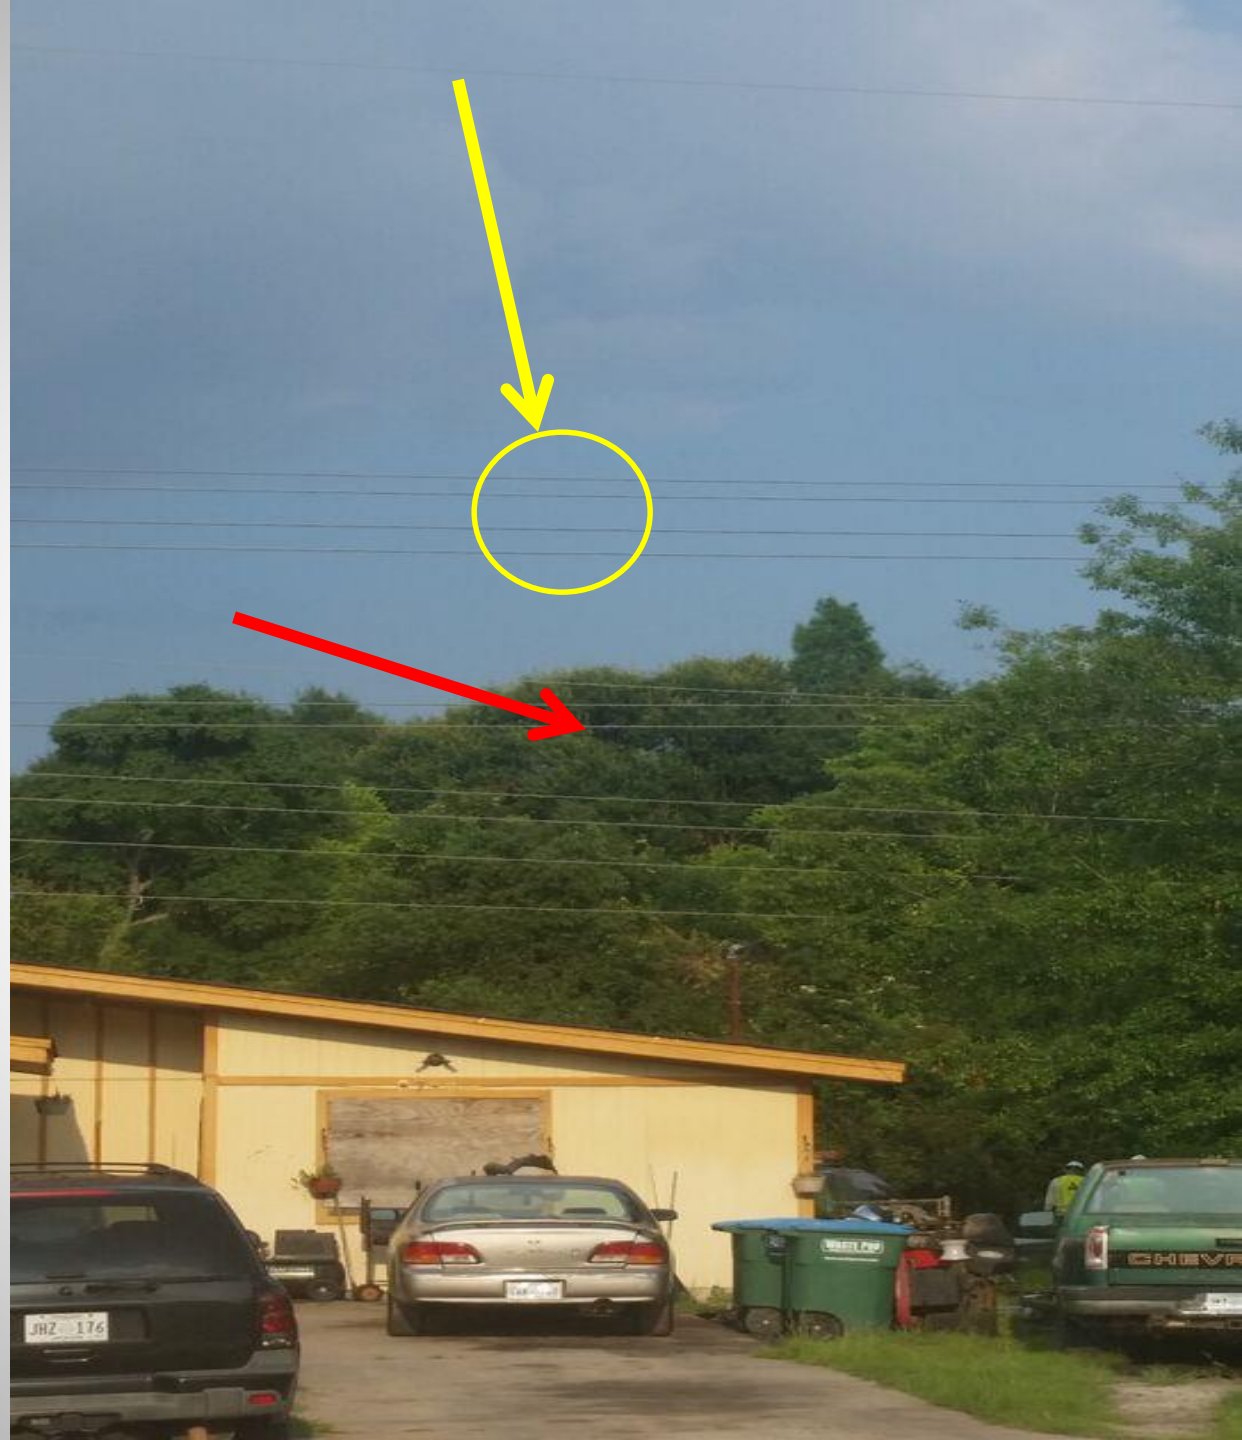
This 230 circuit is a bundled conductor circuit and the top four wires were actually the bundled top and middle phases.

This is the only bundled conductors that are ground patrolled and

the only bundled conductors without spacers, due to the short spans.

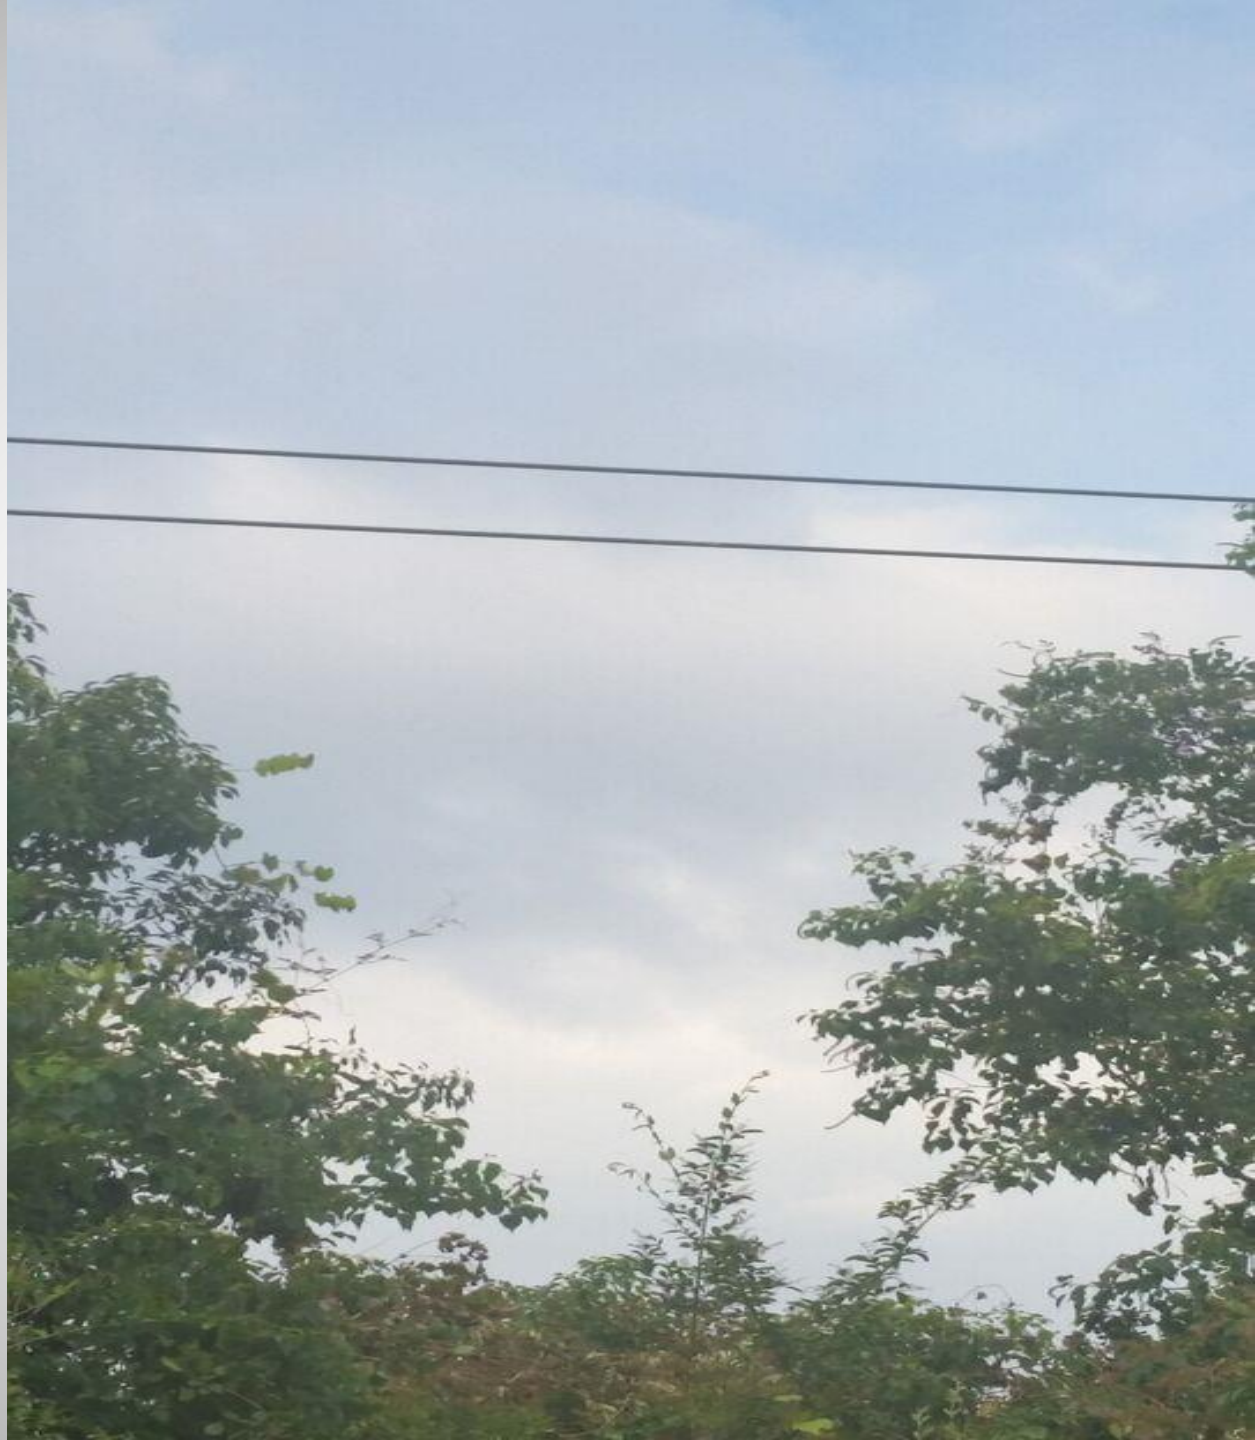
Quarterly ground inspection discontinued in 2013.

Once patrolled five times a year by several employees... now patrolled once per year by one employee.

Bush hogged in 2014

Side trimmed in 2013

Reactivate the quarterly inspections of “No Fly Zone” right-of-ways
