NORTH AMERICAN ELECTRIC RELIABILITY CORPORATION

Lesson Learned

Current Transformer Ground Relay

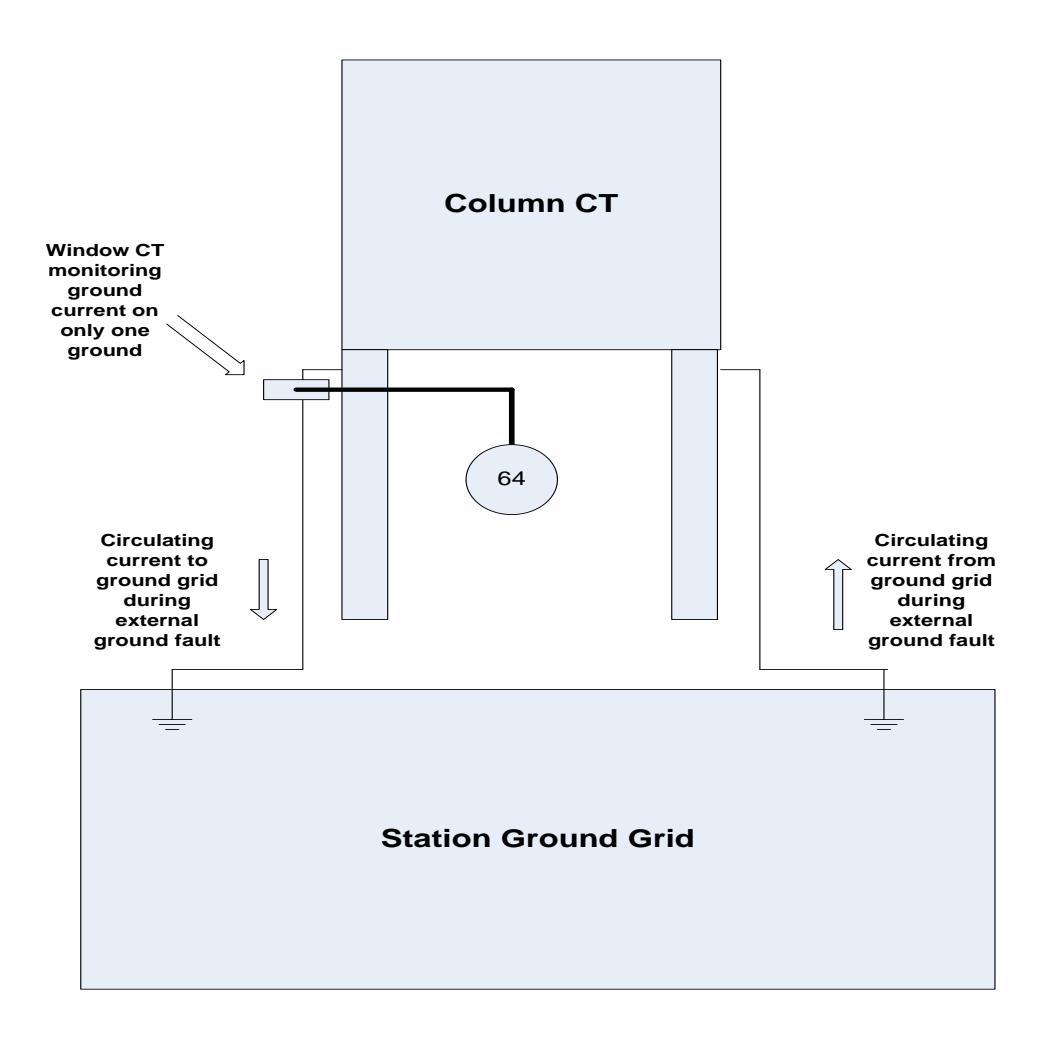
Diagram 1

A relay misoperation at a BES substation was determined to have been caused by the configuration of the Current Transformer (CT) used to measure ground currents. (See Diagrams 1 and 2.)

The attached diagrams show the initial configuration of the window CT monitoring just one ground of the column CT as well as the associated problem with parallel ground current.

In this case, the addition of a second ground conductor created a parallel path for ground grid fault current for an external fault to pass through the CT, which resulted in a relay misoperation. (See Diagrams 1 and 2.)

The initial short-term corrective action was an increase to the over-current pickup setting of the CT column ground relay to a value above the current experienced during this event.

The entity decided to use the second solution.
