Lesson Learned

Transmission Relaying – Backup Ground Protection

Source of Lesson Learned:	ReliabilityFirst Corporation
Lesson Learned #:	20130702
Date Published:	July 2, 2013
Category:	Relaying and Protection Systems

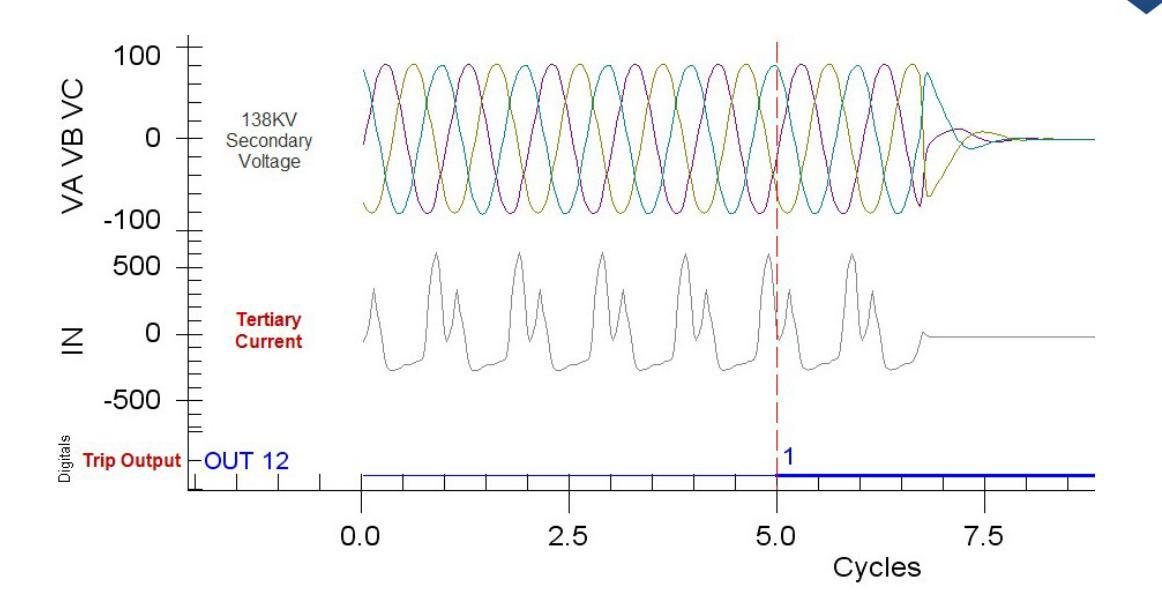
Closing the MOD energized the dead high-side bus and appeared to increase the unbalanced current, which was already elevated from a sustained magnetizing in-rush condition initiated by closing the lowside breakers (i.e., step 2). This raised the circulating tertiary current above the relay pickup. After reviewing digital relay records (see traces in Figure 1) during routine switching of the autotransformer, it was determined that sustained tertiary current flows close to relay pickup were commonly experienced.

Figure 1: Secondary Phase Voltages and Tertiary Current After Energization and at Trip Point

The tertiary winding relay pickup was set differently than previous electromechanical relays to improve coordination for through faults. The pickup was set extremely close to the minimum pickup of the overcurrent element that allowed the use of a long-delay, inverse-time overcurrent operating curve. After the misoperation, the pickup setting was raised slightly, but not enough to adversely reduce sensitivity or speed of operation for the facility during fault conditions. The protective relay with the revised settings was tested and operated correctly during magnetizing inrush conditions.
