NORTH AMERICAN ELECTRIC
RELIABILITY CORPORATION

Detailed Event Analysis

July 2019

Appendix D: Eastern Interconnection Analysis Results

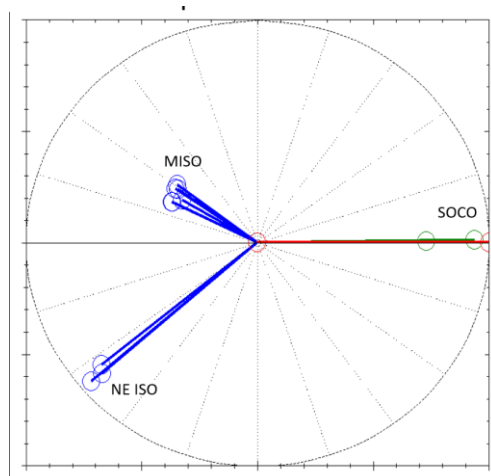
The mode shapes for the listed mode in **Table D.1** can be found in **Figure D.10**. The 0.23 Hz mode demonstrates a north to south mode as well as some interactions from the west to the east. With the small amount of signals used for this analysis, it makes it hard to fully understand the 0.23 Hz mode shape, and other events with more signals will provide a more accurate depiction for the mode shape.

Figure D.10: Mode Shape for 0.23 Hz Mode

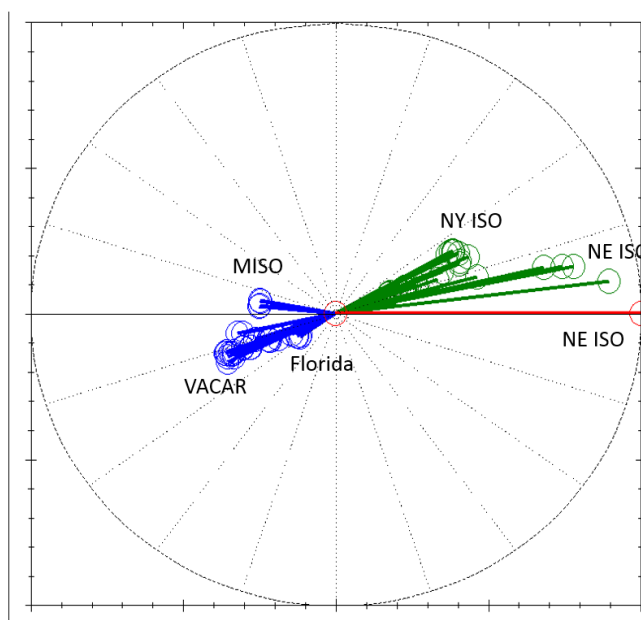
The mode shapes for the listed modes in **Table D.2** can be found in **Figures D.20** and **D.21**. The 0.17 Hz mode demonstrates a north to south mode and the 0.32 Hz mode demonstrates a complex mode shape that is similar to the June 2016 forced oscillation event (Event 3). Based on the **Figure D.20**, it is apparent that the Northeast regions out of phase with the Florida/VACAR and MISO regions. Since this event was closer to VACAR region, that portion of the mode shape may be more pronounced.

Figure D.20: Mode Shape for 0.32 Hz Mode

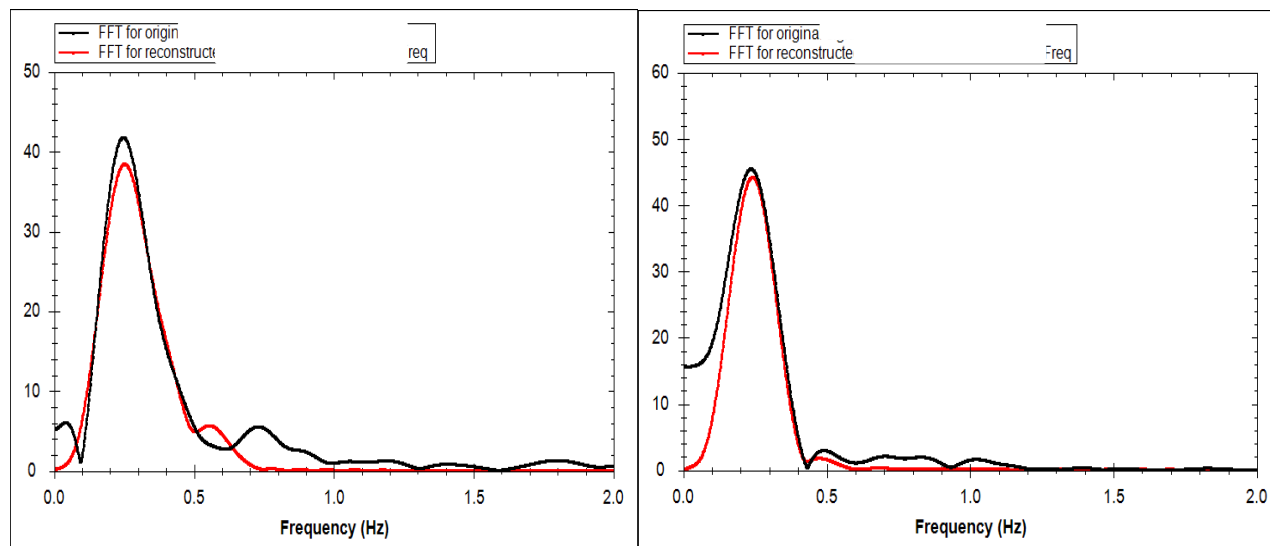
In addition, the spectrum of the lower frequency portions of the signals was analyzed to determine if any mode shape was missed in analysis. **Figure D.63** demonstrates the best and worst matches in the analysis, indicating that the mode shapes are an accurate depiction of the oscillation.

Figure D.63: Reconstructed and Original FFT Results. Left – MISO, Right – Florida
