Impact Analysis of High PV Penetration on Protection of Distribution Systems Using Real-Time Simulation and Testing – A Utility Case Study

Amin Salmani, PhD, PE, SMIEEE
Principal Eng., SDG&E

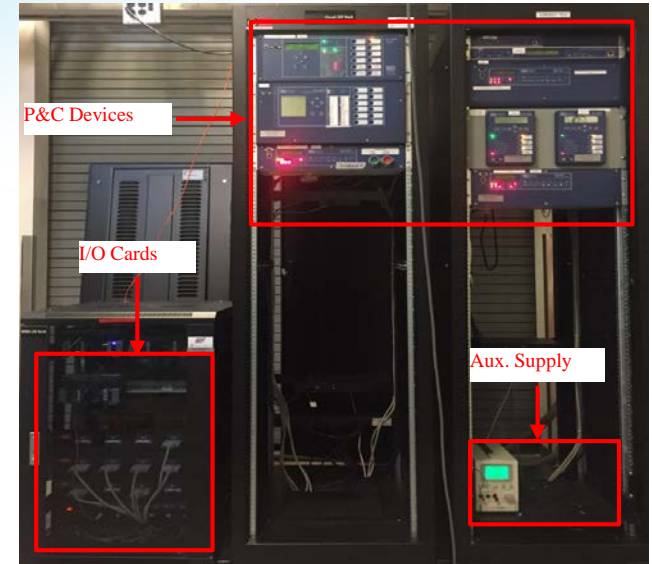
HIL Test Setup

- HIL testbed was developed in SD&GE Integration Testing Facility.
- Power and Control hardware (Inverter, relays, and voltage regulators) were interfaced with the RTDS model.
- Low-Energy Analog (LEA) inputs of relays were utilized to minimize the number of amplifiers required for this testing.

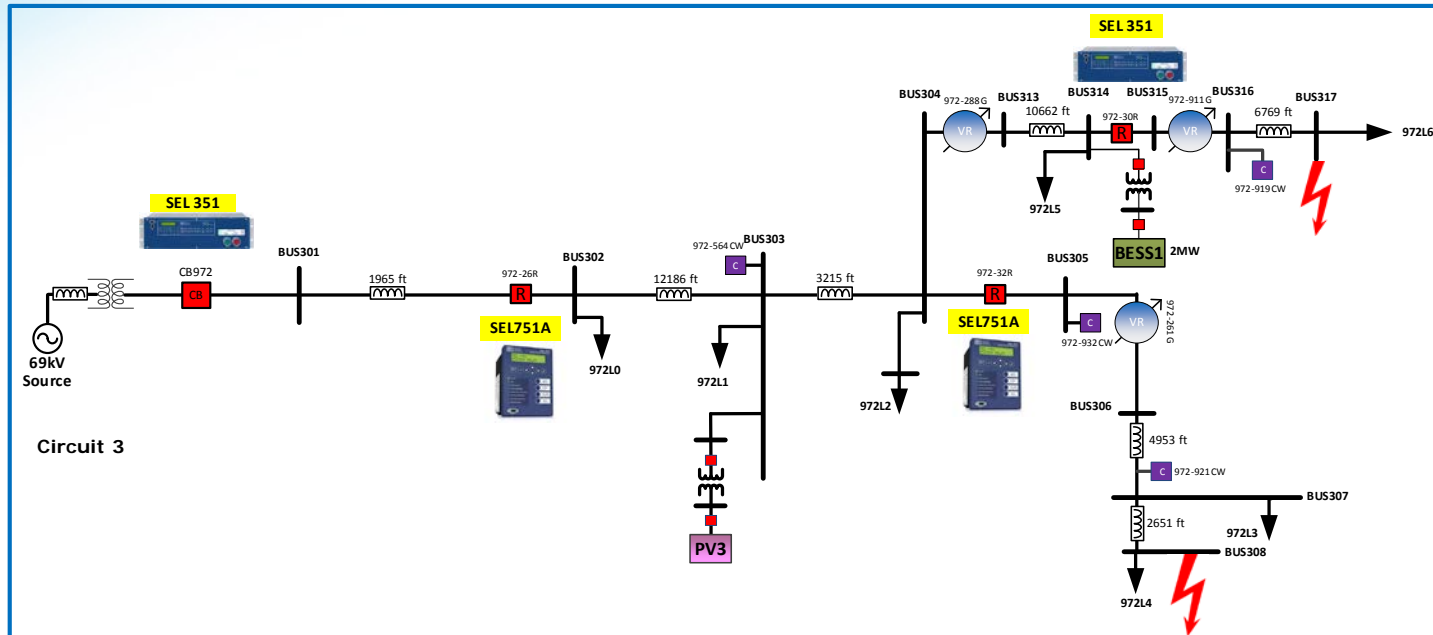
- Let us assume that a 7.5-MW PV system (100% penetration) is connected to Bus 303 on Circuit 3
- Various reactive power support during the fault (power factor ranging from +0.8 leading/Injecting to -0.8 lagging/absorbing)

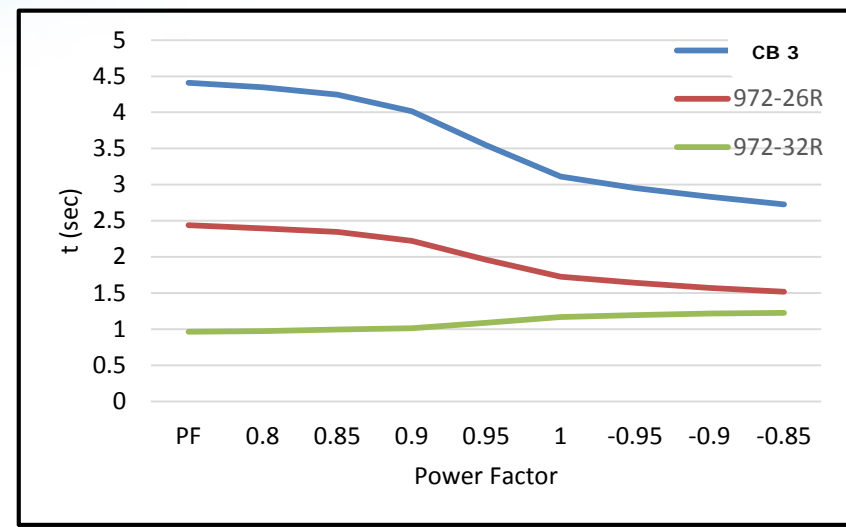
Relay operation time (sec) for a TPH fault at Bus 308

Relay operation time (sec) for a TPH & SLG faults at Bus 308

- Delayed operation of upstream relays
- Reactive power injection during the fault will intensify the situation.
- The results for TPH and SLG faults follow the same trend.
- No major mis-coordination was observed.

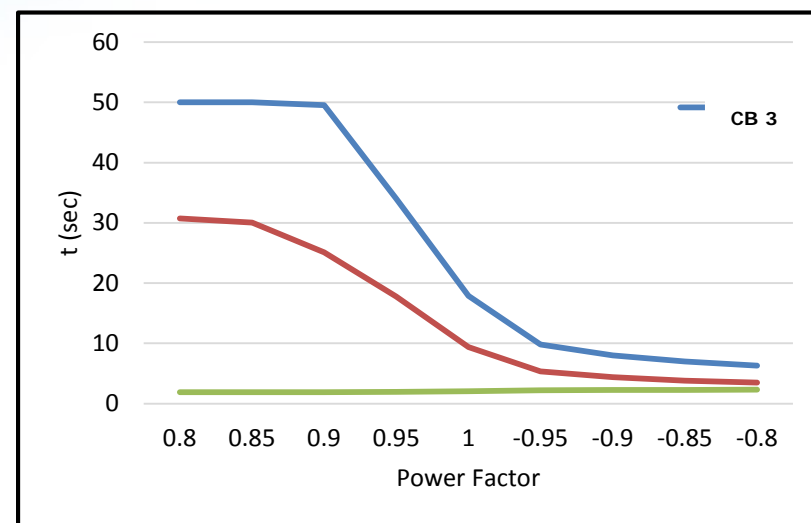
Relay operation time (sec) for a TPH fault at Bus 317

Relay operation time (sec) for a TPH & SLG faults at Bus 317

• The presence of another DER (BESS) has further desensitize substation relay, leading to its failure to operate for a fault at Bus 317.

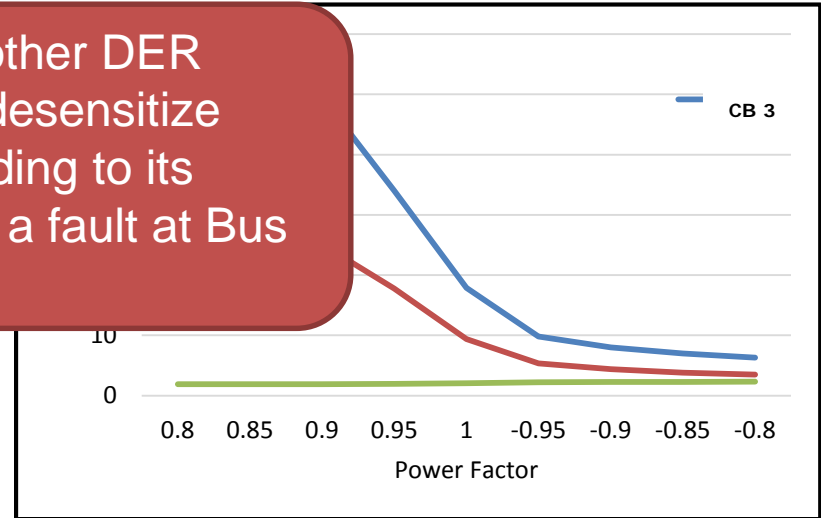
Relay operation time (sec) for a TPH fault at Bus 317

Relay operation time (sec) for a TPH & SLG faults at Bus 317

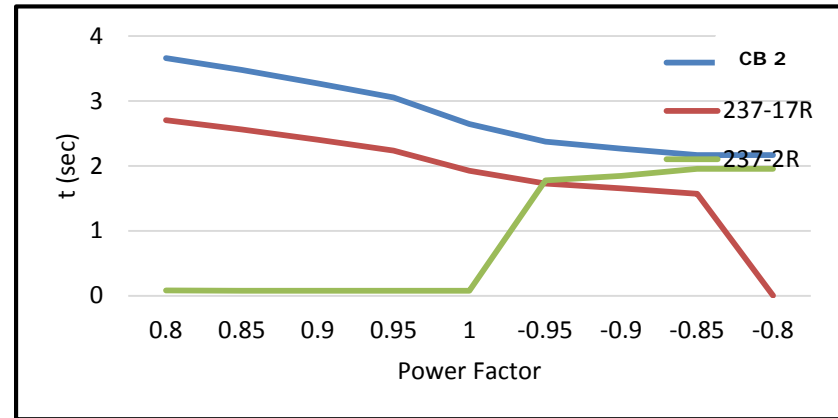
Relay operation time (sec) for a TPH fault at Bus 109

Relay operation time (sec) for a TPH & SLG faults at Bus 109

- High penetration of PV system has caused protection miscoordination between two relays, in reactive power absorbing case.

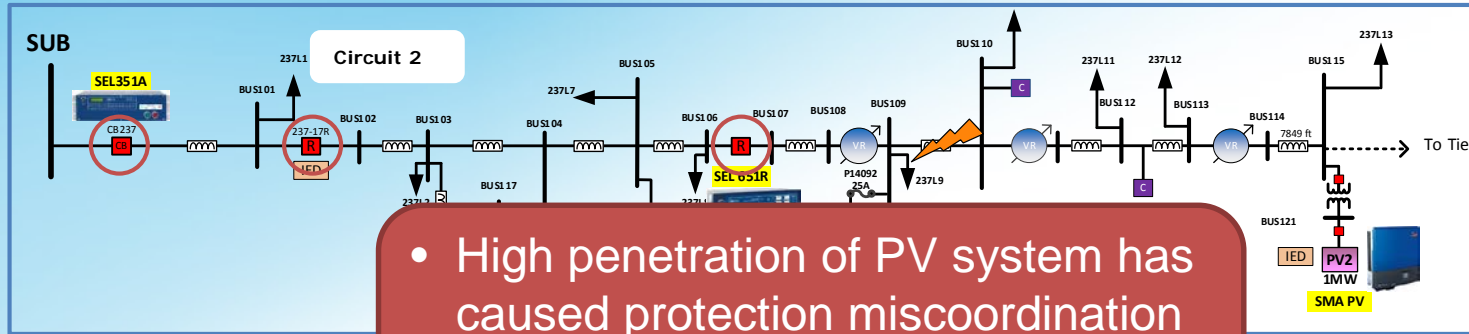
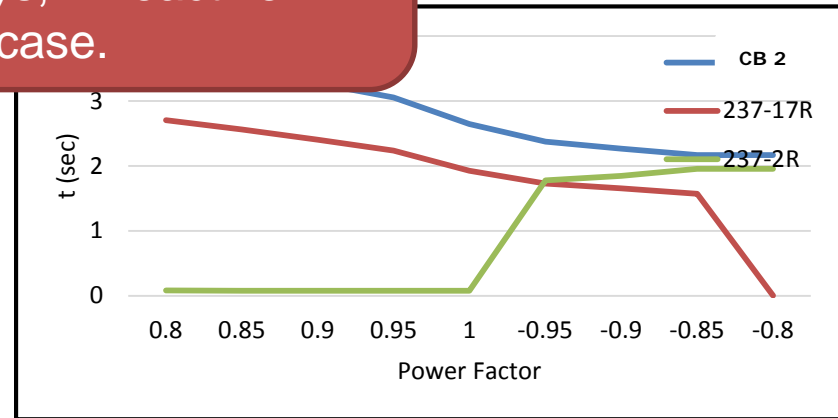
Relay operation time (sec) for a TPH fault at Bus 109

Relay operation time (sec) for a TPH & SLG faults at Bus 109
