NERC

Hurricane Sandy Event Analysis Report

January 2014

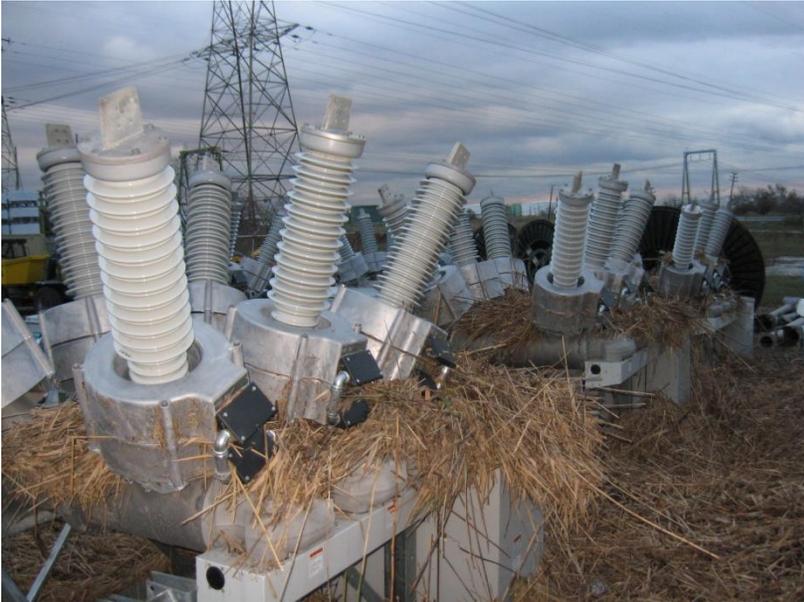
Damaged substation equipment

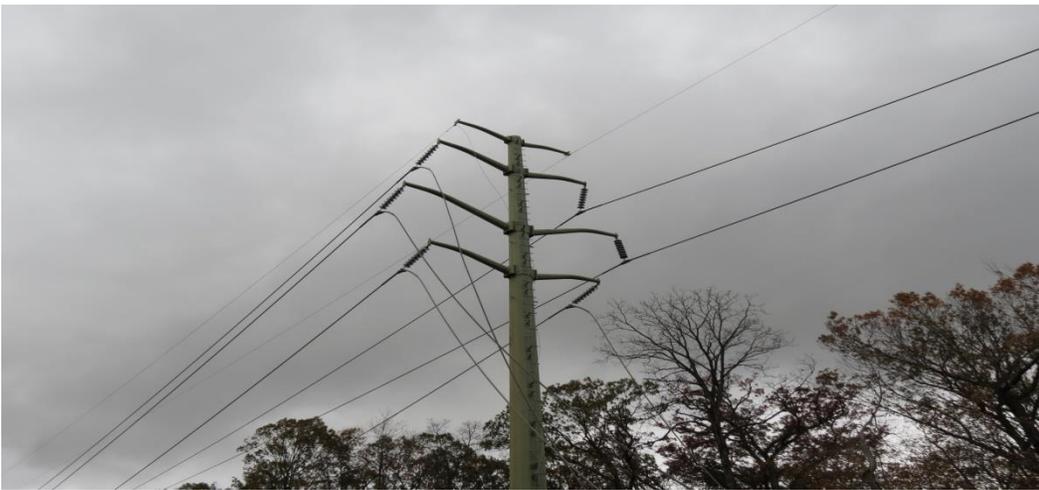
Damaged high voltage transmission line

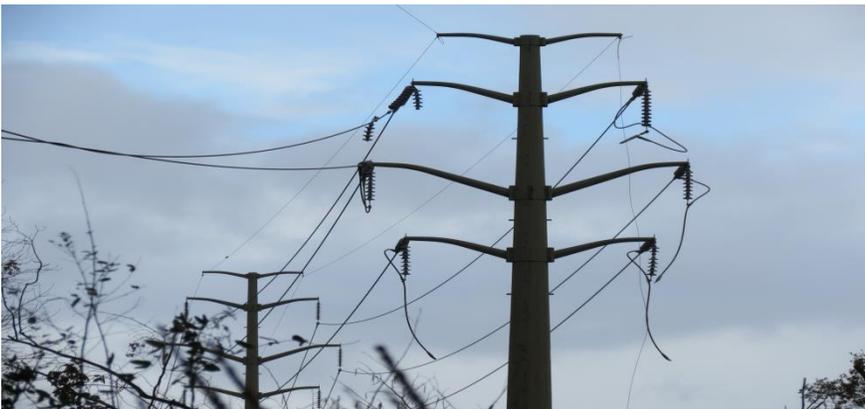
Damaged high voltage transmission line

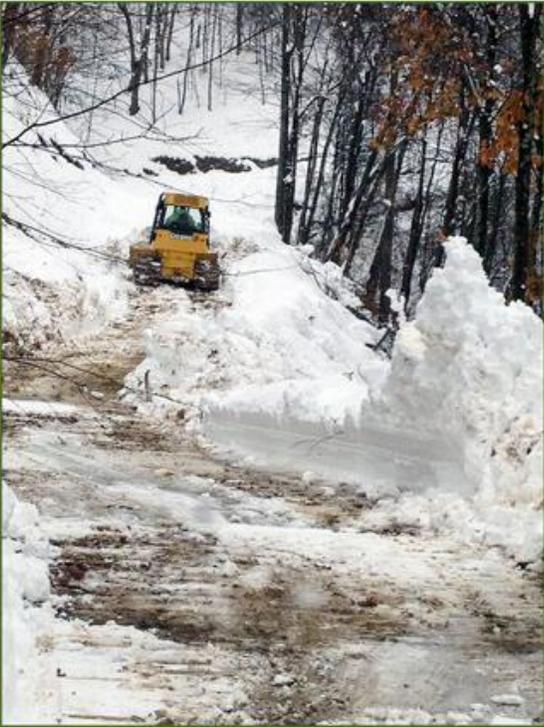
Crews had to clear more than three miles of road through remote terrain to access and repair a line.

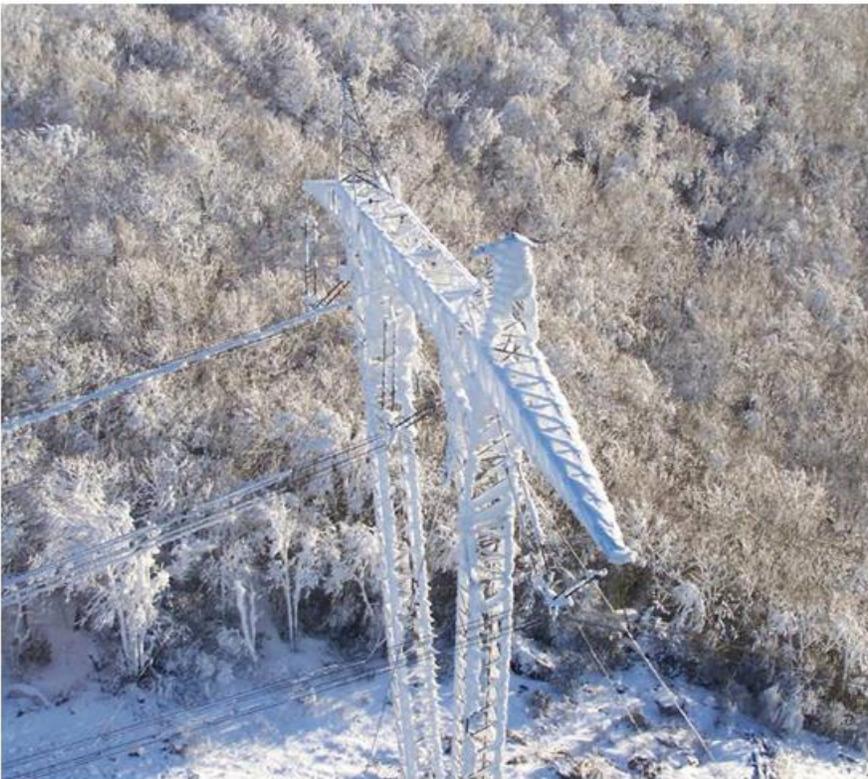
Workers hooked a crane truck to a bulldozer and pulled it more than seven miles past the nearest road to reach this transmission structure on top of East River Mountain near Bluefield. The then used the crane to place a downed static wire back on top of the snow-covered structure.
