**UNITED STATES OF AMERICA
BEFORE THE
FEDERAL ENERGY REGULATORY COMMISSION**

Docket No. RM21-17-000

**COMMENTS OF THE
NORTH AMERICAN ELECTRIC RELIABILITY CORPORATION, MIDWEST
RELIABILITY ORGANIZATION, NORTHEAST POWER COORDINATING
COUNCIL, INC., RELIABILITYFIRST CORPORATION, SERC RELIABILITY
CORPORATION, TEXAS RELIABILITY ENTITY, INC., AND WESTERN
ELECTRICITY COORDINATING COUNCIL ON
THE ADVANCE NOTICE OF PROPOSED RULEMAKING**

Attachment 1: Odessa Report, September 2021

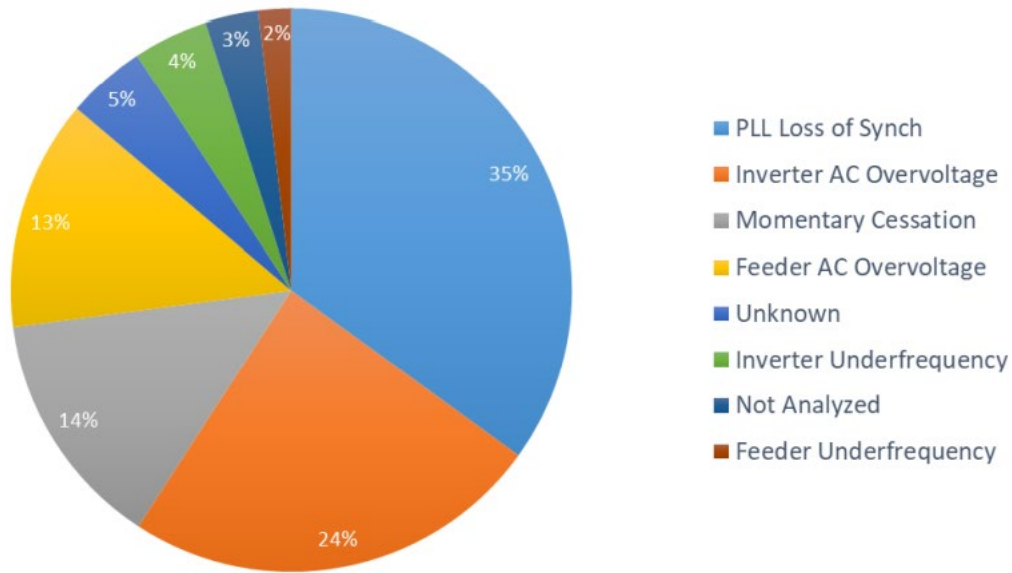
EMT studies would be capable of modeling all forms of tripping and abnormal performance during faults. Multiple types of inverter tripping were identified during the Odessa Disturbance and past solar PV resource loss events evaluated by NERC. Figure 1.1 of the Odessa Report presents causes of solar PV power reduction during the disturbance and associated inverter characteristics.²⁹

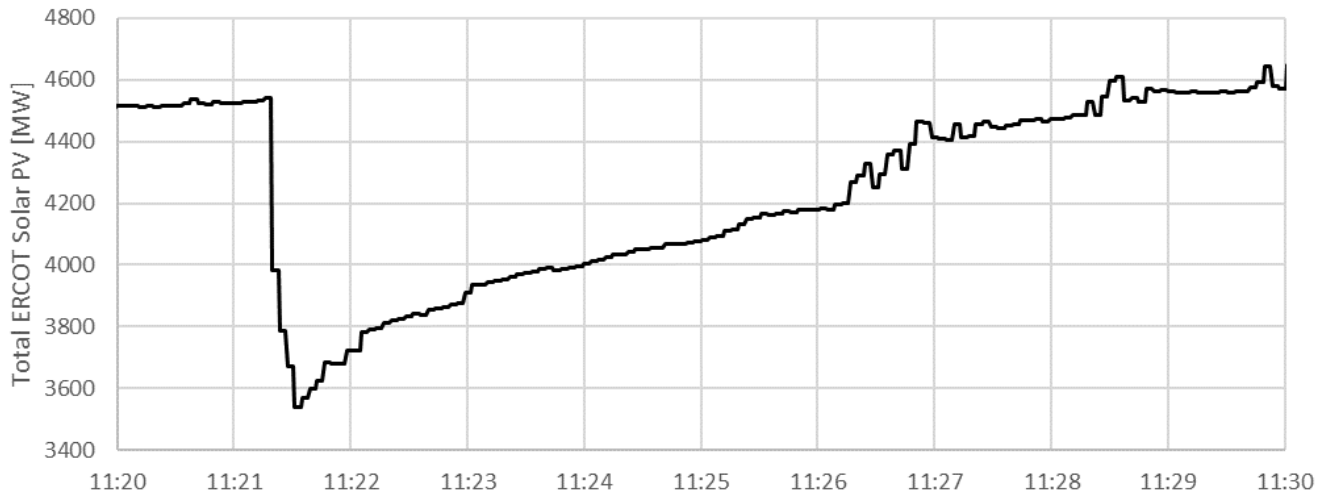
Figure I.5: ERCOT BPS-Connected Solar PV during Disturbance [Source: ERCOT]

Figure I.5 shows the reduction in solar PV resources reported by ERCOT supervisory control and data acquisition (SCADA) data. As with the past disturbance reports involving fault-induced solar PV reductions, the size of the active power reduction is determined using SCADA data from the affected BA (i.e., ERCOT) in addition to analyzing data provided by individual facilities. Due to SCADA scan rate differences, different metering points, different accounting practices, and other factors, small discrepancies may exist between the values; however, the reductions in solar PV output provide a relative indicator of the impact of these reductions compared to past disturbances.

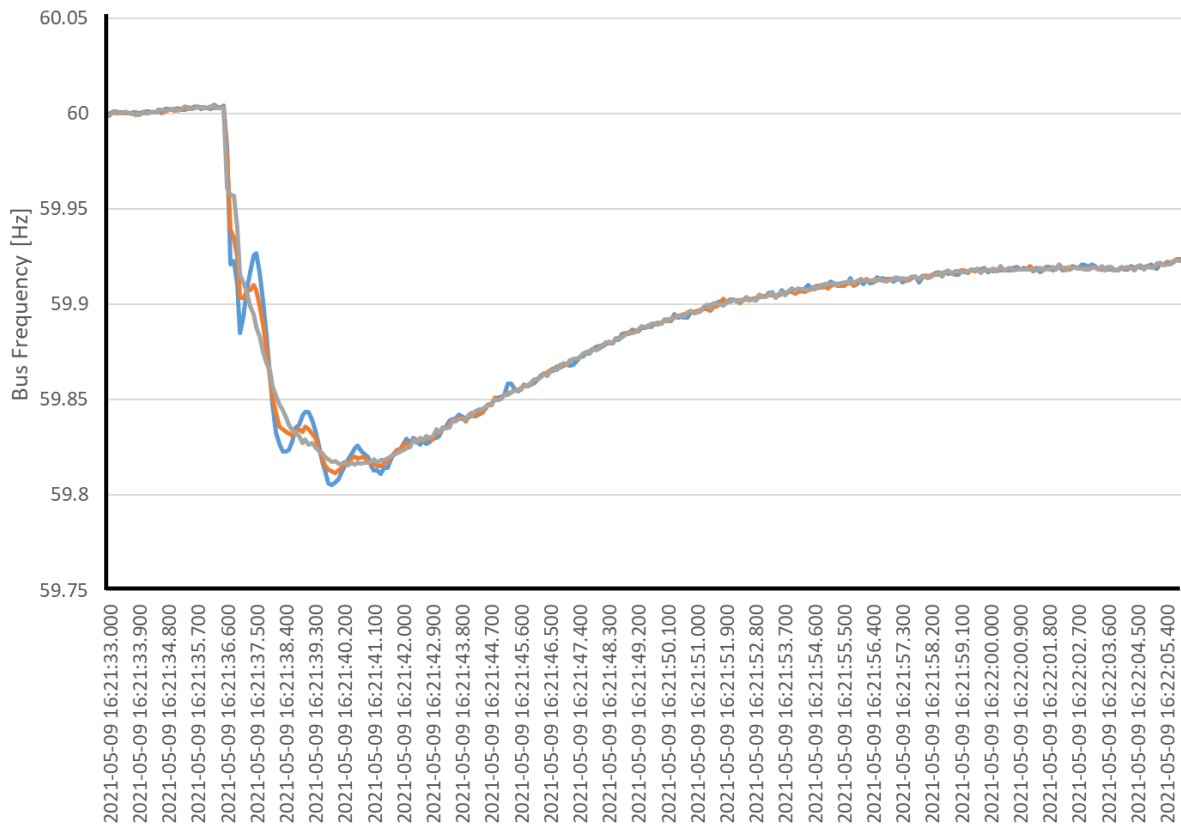
Figure I.6: System Frequency during Event [Source: UTK/ORNL]

Lastly, **Figure I.6** shows system frequency measurements for the event. Pre-disturbance frequency was very close to 60 Hz and the frequency nadir occurred at around 59.805 Hz at 3.3 seconds after the initiation of the event.

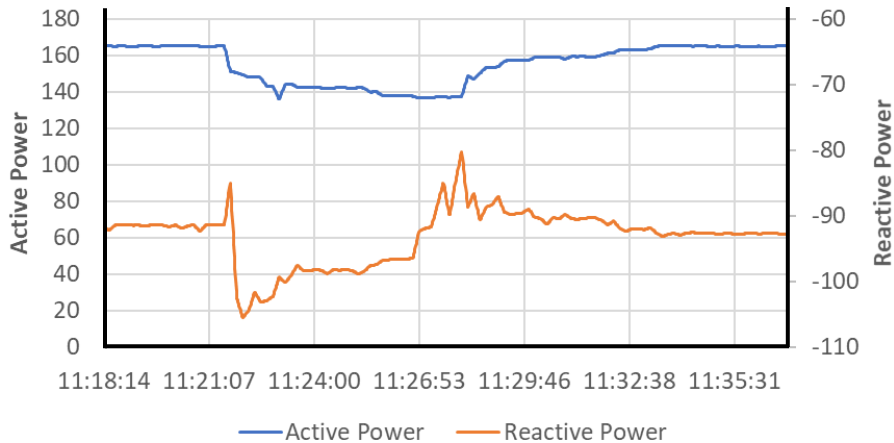
Figure B.1: Plant Active and Reactive Power Output

Plant A is a 180 MW facility connected to the 138 kV network that went into commercial operation in June 2018. The facility is actually a hybrid resource that includes a battery energy storage system component within the facility. The plant reduced output by 28 MW during the event (see [Figure B.1](#)) and started recovering after about 6.5 minutes. The plant returned to pre-disturbance output about 12 minutes later. According to the facility, 6 of 90 inverters reduced output “to idle operation” due to a “voltage deviation at the POI,” and plant staff stated that no protection functions operated. Plant staff were unable to identify a cause of tripping for any of the inverters and stated that they do not have “enough knowledge on site at these facilities to get the data needed” to identify a root cause for the abnormal behavior (within the timing required by the ERCOT RFI and follow-up discussions with NERC and Texas RE). Therefore, the plant has no identified cause of tripping due to lack of information provided.

The plant had a PMU located at the interconnection point and measured POI voltage of around 0.63 pu followed by a slight voltage overshoot upon fault clearing—well within the PRC-024-2 curve. The plant was operating near maximum active power output and also consuming a significant amount of reactive power prior to the fault event.

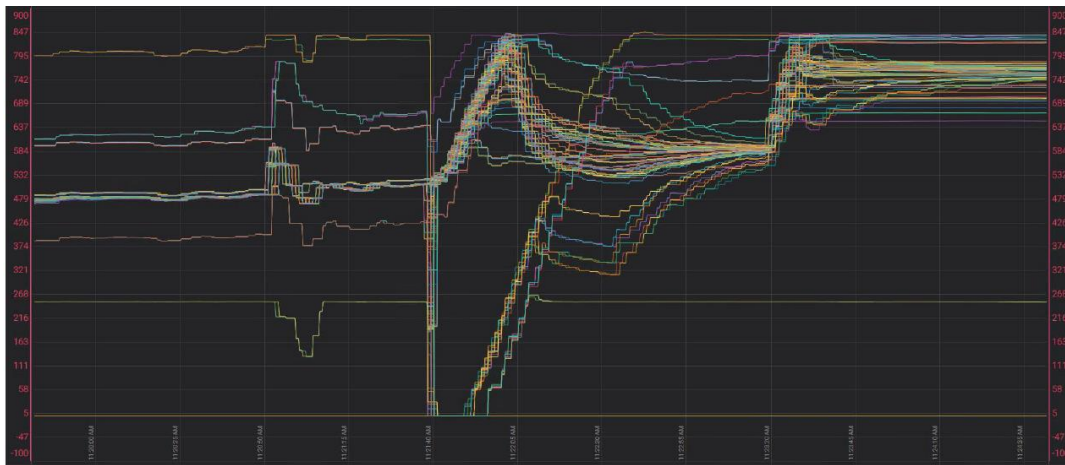
Figure B.5: Inverter Active Power Output per Skid

- Rapid Return to Service by Tripped Inverters:** The 15 inverters that tripped on instantaneous ac overvoltage began recovery back to pre-disturbance levels after 10 seconds (see [Figure B.5](#)). This type of tripping is commonly followed by a 5-minute auto-restart timer. This facility was able to bring the inverters back significantly faster; this should be explored for all existing inverters from this manufacturer.

- Primary Frequency Response due to Curtailment:** Due to the previous curtailment of the facility prior to the fault, the facility was operating with headroom³⁴ to provide frequency response capability. When frequency declined, many of the inverters within the facility that remained on-line responded by increasing their active power output in response to the declining system frequency (see [Figure B.5](#)).

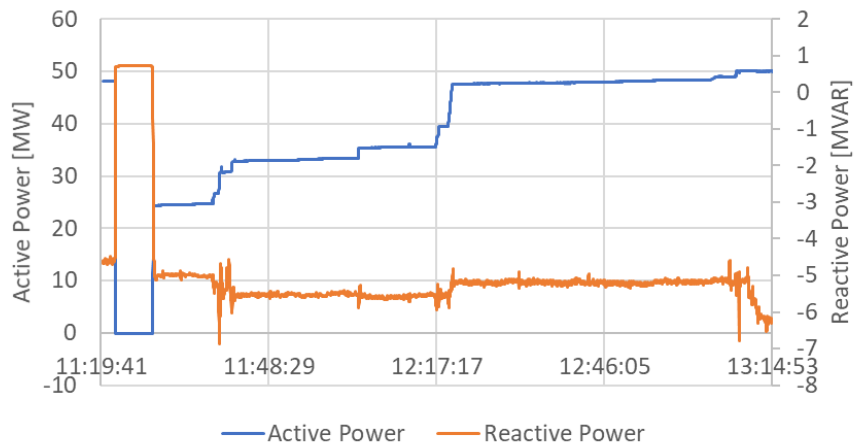
Figure B.10: Plant Active and Reactive Power Output

Plant F is a 50 MW facility connected to the 69 kV network that went into commercial operation in April 2017. The plant reduced output by 48 MW during the event (see [Figure B.10](#)). All 26 inverters in the plant tripped off-line during the fault; however, only 17 of the 26 inverters recorded the cause for tripping. Those inverters indicated a “grid underfrequency” event. The plant informed the team that the underfrequency trip settings for 59.4 Hz, 58.4 Hz, and 58.2 Hz were all set to three-cycle tripping. Plant staff stated that specifically the 58.2 Hz trip setting is what triggered inverter tripping. This plant is connected to 69 kV and less than the bulk electric system size threshold, so this facility is not subject to NERC requirements. The team wanted to reach out to the facility to help improve performance regardless.

The inverters came back on-line after 7 minutes; however, the plant did not return to predisturbance output levels for 50 minutes.

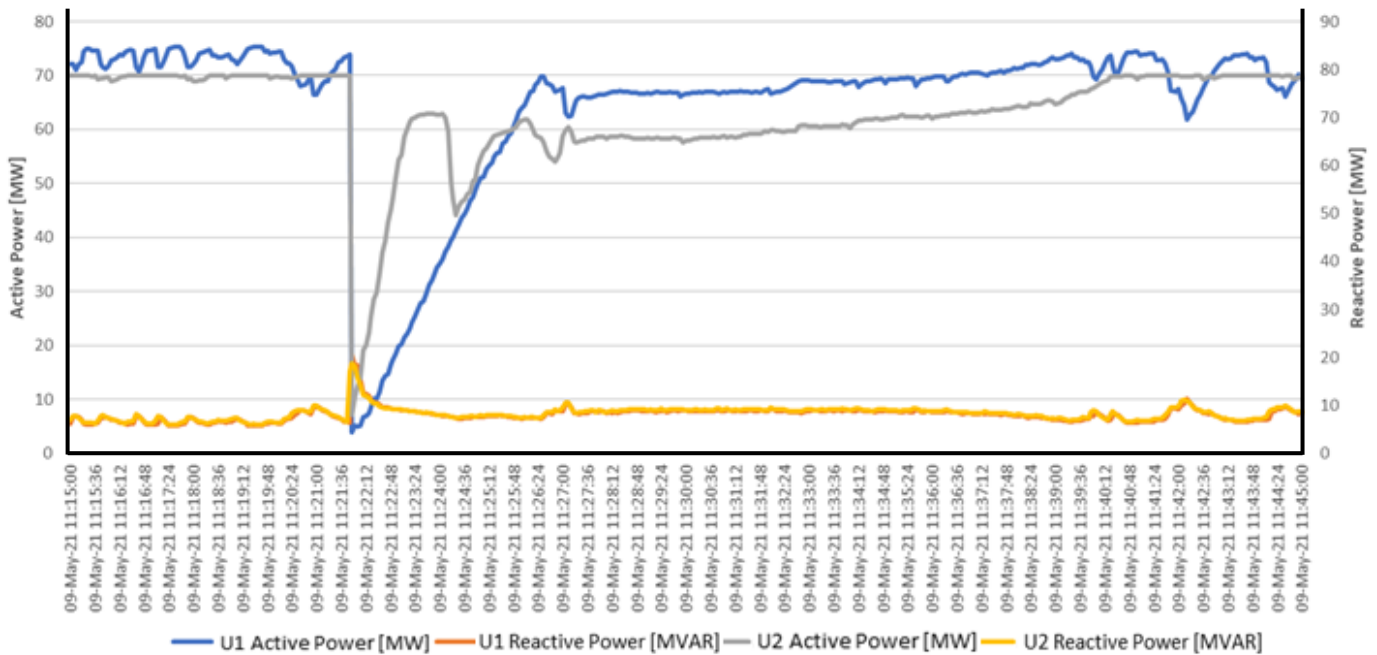
Figure B.15: Plant Active and Reactive Power Output

Upon fault clearing, the inverter power output began ramping back to predisturbance levels. However, the response of these plants, particularly their return to predisturbance output levels, does not meet the recommended performance specified in the NERC reliability guidelines. Plant L took nearly 5 minutes and Plant M took about 1.5 minutes to return to near predisturbance output. However, both plants exhibited an anomalous recovery behavior that appears to have limited them from returning to full predisturbance levels until nearly 18 minutes later. Plant controller ramp rates (set at around 8 MW/minute upward ramp and 16 MW/minute for emergency ramps) interacted with the inverter-level recovery, precluding the inverter ramp rate (500%/second) from fully recovering within 0.5 seconds. This is a systemic issue observed across multiple BPS-connected solar PV plants in both the WECC and Texas RE regions. The inverter controls should fully recover power output back to pre-disturbance levels rather than being limited by the plant controller, which is set based on BA ramp rate requirements.

The plant responded to questions regarding mitigating measures to eliminate the plant controller ramp rate interactions with “N/A” so no further modifications to improve performance are expected from this facility. It will continue to not meet the recommendations set forth in the NERC reliability guidelines.

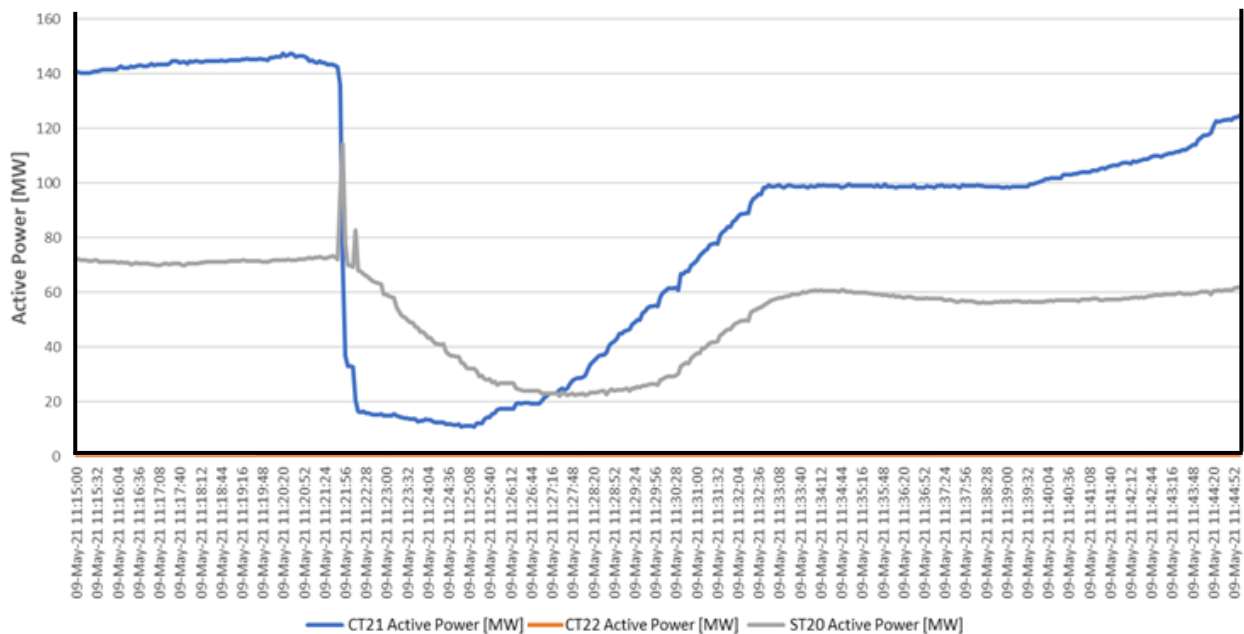
Figure B.21: Combined Cycle Plant Unit 2 Active Power Output

The combined cycle plant is a 1,356 MVA facility connected to the 345 kV network that went into commercial operation in June 2001. The plant consists of two 2x1 combined-cycle (CC) blocks that consist of two CTs and one steam turbine (ST). Prior to the event, CT11 was in startup. **Table B.3** shows the predisturbance operating conditions, the lowest power output reached for each unit, and the cause of reduction. The fault occurred on the 345 kV high-side of the GSU for CT11. CT11 tripped consequentially due to the fault. CT21 ran back power output for an unknown reason,³⁷ and ST20 experienced a decaying power output due to CT21 tripping. In total, the plant reduced output by 192 MW. **Figure B.21** shows the net power output from each on-line unit in the facility.

Table B.3: Review of Combined Cycle Plant Tripping				
Unit	Nameplate Capacity [MW]	Pre-Disturbance Output [MW]	Reduction [MW]	Cause of Tripping
CT11 (CC1)	176	12	12	Consequential tripping from fault on 345 kV surge arrester
CT12 (CC1)	176	0	0	N/A
ST10 (CC1)	224	0	0	N/A
CT21 (CC2)	176	142	131	Turbine-generator runback for unknown reason
CT22 (CC2)	176	0	0	N/A
ST20 (CC2)	224	72	49	Steam turbine power decay from CT runback
TOTAL			192
