Odessa Disturbance

Texas Events: May 9, 2021 and June 26, 2021
Joint NERC and Texas RE Staff Report

September 2021

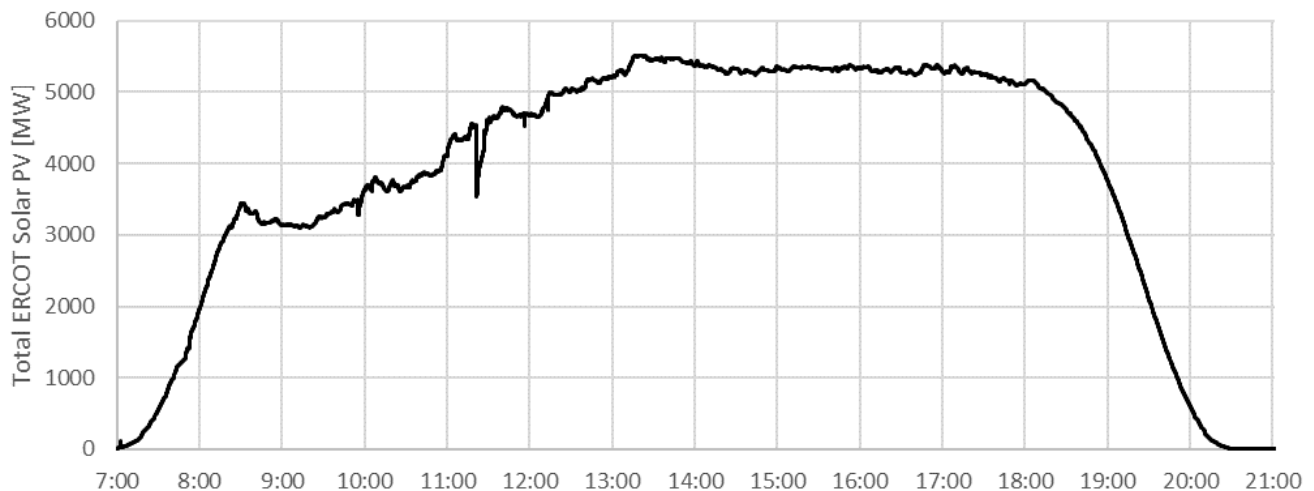
Figure I.1: ERCOT Solar PV Profile for May 9, 2021

Figure I.1 shows the total ERCOT solar PV profile for May 9, 2021. The disturbance occurred at 11:21:36 a.m. Central time when solar was still ramping up. The disturbance is clearly visible in the total solar PV power output; however, the magnitude of reduction is not the primary concern. The unexpected reduction of power output across many solar PV resources is the primary focus of this analysis. Most of the affected facilities were located in the West Texas area with one affected facility near the Texas Panhandle.

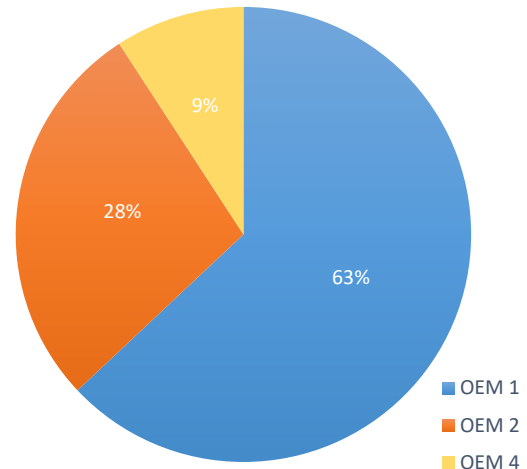
Figure 1.2: Inverter Manufacturers Involved in Disturbance

Figure 1.2 shows the share of inverter manufacturers involved in the solar PV reductions. Only three different types of inverter manufacturers were involved in this event. The inverter manufacturer with only 9% of the total reduction is no longer in the business of manufacturing large-scale inverters. The other two manufacturers are actively involved in the production of inverters for large-scale solar PV power plants.

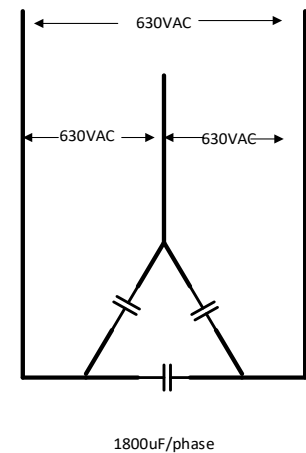
Figure 1.9: Inverter Output Capacitor Configuration

ERCOT analyzed the production of reactive power during nighttime operations and noted only a minor reactive power injection during these conditions. NERC corroborated this finding with a model-based approach by analyzing reactive power injection with all inverters off-line in the model. NERC then noticed that the affected facilities exhibiting this behavior had a common inverter manufacturer, and NERC coordinated with this manufacturer to get additional information. The manufacturer stated that, upon tripping (often referred to as “idle”), the inverters gate blocked²⁴ “to prevent overuse of the inverter ac circuit breaker,” but the inverter output capacitors remain on-line. The capacitors in this situation are 1,800 μF /phase and installed in a delta configuration on the ac-side of the inverter on the 630 V level. [Figure 1.9](#) shows an illustration of the configuration. The capacitance values for each inverter aligned closely with the expected reactive power injection of the facilities that experienced gate blocking (cessation of current). This also helps partly explain some possible ac overvoltage experienced during these inverter tripping conditions.

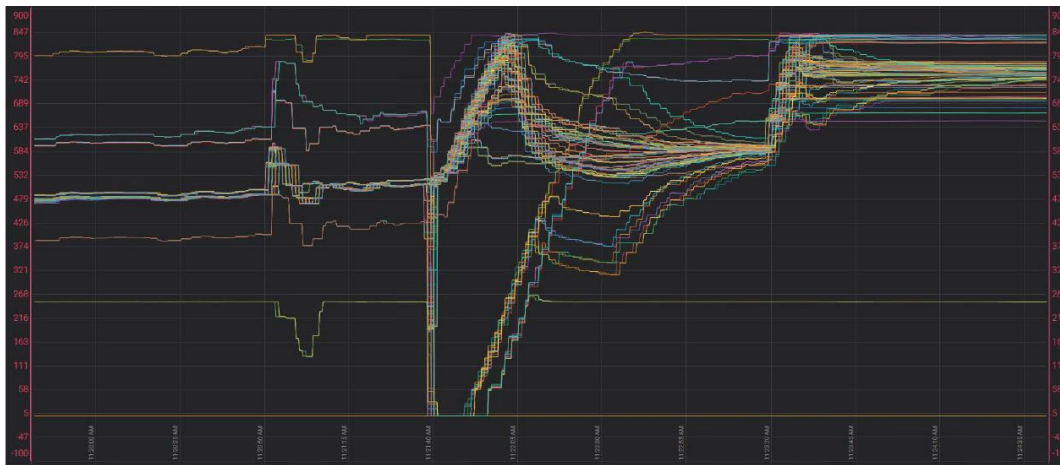
Figure B.5: Inverter Active Power Output per Skid

- Rapid Return to Service by Tripped Inverters:** The 15 inverters that tripped on instantaneous ac overvoltage began recovery back to pre-disturbance levels after 10 seconds (see [Figure B.5](#)). This type of tripping is commonly followed by a 5-minute auto-restart timer. This facility was able to bring the inverters back significantly faster; this should be explored for all existing inverters from this manufacturer.

- Primary Frequency Response due to Curtailment:** Due to the previous curtailment of the facility prior to the fault, the facility was operating with headroom³⁴ to provide frequency response capability. When frequency declined, many of the inverters within the facility that remained on-line responded by increasing their active power output in response to the declining system frequency (see [Figure B.5](#)).

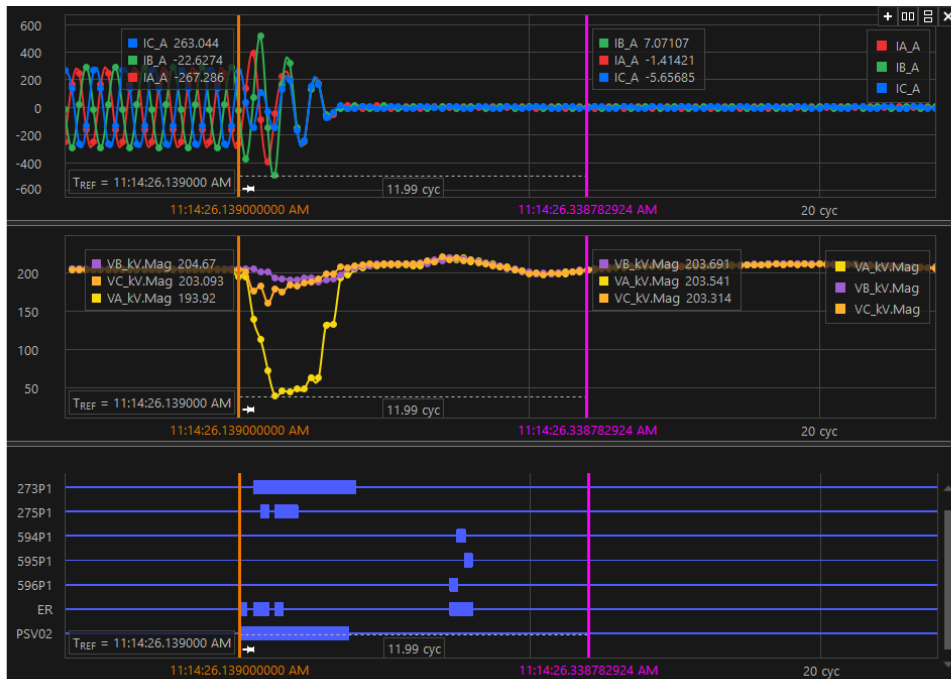
Figure C.5: June 26 Event System Frequency

In the May 9 event, this facility tripped on inverter-level instantaneous ac overvoltage conditions while the POI voltage remained within the PRC-024-3 voltage boundaries. For the June 26 event, the facility tripped on a different tripping mechanism: ac overcurrent and ac undervoltage. The ac overcurrent is a peak (instantaneous) measurement also hard-coded into the inverter. This setting is set by the equipment manufacturer at 150% of rated value. Between these two events, it is likely that the equipment manufacturer had disabled the inverter loss of synchronism tripping (as mentioned previously in this report) and that another form of protection then triggered for the latter event. This
