NORTH AMERICAN ELECTRIC RELIABILITY COUNCIL

2002 System Disturbances

Review of Selected Electric System Disturbances in North America

August 2004

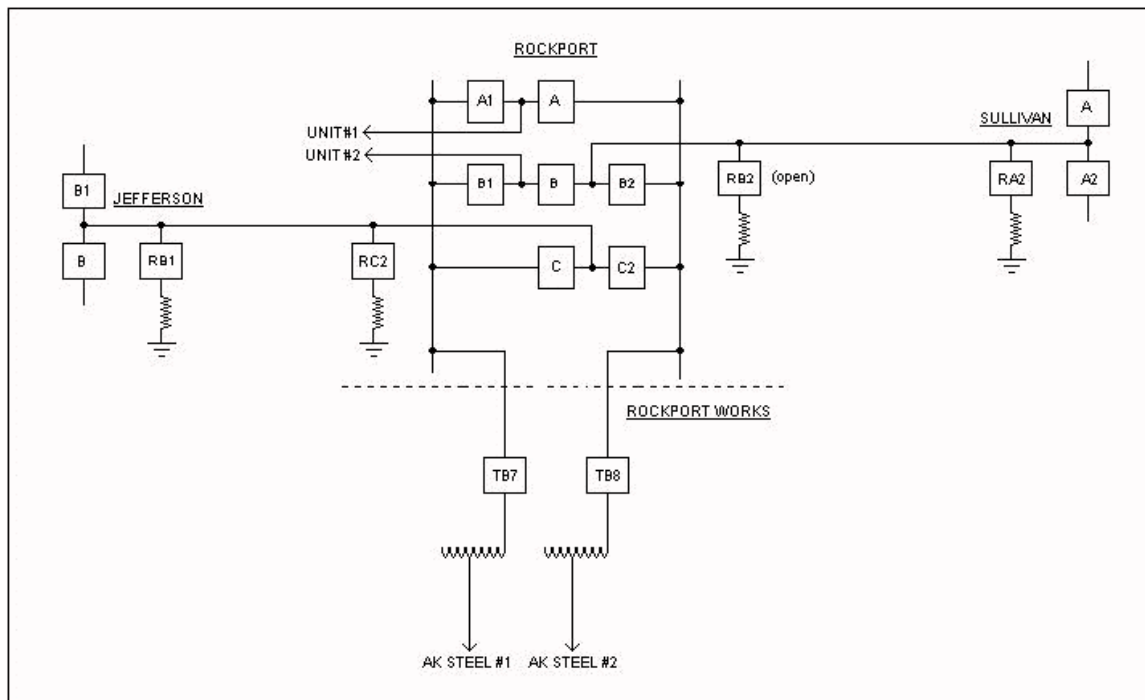
Figure 1: Rockport Area One-Line Diagram

On April 23, 2002, circuit breaker C at the Rockport 765 kV station on the Rockport-Jefferson 765 kV line was being restored to service following maintenance (see Figure 1). When the breaker was closed, a column disagreement condition occurred, which resulted in a breaker failure relay operation, as designed. This caused system protection to remove from service circuit breakers A1, B1, C2, and transformer bank 7 at Rockport, and B and B1 at Jefferson, causing a lockout of the Rockport-Jefferson 765 kV line. Rockport Generating Plant, with an installed 2,600 MW capacity, was isolated onto the Rockport-Sullivan 765 kV line, which was the only remaining outlet from the plant. Rockport generating plant's two units were operating at a combined output of 2,500 MW. The two 1,300 MW units immediately experienced growing oscillations. After 6.4 seconds, system protection at Sullivan removed the Rockport-Sullivan 765 kV line from service in response to the large voltage and current swings due to the oscillations. Following the loss of the Rockport-Sullivan 765 kV line, system protection removed the two Rockport generating units from service due to over-frequency protection.

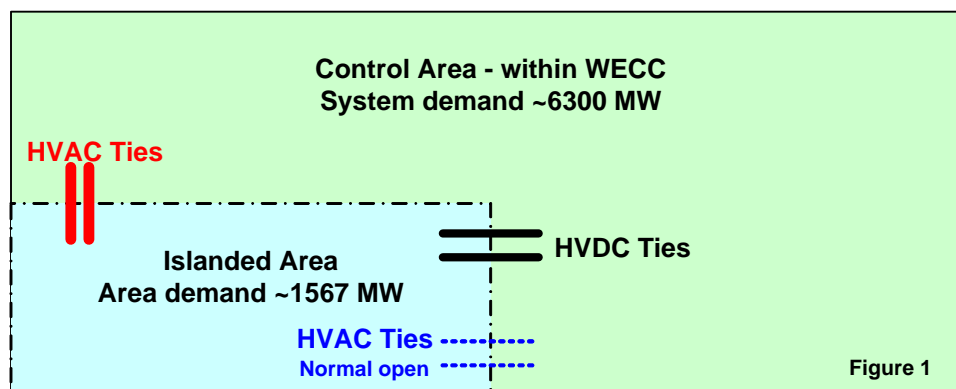
On December 26, 2002, at 12:02 PST, a portion of a control area within the Western Interconnection lost its synchronous connection to the Interconnection resulting in an asynchronous island. (See Figure 1)
