1996 System Disturbances

Review of Selected 1996 Electric System Disturbances in North America

North American Electric Reliability Council
Princeton Forrestal Village
116-390 Village Boulevard
Princeton, New Jersey 08540-5731

August 2002

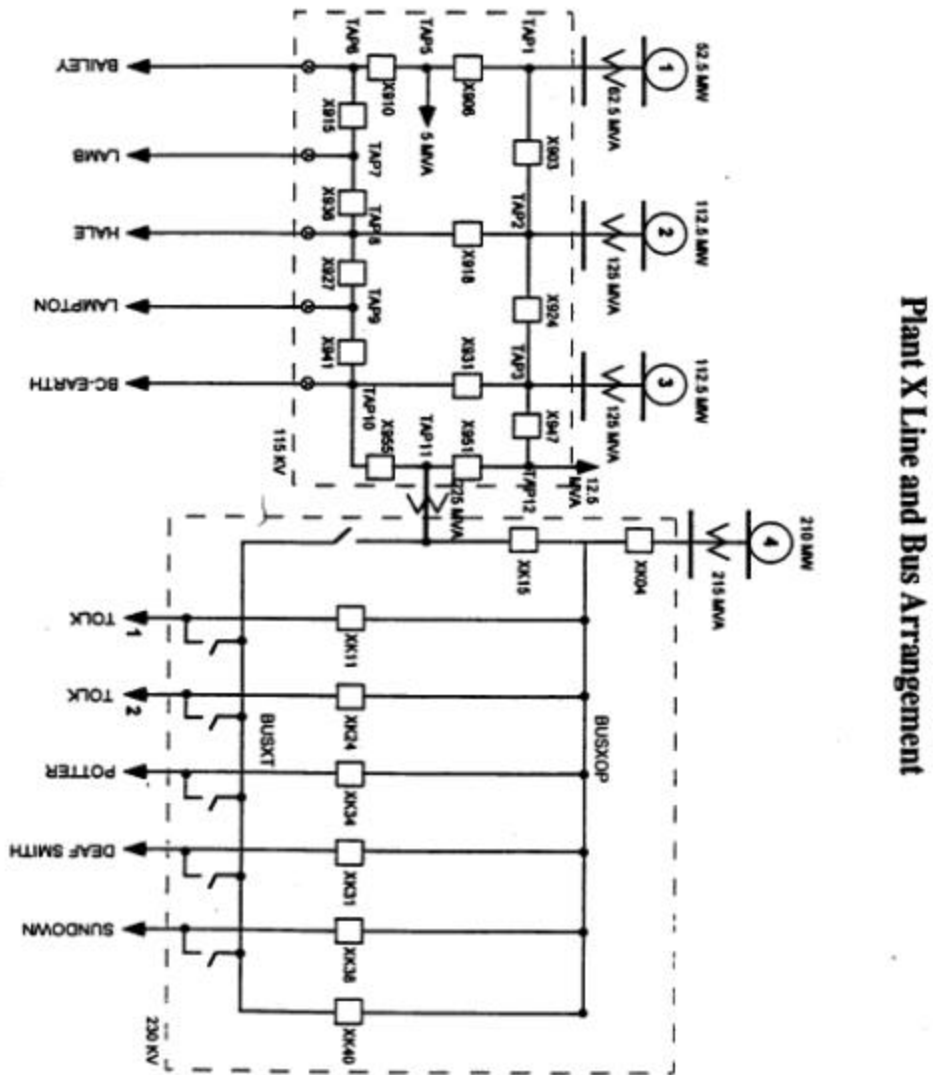
Figure 2

A 230 kV bus backup relay (zone 3) at Plant X saw the fault and operated. This relay operates through a timer, which was set at 1.2 seconds. This backup timer was wired through the ICS target relay and did not drop out after the fault was cleared. 1.27 seconds after the initial fault, all breakers on the 230 kV bus at Plant X opened due to this relay mis-operation. This mis-operation removed Plant X unit No.4 and two major ties to the north end of the system (See Figure 2, Plant X oneline).

- a.) Removing the existing 230 kV bus tie breaker TK29. This action would eliminate the single point of failure that would operate both Tolk unit No.1 and Tolk unit No.2 bus differentials. The 230 kV bus tie connection would be maintained through TK50 and TK55. This change was completed early in 1997.
- b.) Converting the Tolk Buses to a breaker and a half scheme would eliminate any common point of failure and minimize exposure to differential relay operations.
- c.) Establish a 345 kV bus at Tolk Station and move unit No.2 to this bus to provide additional isolation as well as a spare unit transformer for both Tolk units.

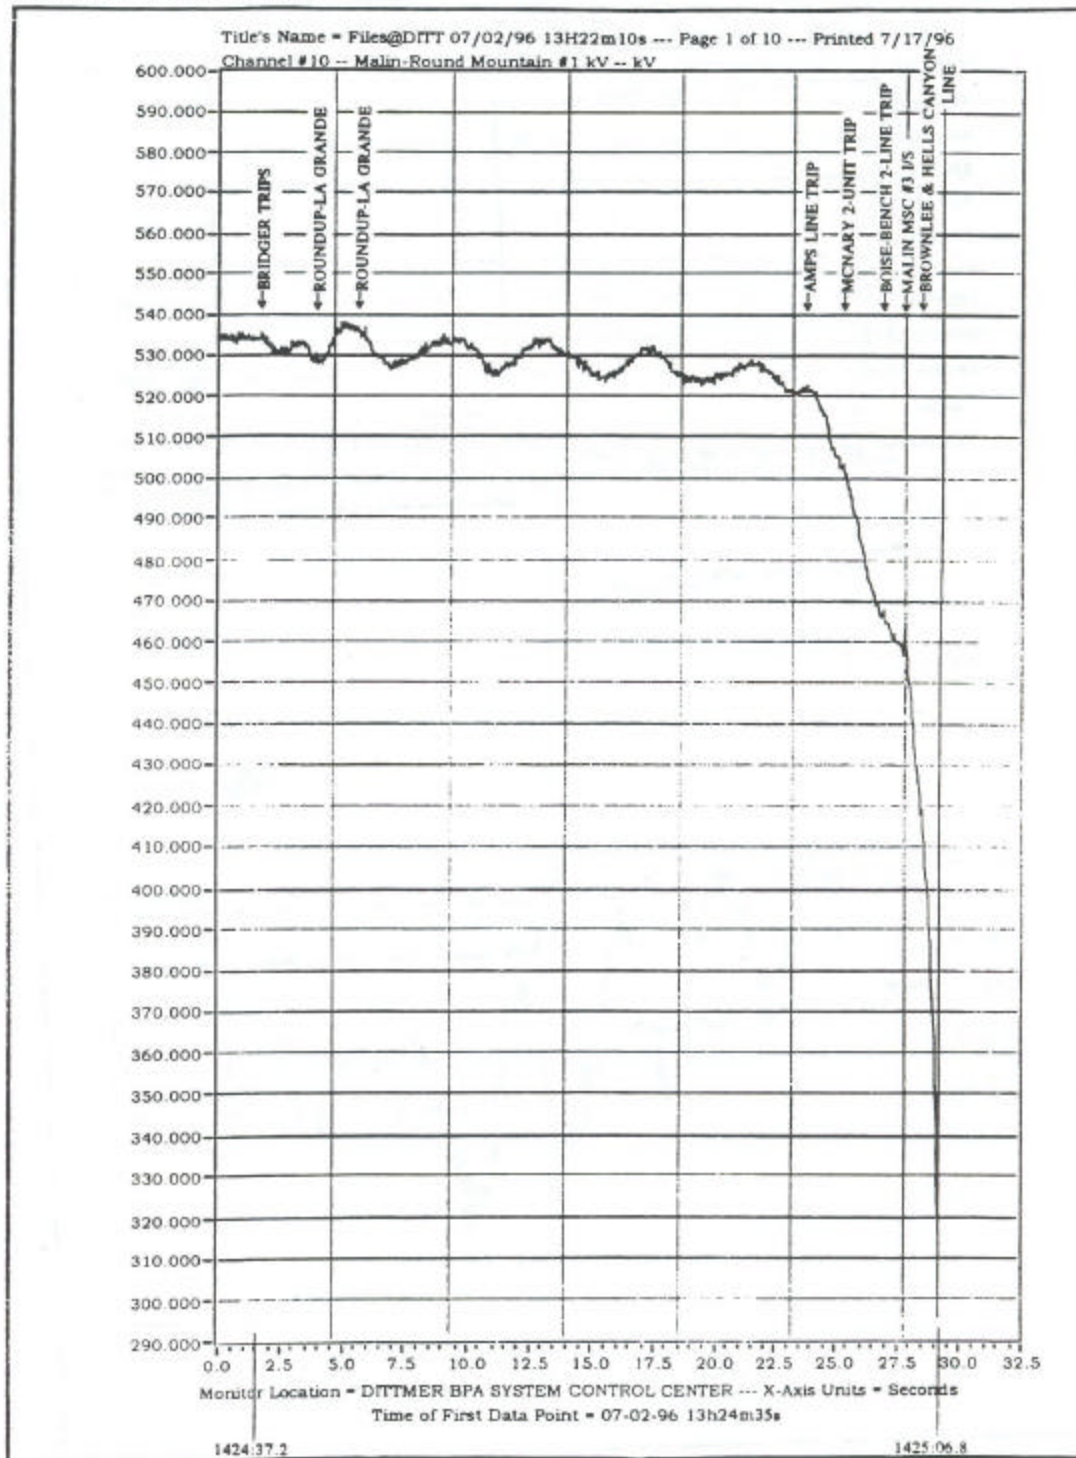
Figure 3

Following the opening of the Mill Creek – Antelope line, about 23 seconds after the Bridger units were removed from service, the voltage began to collapse rapidly in the Boise, Idaho area and on the Oregon section of the California–Oregon Intertie. See Malin and Boise area voltage plots (Figure 3).

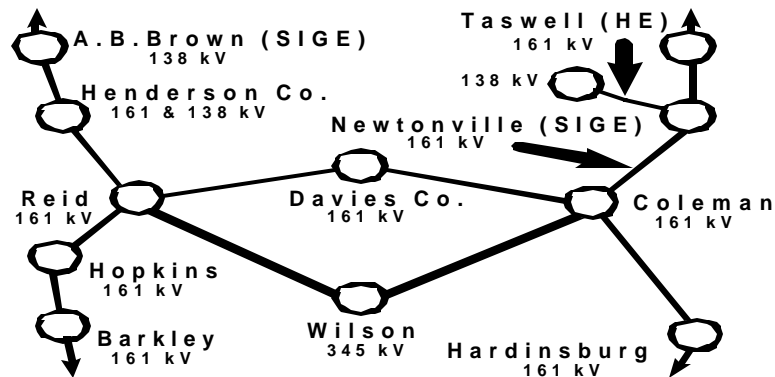
On the morning of August 7, the BREC 161 kV transmission interconnection between its Coleman station and Hoosier Energy at SIGE's Newtonville station, and the SIGE 161/138 kV tie transformer at Newtonville were heavily loaded.

Over the course of the morning, loadings on those system elements drifted upward, eventually exceeding their normal thermal ratings. At 1030 CDT, BREC redispatched internal generation to alleviate the loadings, achieving a 4% reduction on the 161 kV Coleman – Newtonville tie flow. However, across the next hourly ramping period (1050 to 1110 hours), network south-to-north flows increased by about 40 MW, eradicating the line loading relief previously achieved by the redispatch of generation. This change in flows was later attributed to an electricity transaction accepted by the BREC system operator of a 50 MW purchase from the south, coupled with a 50 MW sale to the north. This transaction resulted in a 30 MW increase in loading on the already-overloaded 161 kV Coleman – Newtonville tie to HE.

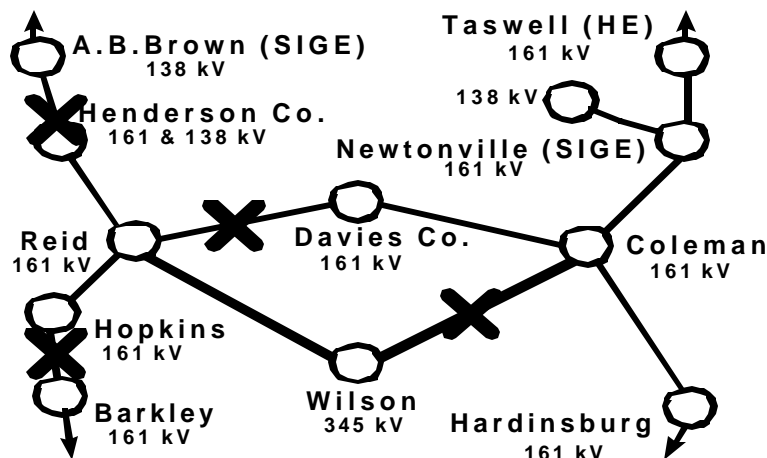
At 1105 CDT, SIGE advised BREC of its intent to open the low-side breaker on the 161/138 kV Newtonville tie transformer to protect it from damage. The BREC system operator requested five minutes to alleviate the loadings and began an immediate significant reduction in generation. Before the effects of the generation reduction could be realized, the BREC system operator opened the 345 kV Wilson – Coleman line (1109) to divert flows from the Coleman area. This operator action was premature, but the operator believed that it would alleviate the overload problem. The opening of the 345 kV Wilson – Coleman line resulted in an overload of the Reid – Davies County 161 kV line, causing it to sag into a tree about four (4) minutes after the 345 kV line was opened. The Reid – Davies County line outage caused subsequent overloads on two additional circuits, the 161 kV Hopkins County – Barkley tie line to TVA and the 161/138 kV tie transformer to SIGE at BREC's Henderson County station. System protection opened both circuits, effectively isolating or islanding a major segment of the BREC system.

The islanded section of the system suffered severe voltage and frequency swings and system protection removed all but one generator serving 12 MW of local demand in the HMPL system, resulting in loss of all 347 MW of other demand in the islanded system.

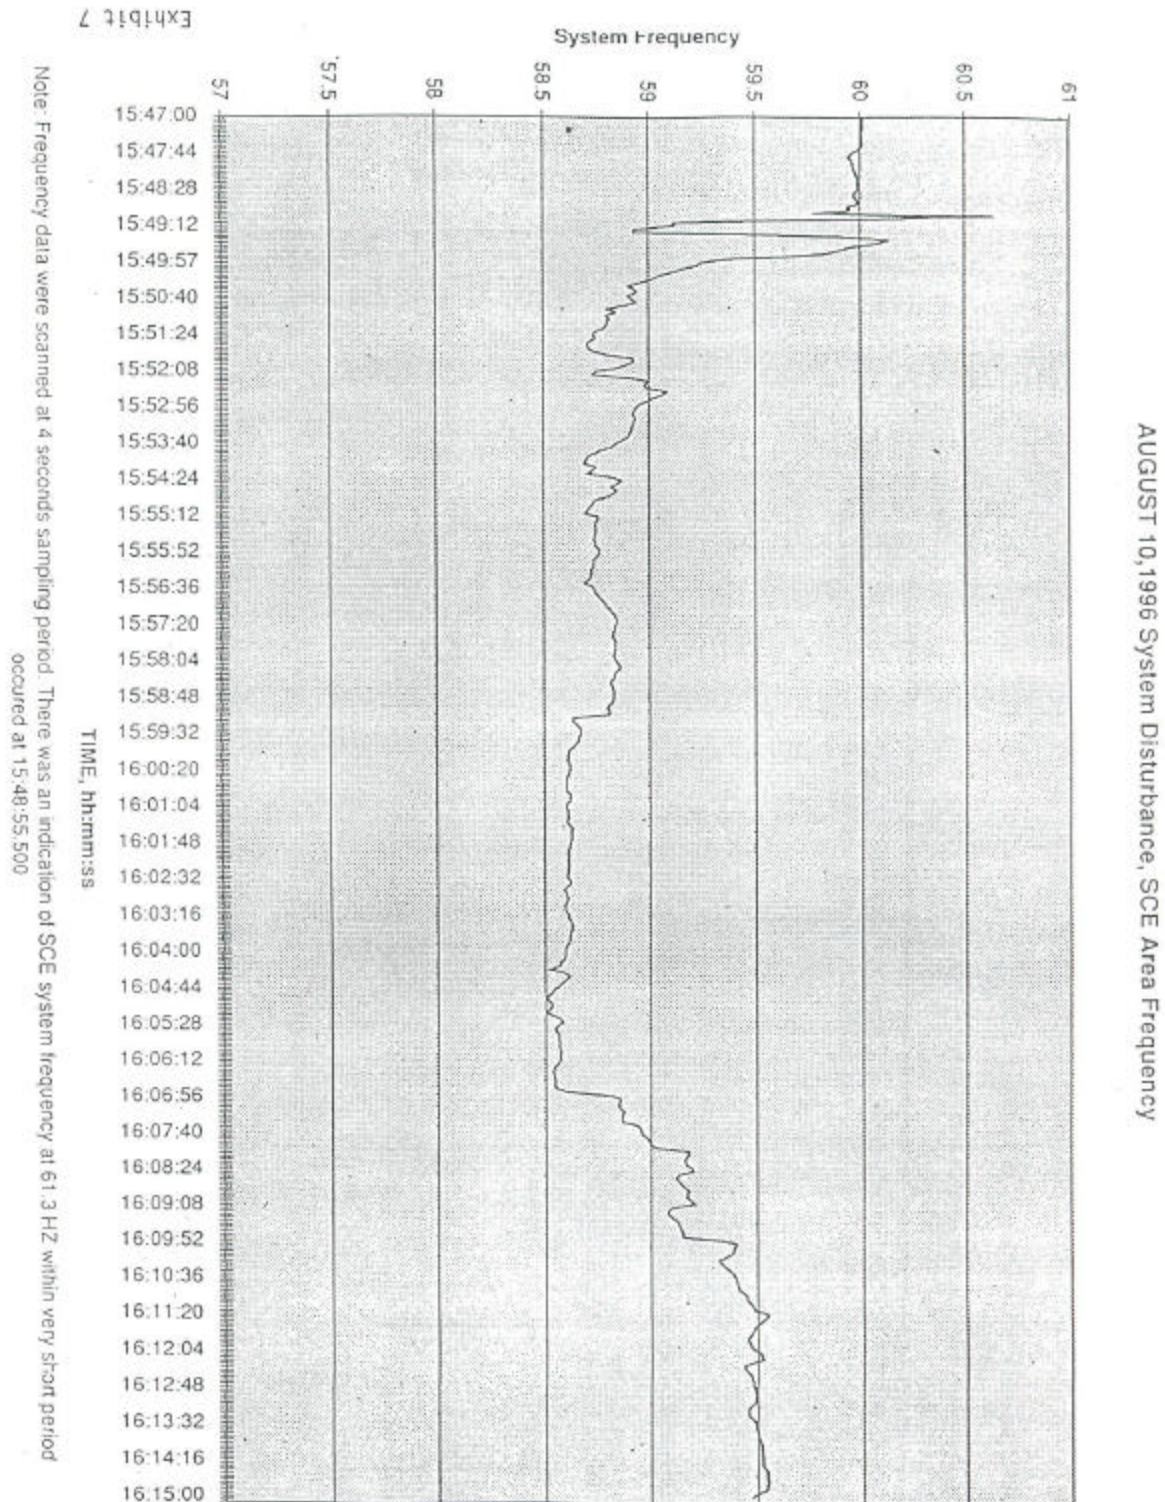
Figure 3

After the initial swing, when the frequency dropped to 58.5 Hz, frequency rapidly overshot to 60.7 Hz and fluctuated slightly above 60 Hz for more than three minutes (Figure 3). Some of Pacific Gas & Electric's (PG&E) demand that was automatically shed was automatically restored after three minutes. (The PG&E load shedding program is designed to restore customer demand in three to six minutes after frequency returns to near 60 Hz.) Over the next five minutes, as demand was automatically restored and additional generation was removed from service, frequency further declined to 58.3 Hz so that the demand that had been automatically restored was removed from service again. Frequency then returned to slightly above 59.0 Hz where it began to stabilize. At 1607, frequency returned to 59.5 Hz where it stayed for about 75 minutes. At 1722, PG&E dispatchers manually shed load to bring the frequency back to normal. The low frequency in the Northern California Island prevented its reconnection with the Northern Island. From 1722 to 1732, PG&E manually shed 2,524 MW of additional customer demand. This demand was restored by 2037.
