2023 Southwest Utah Disturbance

Southwestern Utah: April 10, 2023
Joint NERC and WECC Staff Report

August 2023

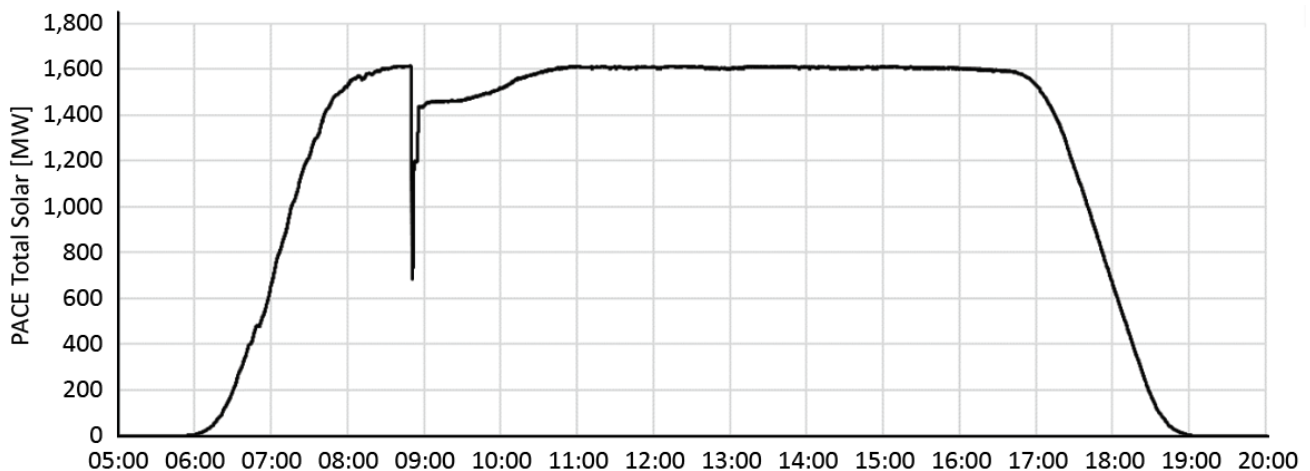
Figure I.1: PACE Solar PV Profile for April 10, 2023

Figure I.1 shows the total PACE solar PV profile for April 10. The disturbance occurred at 08:51 a.m. Pacific time, right about the time when aggregate solar PV output reached its peak for the day. Synchronous generation, wind, and solar PV resources comprised 42%, 31%, and 26% of total generation prior to the disturbance, respectively (see **Table I.1**).

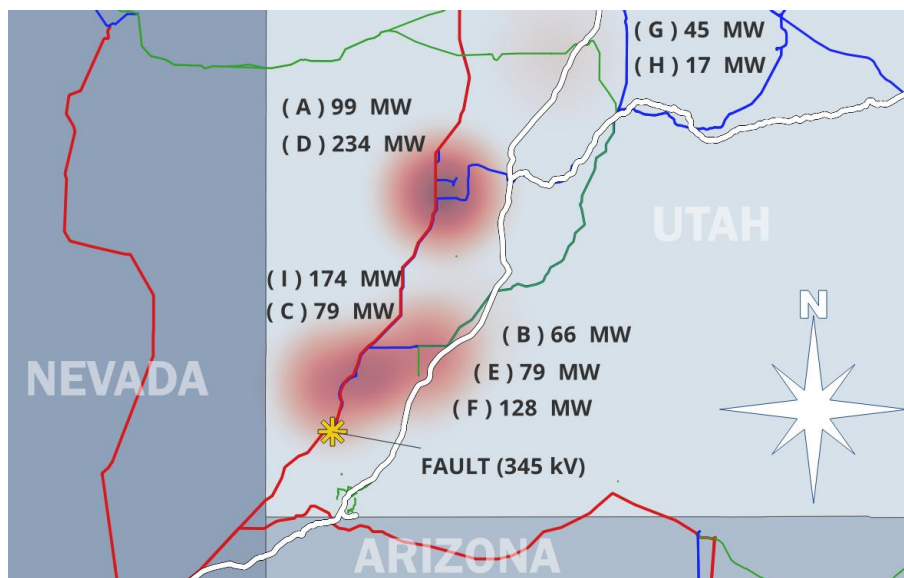
Figure I.3: Map of Fault Location and Affected Solar PV Facilities

At 08:51 Pacific time, a single-line-to-ground fault occurred on a 345 kV transmission circuit in the Southern Nevada/Southwest Utah area. Protective relaying cleared the fault normally in 3.5 cycles.⁸ While no generation tripped consequentially due to the transmission line outage, PACE supervisory control and data acquisition (SCADA) data⁹ shows that aggregate solar PV output in the PACE footprint dropped significantly (see [Figure I.2](#)). All affected solar PV facilities are located in the Southwest Utah area (see [Figure I.3](#)). The abnormal response from multiple facilities was caused by the protection and controls within each facility responding to the BPS fault in an unreliable manner. The loss of generation caused system frequency to fall from around 60.01 Hz to 59.89 Hz (see [Figure I.4](#)).

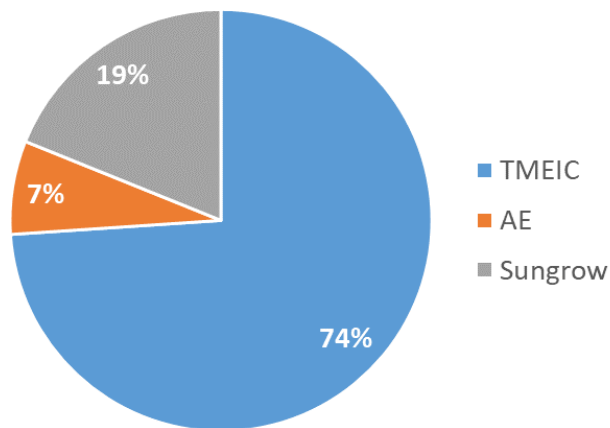
Figure 1.1: Share of Inverter OEMs at Affected Solar PV Facilities

The causes of abnormal active power reduction for each facility is listed in [Table 1.1](#), and [Figure 1.1](#) shows the inverter OEMs involved in this event. Multiple facilities tripped for several reasons, making attribution of active power reductions to specific causes difficult. Technical details are omitted in this report since the causes of reduction have been well-documented in past disturbance reports.¹⁰ The following are brief descriptions of the causes of tripping:
