2022 Odessa Disturbance

Overview, Key Findings, and Recommendations

Informational Webinar
January 4, 2023

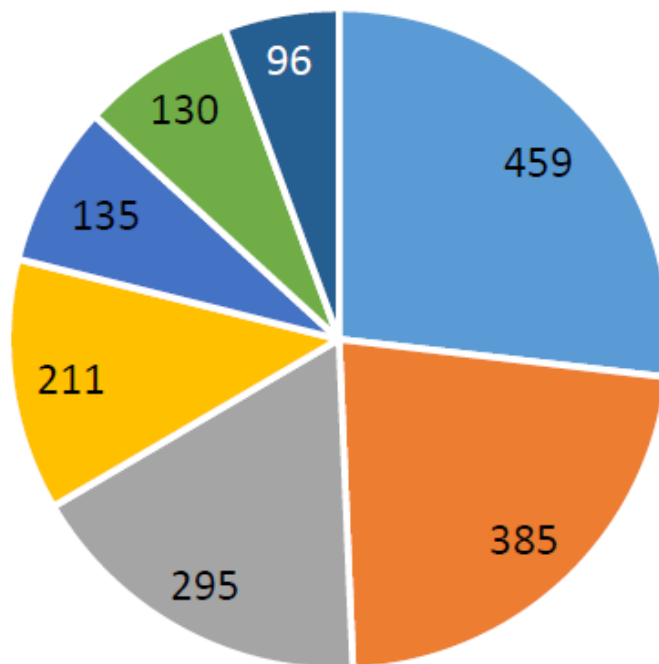
Cause of Solar PV Reduction

- Inverter AC Overcurrent
- Inverter AC Overvoltage
- Incorrect Ride-Through Configuration
- Unknown
- Inverter Phase Jump
- Inverter DC Voltage Imbalance
- Momentary Cessation/Power Supply

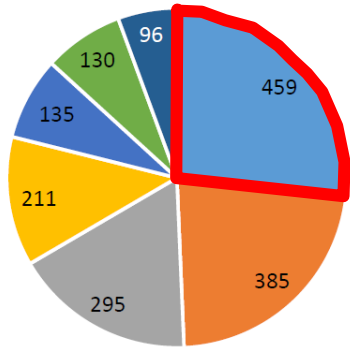
- Observed across three inverter manufacturers; tripping primarily one large manufacturer
- Caused by inverter controls during on-fault conditions
 - Inverter drives ac current over ratings and trips during fault
- Software algorithm developed to mitigate tripping
 - Modifies inverter switching logic during faults
 - Testing confirmed with hardware-in-the-loop testbed
- Requires inverter personnel on-site to modify inverter firmware and parameters
- Changes only being made to facilities that request the update
- Changes to EMT model will be needed to reflect updated inverter control strategy

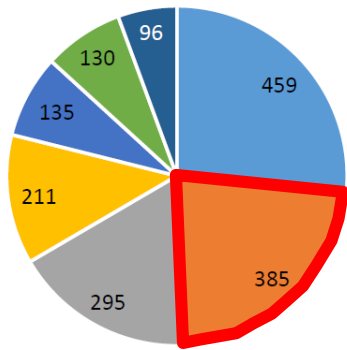
- Largest reduction in 2021 Odessa Disturbance = “PLL loss of synchronism tripping”
 - NERC guidance years before highlighted that changes in grid phase should not trip inverters
 - Inverter OEM determined it to be redundant to other protections; now disables PLL loss of synch protection by default
 - ERCOT has confirmed that updates have been made at all BPS-connected facilities of this manufacturer in their footprint; however, this protection may still be enabled in other existing inverters.
 - GOs will need to request disabling the protection to ensure ride-through during BPS faults.

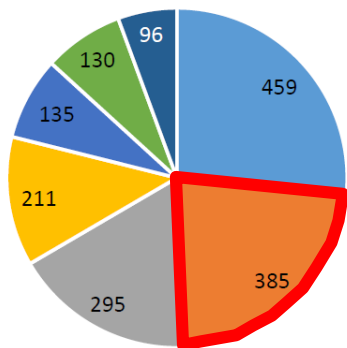
- “PLL loss of synch” tripping \neq “Phase jump” tripping
 - No inverters tripped on PLL loss of synch
 - Phase jump protection is form of passive anti-islanding, misinterpreting phase angle shift during faults as islanding
 - Compares angle diff between inverter voltage and current phasors; operates for a change larger than 15 degrees within 500 ms.
 - NERC guidance specifically states that passive anti-islanding protection should be disabled for all BPS-connected inverter-based resources
 - This inverter OEM has been installing inverters across North America with this form of protection enabled at the vast majority of BPS-connected facilities. Poses a relatively significant risk to BPS reliability – likely to misoperate for normal BPS faults.

- NERC, Texas RE, and ERCOT strongly recommended this protection be disabled at all BPS-connected solar PV facilities.
 - ERCOT corroborated this statement with local TOs to ensure they do not rely on this form of protection in any way
 - TOs also strongly recommended that this protection be disabled so as to not cause inadvertent tripping
- The inverter OEM has stated they will be disabling the passive anti-islanding protection upon request from GOs and will likely be disabling the protection as a default for future installations
 - Increased trip threshold in cases where entities keep it enabled

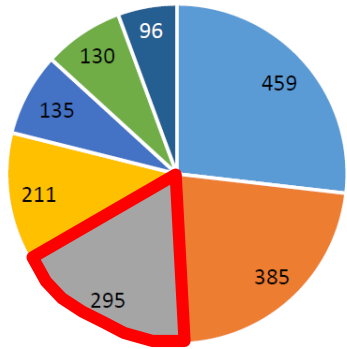
- Persistent, recurring cause of tripping for solar PV
- Overvoltage occurs at fault clearing
- Linked to inverter control strategy during and immediately following fault condition
 - Tripping set at 1.25 pu for 0.2 ms
- Inadequacies in PRC-024-3 to address this cause of tripping
 - Uses POI voltages; but no industry standard to translate POI voltages to inverter voltages during faults
 - Requires extensive EMT modeling and studies to identify risk

- Inverter OEM updated inverter protection settings to extend ac overvoltage protection
 - Changes to user-settable and OEM-settable settings
 - Updates require inverter OEM technician on-site
 - Protections should match actual equipment capabilities

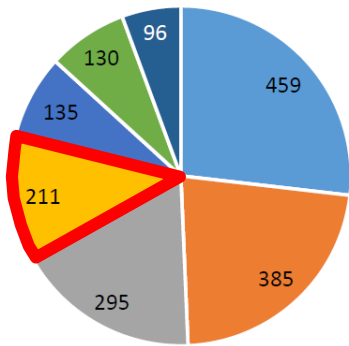
- Observed at three facilities, same OEM, different inverter models
 - Observed in California in 2021 for same types of inverters
- Occurs when voltage difference between positive and negative terminals on the inverter dc bus is measured ($|V(P) - V(N)| > \text{Threshold}$)
 - Unbalanced (negative sequence) voltage on ac side of inverter can cause a ripple on the dc bus that must be managed by inverter inner control loops
 - If inverter controls are not fast enough, dc-side ripple may surpass the trip threshold
- NERC and WECC identified that a firmware upgrade was available for existing solar PV facilities after the 2021 solar PV disturbances in California.

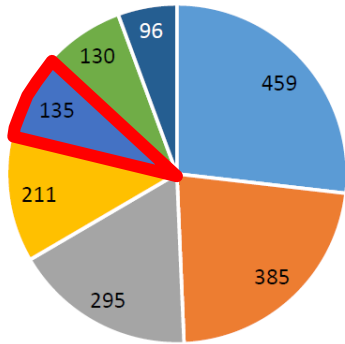
- One facility had all inverters misconfigured with low voltage ride through settings disabled.
 - Unable to provide active and reactive current/power during and immediately after fault events
- GO identified the misconfiguration during its investigation of the facility
- GO changed all inverters to a mode that allows for both active and reactive power injection during ride-through operation.

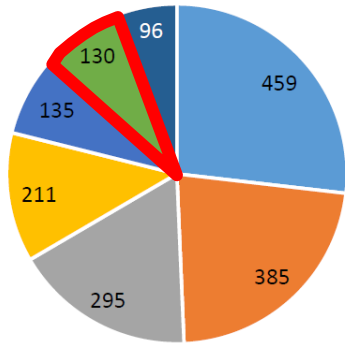
- One facility had momentary cessation enabled
- GO disabled momentary cessation for all inverters based on 2019 NERC alert
- However, inverters are not equipped with uninterruptible power supplies; rely on momentary cessation during low voltage conditions to avoid tripping (hardware limitation).
- Design choice leads to poor performance and lack of essential reliability services; should not be allowed
 - Not a legitimate reason for the facility to not be able to provide dynamic reactive power support

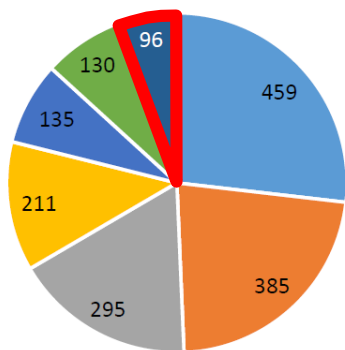
- Multiple solar PV facilities tripped for unknown reasons
- Attributed to issues including:
 - Inverter firmware issues
 - Inverter logs being overwritten
- No systemic causes of lack of data or information in this event
 - Majority of facilities have legacy KACO inverters (now out of business)
