Odessa Disturbance

NERC Event Analysis and Engineering

Industry Webinar – October 2021

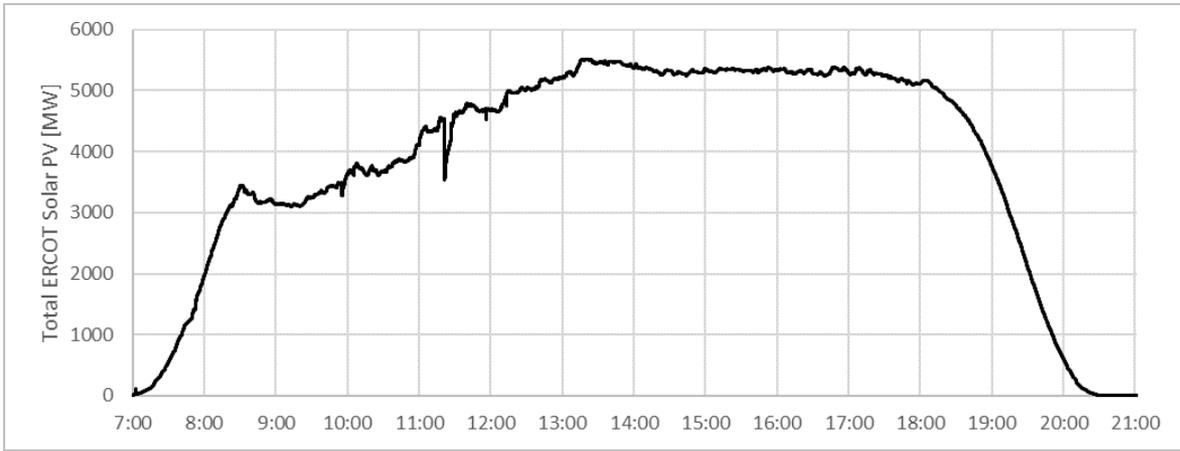
May 9 Solar PV Profile and Reduction

- Magnitude of reduction highlights importance of ensuring all BPS-connected inverter-based resources are operating in a manner that ensures reliable operation of the BPS
- **Time of Event:** 7,200 MW solar PV resources in ERCOT
 - Additional 790 MW in commissioning process
- **End of August:** 8,900 MW solar PV resources in the ERCOT
 - Additional 1,000 MW in commissioning process
- **Near Future:** 25,000 MW solar PV resources with signed interconnection agreements in ERCOT generation interconnection queue between now and 2023

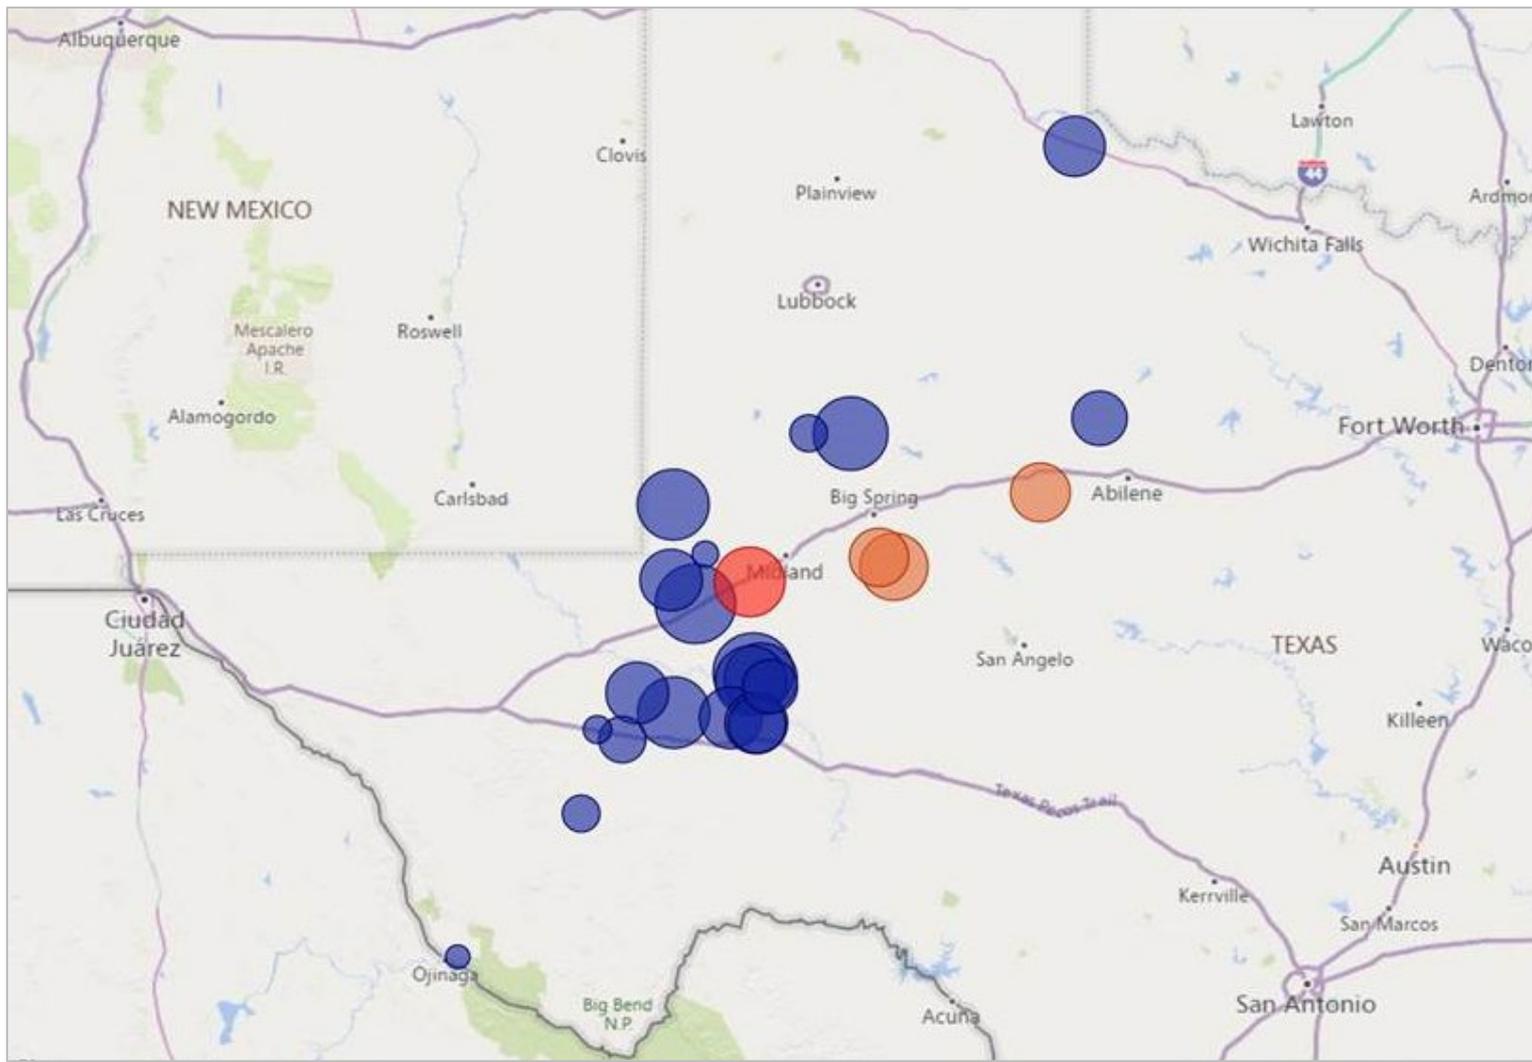
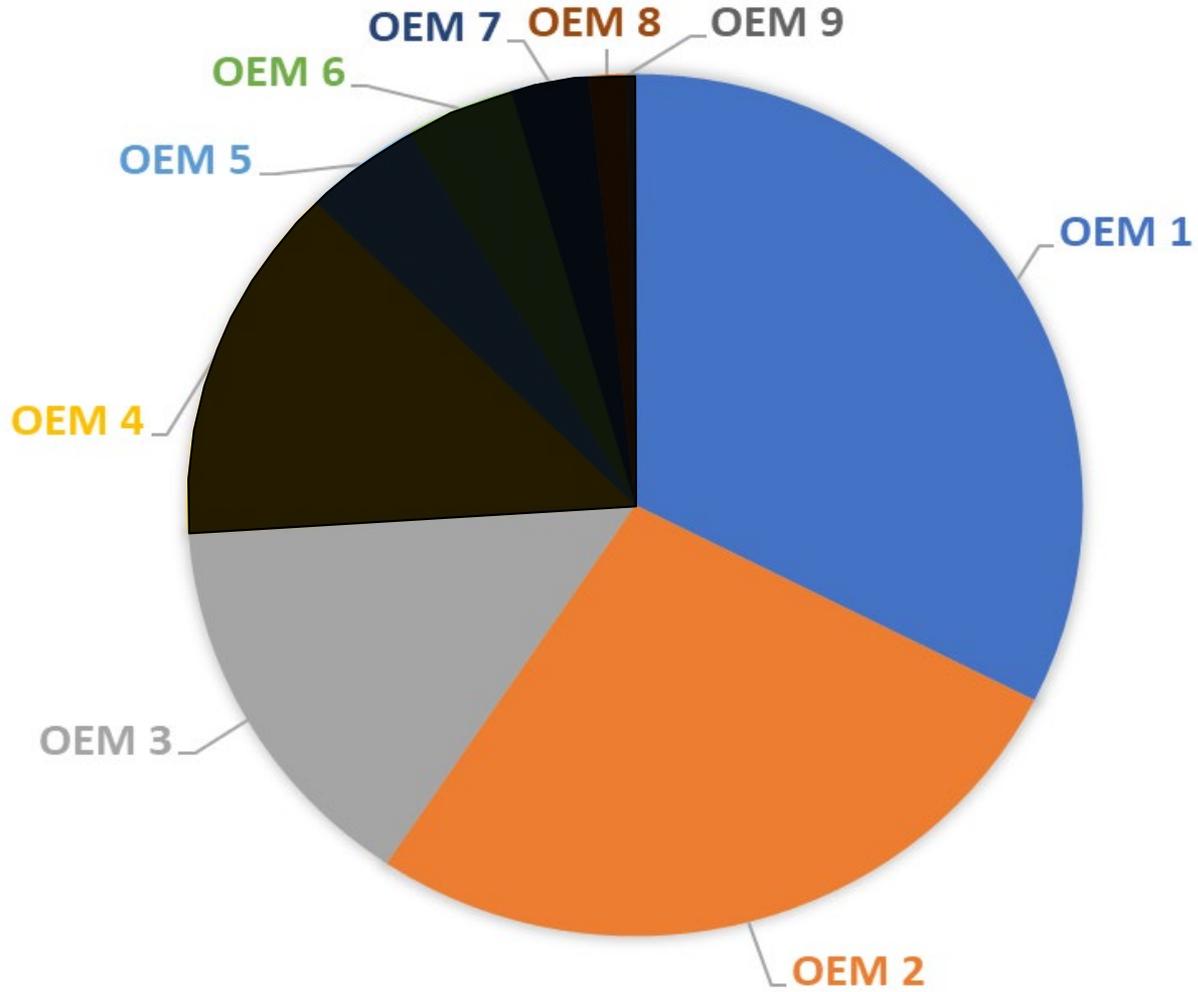
Fault Location and Affected Facilities

- 345 kV SLG fault (3 cycles)
 - Lightning arrester failure on GSU
- 1,340 MW loss of generation
 - 1,112 MW solar PV loss
 - 14 facilities (> 10 MW reduction)

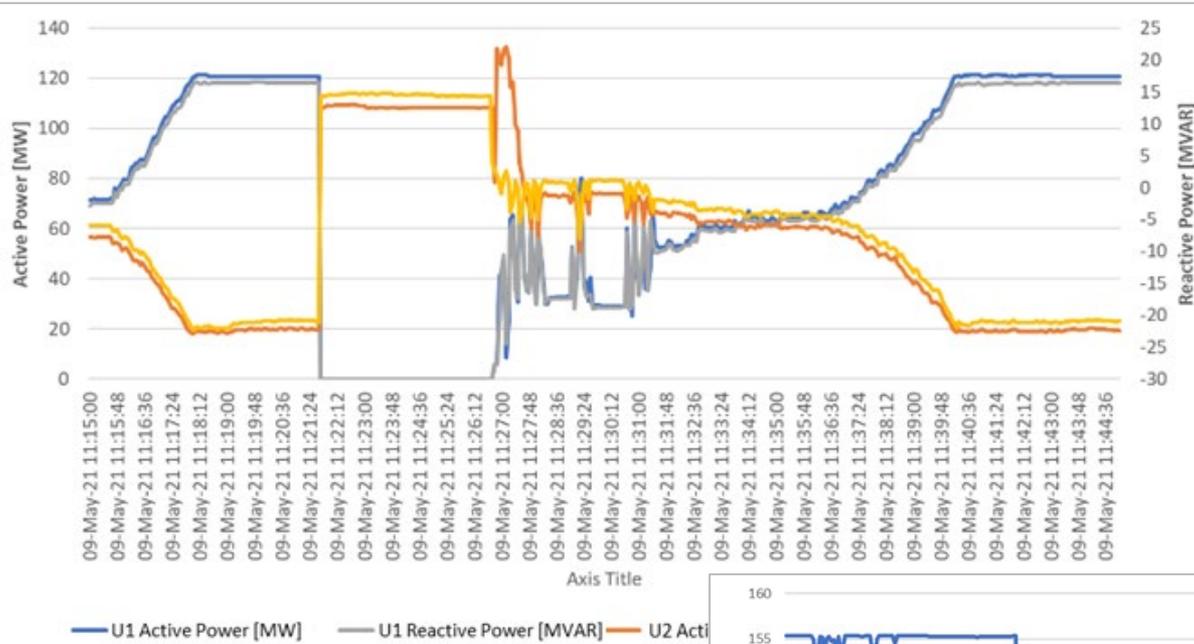
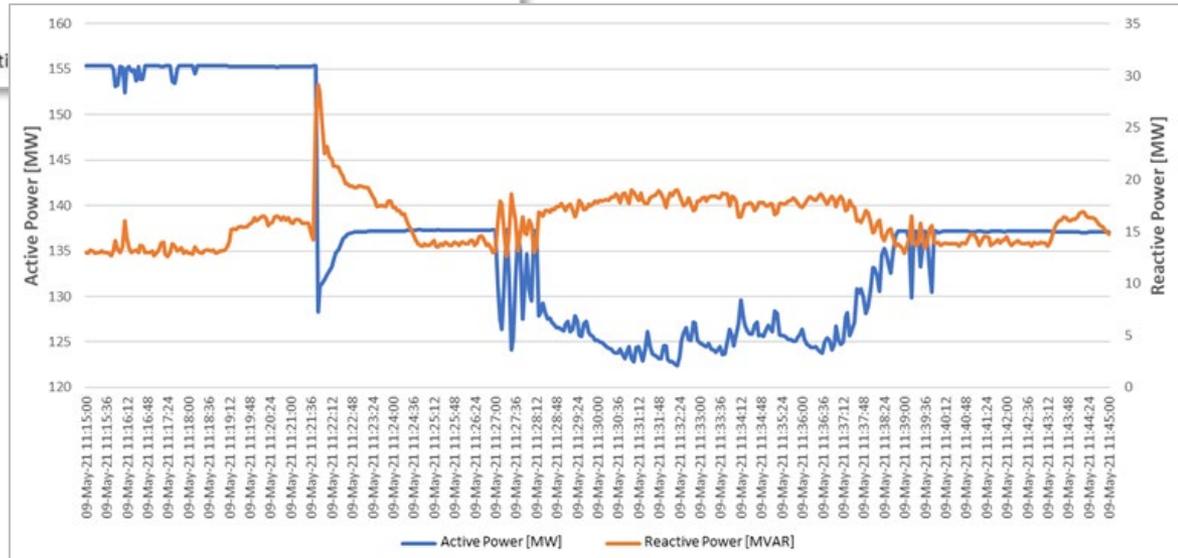
- Most commonly, solar PV facilities experiencing a “minor fault” event undergo a 5-min disconnection with automatic restart timer and ramp back to pre-disturbance levels

- 5-min restart observed across all solar PV disturbances analyzed by NERC
- In this event, some facilities experienced a trip and were able to return to service following the trip in a relatively short time period

- *“TOs, in coordination with their BA, should specify the expected performance of inverter-based resources following a tripping event. This may include automatic reconnection after a predefined period of time or may include manual reconnection by the BA. Ramp rates during return to service conditions should be specified as well...”*

- However, ERCOT has not implemented any return to service specification following the recommendations outlined in the NERC Reliability Guideline

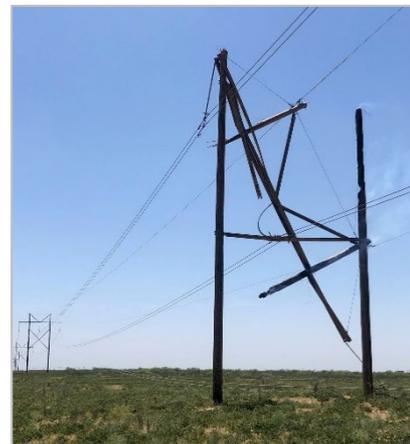
- 345 kV SLG fault (3.5–4 cycles)
- 518 MW solar PV loss
- 5 facilities (> 15 MW reduction)
