NORTH AMERICAN ELECTRIC RELIABILITY COUNCIL

Technical Analysis of the August 14, 2003, Blackout: *What Happened, Why, and What Did We Learn?*

**Report to the NERC Board of Trustees
by the NERC Steering Group**

July 13, 2004

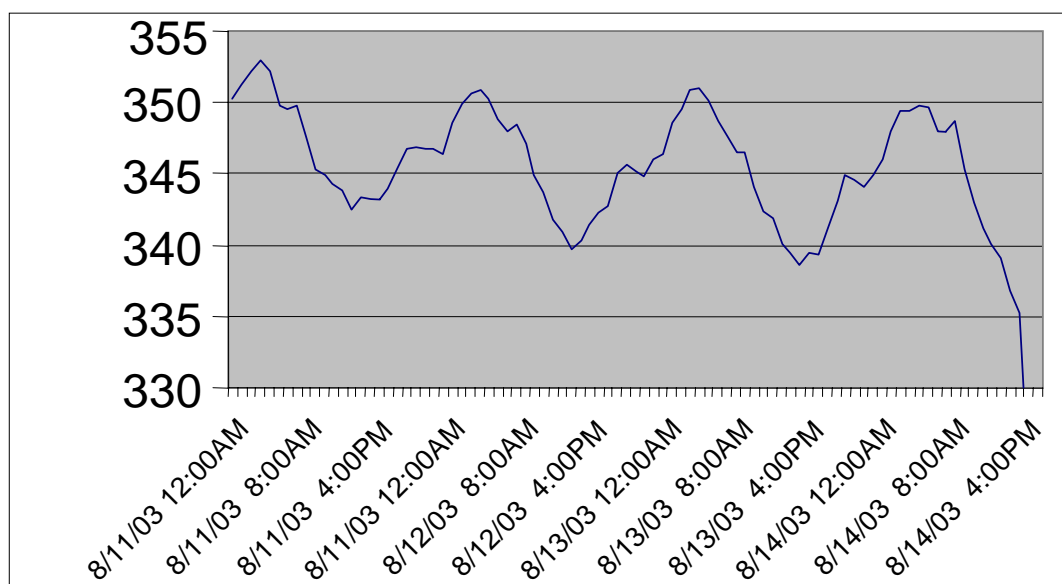
Figure II.6 — Representative Voltage Profile on FE System during Week of August 11

Unlike frequency, which is the same at any point in time across the interconnection, voltage varies by location and operators must monitor voltages continuously at key locations across their systems. During the days and hours leading up to the blackout, voltages were routinely depressed in a variety of locations in northern Ohio because of power transfers across the region, high air-conditioning demand, and other loads. During an interview, one FE operator stated, “some [voltage] sagging would be expected on a hot day, but on August 14 the voltages did seem unusually low.” However, as shown below in figures II.6 and II.7, actual measured voltage levels at key points on the FE transmission system on the morning of August 14 and up to 15:05 were within the range previously specified by FE as acceptable. Note, however, that most control areas in the Eastern Interconnection have set their low voltage limits at levels higher than those used by FE.

- The voltage profiles in both west-to-east and north-to-south directions display a dip at the center, with FE critical buses in the Cleveland-Akron area forming a low voltage cluster at Avon Lake, Harding, Juniper, Chamberlin, and Star.
- Voltages were observed to be higher in the portions of the FE control area outside of the Cleveland-Akron area. Voltages bordering FE in adjacent control areas were observed to be higher still. The bus voltages outside the Cleveland-Akron area are consistently higher during the period leading up to August 14.

- The bus voltages in the Cleveland-Akron area show a greater decline as the week progressed compared to buses outside this area.

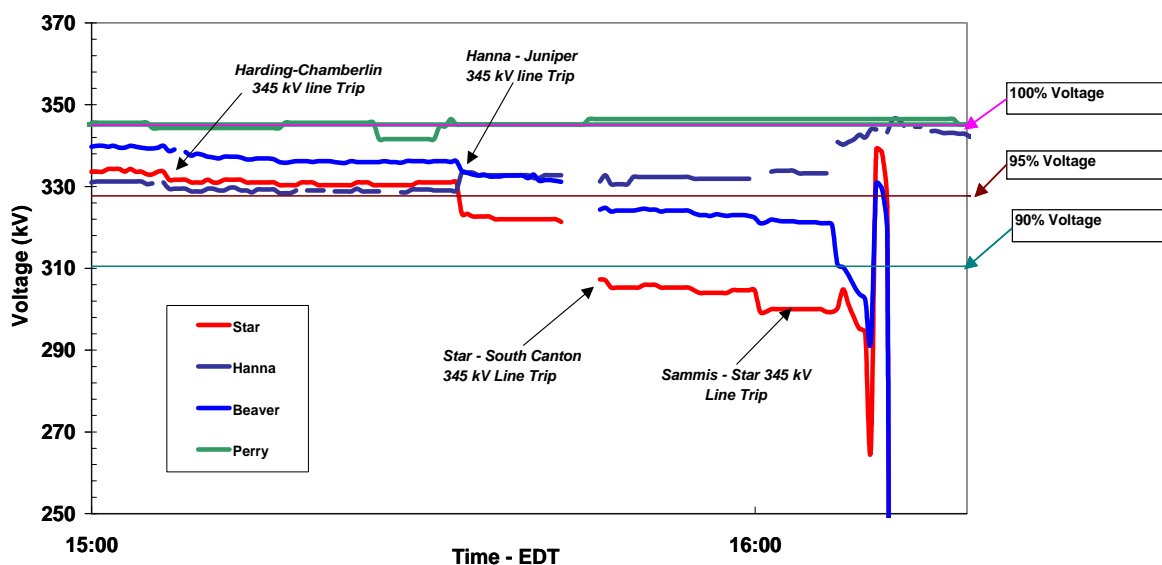
Figure II.7 — 345-kV Voltages in Northeastern Ohio on August 14, 2003

Low voltages were found in the Cleveland-Akron area operated by FE on August 14 prior to the blackout. These voltages placed the system at risk for voltage collapse. However, it can be said with certainty that low voltage or voltage collapse did not cause the August 14 blackout. P-Q and V-Q analysis by investigators determined that the FE system in northeastern Ohio was near a voltage collapse, but that events required to initiate a voltage collapse did not occur.

The existence of low voltages in northern Ohio is consistent with the patterns of power flow and composition of load on August 14. The power flow patterns for the region just before the Chamberlin-Harding line tripped at 15:05 show that FE was a major importer of power. Air-conditioning loads in the metropolitan areas around the southern end of Lake Erie were also consuming reactive power (Mvar). The net effect of the imports and load composition was to depress voltages in northern Ohio. Consistent with these observations, the analysis of reactive power flow shows that northern Ohio was a net importer of reactive power.

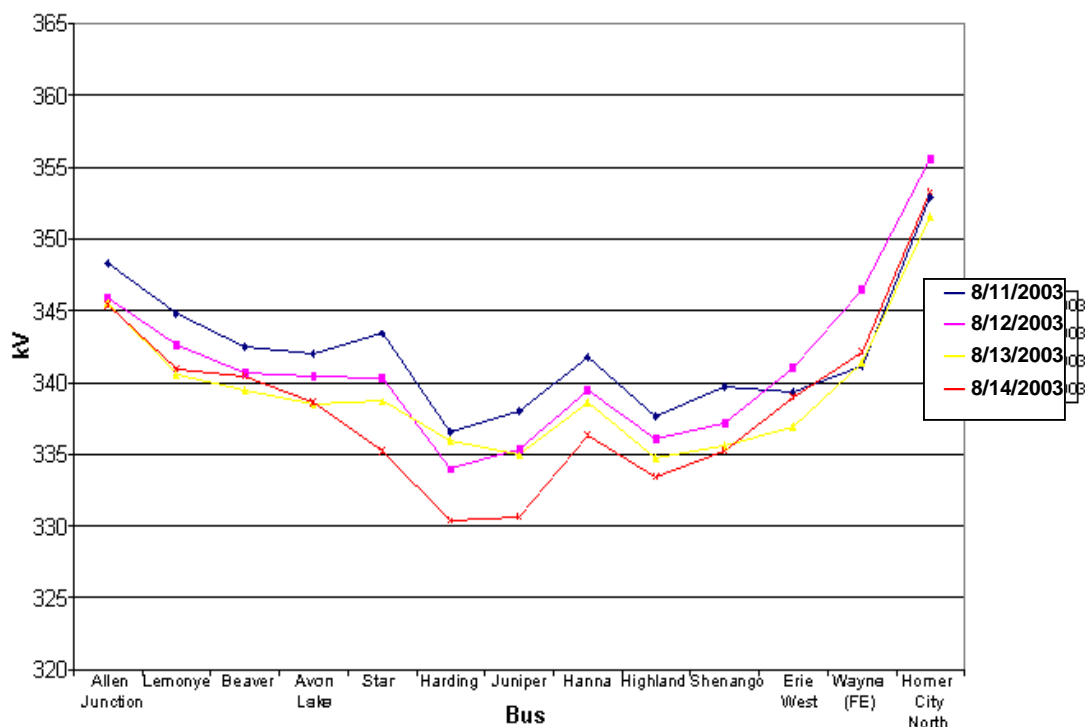
Figure II.8 — West-to-East Voltage Profile

Analysis showed that the declining voltages in the Cleveland-Akron area were strongly influenced by the increasing temperatures and loads in that area and minimally affected by transfers through FE to other systems. FE did not have sufficient reactive supply in the Cleveland-Akron area on August 14 to meet reactive power demands and maintain a safe margin from voltage collapse.

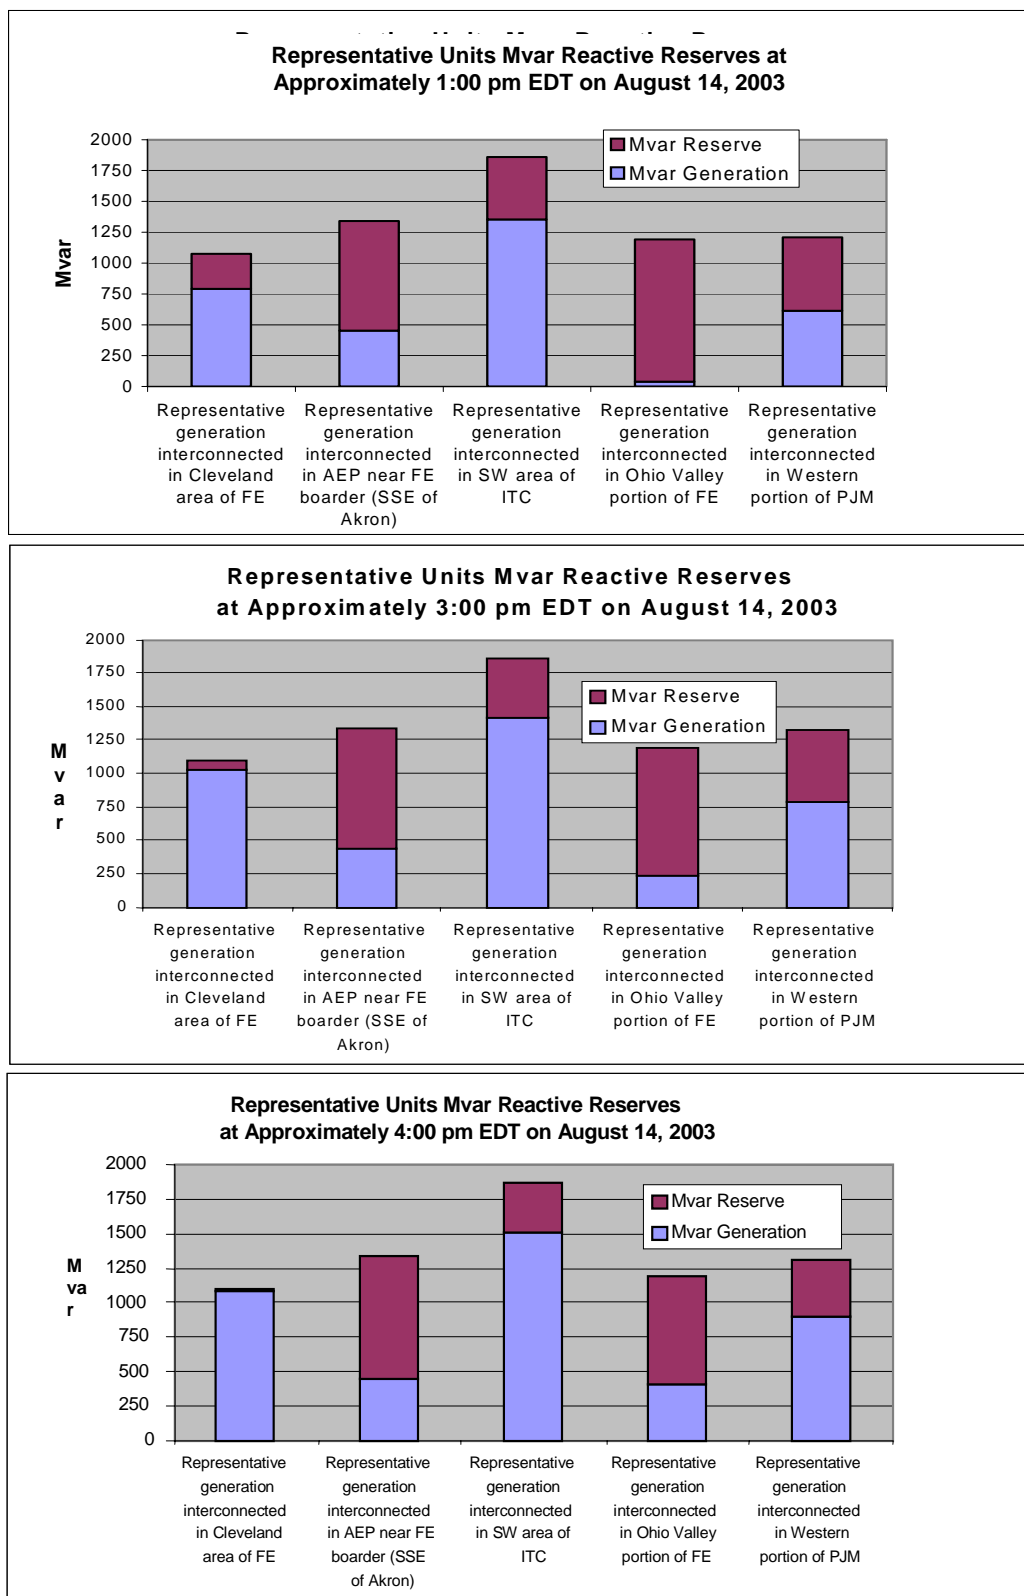
Figure II.10 — Reactive Reserves of Representative Groups of Generators on August 14, 2003

Figure II.10 shows the actual reactive power reserves from representative generators along the Lake Erie shore and in the Cleveland-Akron area for three time periods on August 14. It also shows the reactive power reserves from representative generators in AEP, MECS, and PJM that are located in the proximity of their interconnections with FE.

- The reactive reserves in the Cleveland-Akron area were progressively reduced as successive outages occurred on the afternoon of August 14. By 16:00, after numerous 138-kV line failures, the reserve margins in the Cleveland-Akron area were depleted.

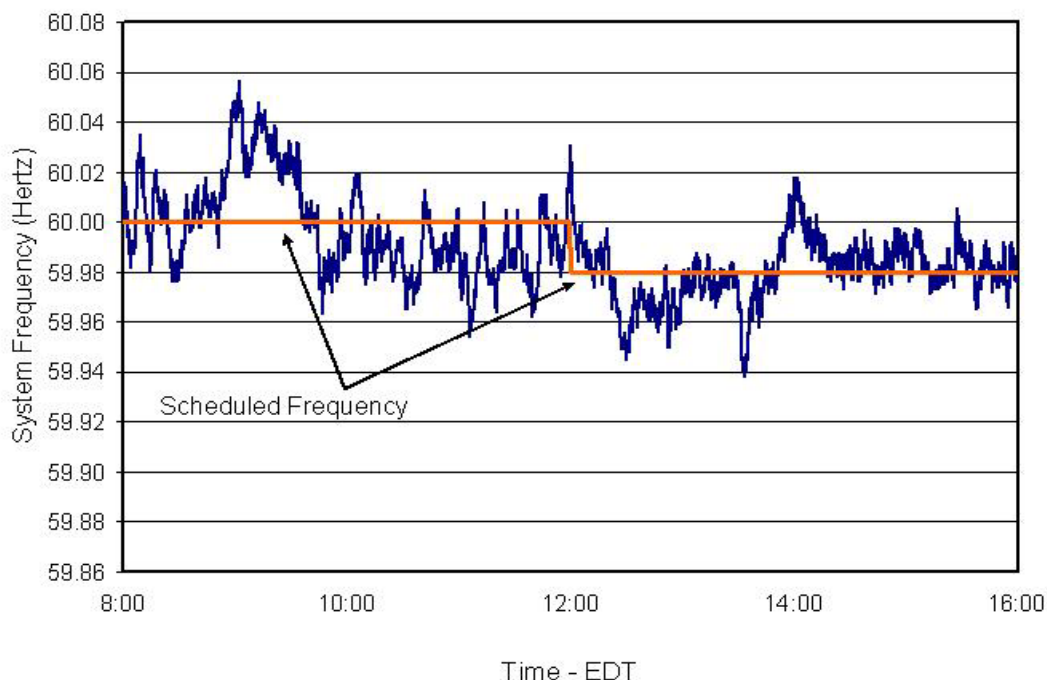
Figure II.11 — Eastern Interconnection Frequency Plot for August 14, 2003

Figure II.11 shows a plot of the frequency for the Eastern Interconnection on August 14. As is typical, frequency is highly random within a narrow band of several one hundredths of a hertz. Prior to the blackout, frequency was within the statistical bounds of a typical day. Scheduled frequency was lowered to 59.98 at noon to conduct a time error correction. This is a routine operation. After the blackout, the frequency was high and highly variable following the loss of exports to the Northeast. Also, there appears to be a pattern relating to the times during which frequency deviations are larger.

System frequency anomalies earlier in the day on August 14 are explained by previously known interchange scheduling issues and were not a precursor to the blackout. Although frequency was

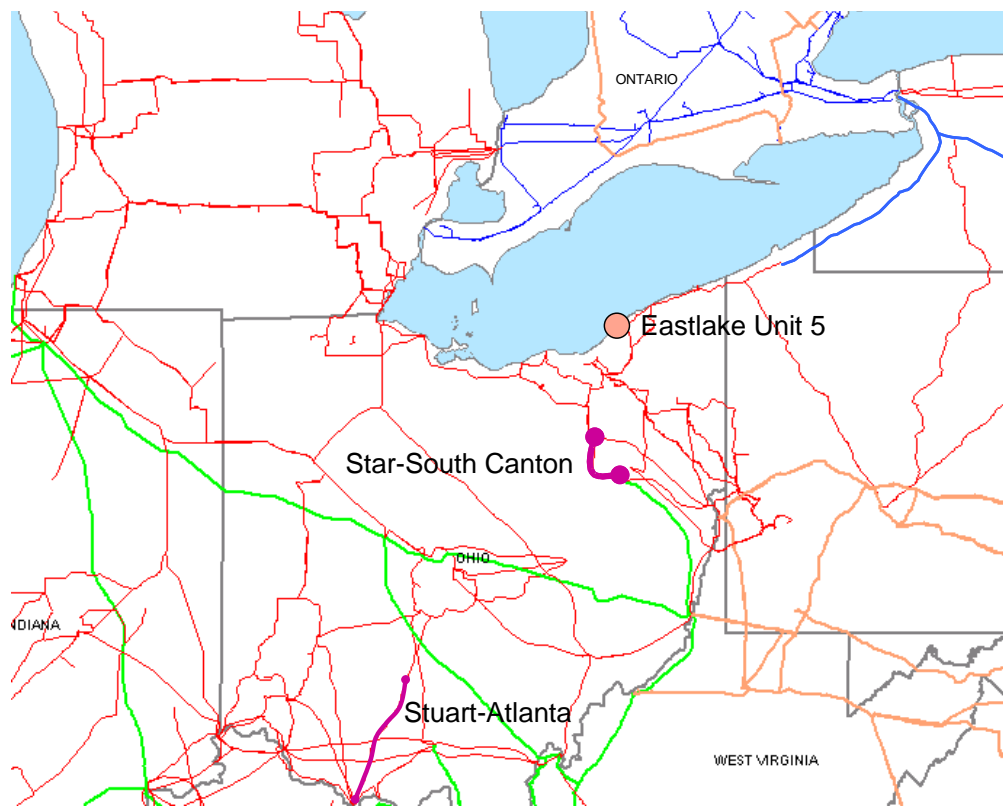
Figure III.2 — Initial Events

At 14:27:16, while loaded at about 54 percent of its emergency ampere rating, the Star-South Canton 345-kV tie line (between AEP and FE) tripped and successfully reclosed. The digital fault recorder indicated a solid Phase C-to-ground fault near the FE Star station. The South Canton substation produced an alarm in AEP's control room. However, due to the FE computer alarm system failure beginning at 14:14, the line trip and reclosure at FE Star substation were not alarmed at the FE control center. The FE operators had begun to lose situational awareness of events occurring on their system as early as 14:27, when the Star-South Canton line tripped momentarily and reclosed. Figure III.2 presents the initial events: the Eastlake 5 trip, the Stuart-Atlanta trip, and the Star-South Canton trip and reclose.

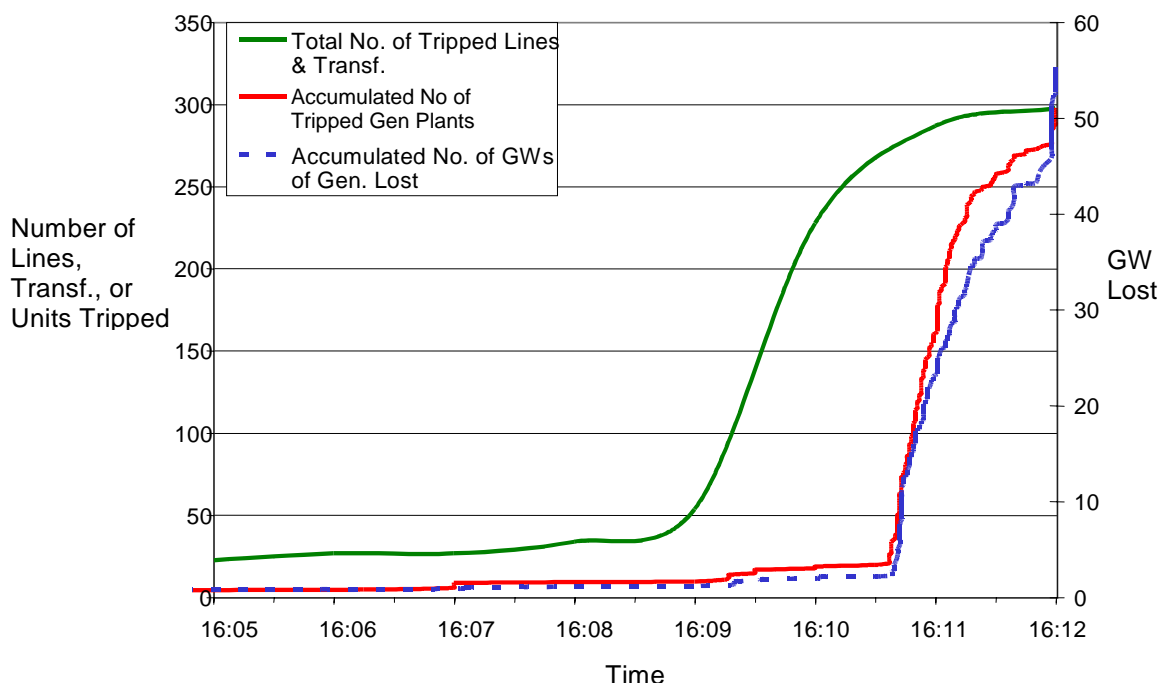
Figure IV.1 — Accumulated Line and Generator Trips During the Cascade

The events in the cascade started slowly, but spread quickly. Figure IV.1 illustrates how the number of lines and generators lost stayed relatively low during the Ohio phase of the blackout, but then picked up speed after 16:08:59. The cascade was complete only two-and-one-half minutes later.

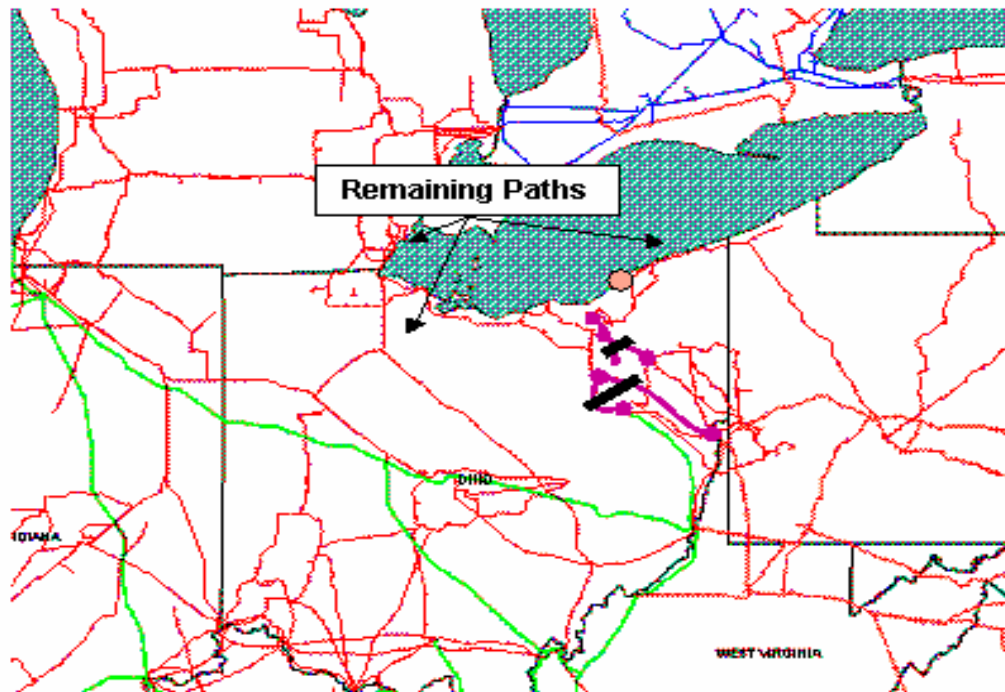
Figure IV.3 — Sammis-Star 345-kV Line Trip 16:05:57

After the loss of Sammis-Star and the underlying 138-kV system, there were no large capacity transmission lines left from the south to support the significant amount of load in northern Ohio (Figure IV.3). This overloaded the transmission paths west and northwest into Michigan, causing a sequential loss of lines and power plants.

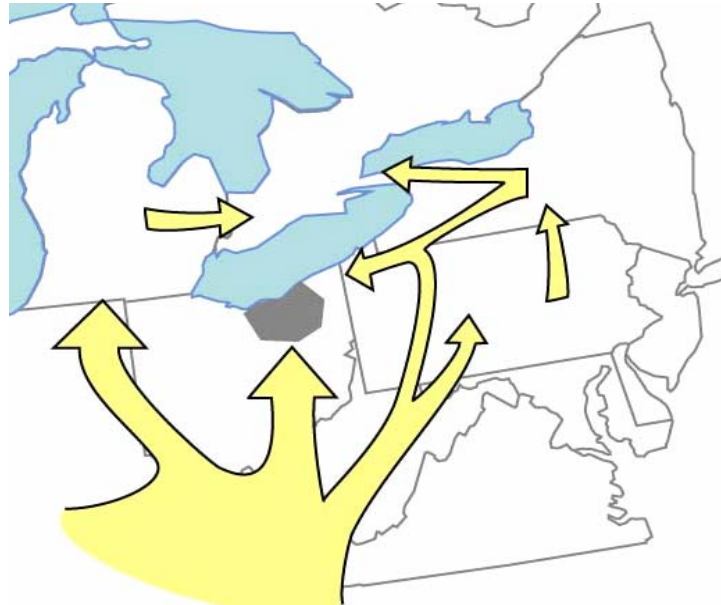
Figure IV.4 — Power Flows at 16:05:57, Prior to the Sammis-Star Trip

The Sammis-Star trip completely severed the 345-kV path into northern Ohio from southeastern Ohio, triggering a new, fast-paced sequence of 345-kV transmission line trips in which each line trip placed a greater flow burden on those lines remaining in service. These line outages left only three paths for power to flow into western Ohio: (1) from northwestern Pennsylvania to northern Ohio around the south shore of Lake Erie, (2) from southwestern Ohio toward northeastern Ohio, and (3) from eastern Michigan and Ontario. The line interruptions substantially weakened northeast Ohio as a source of power to eastern

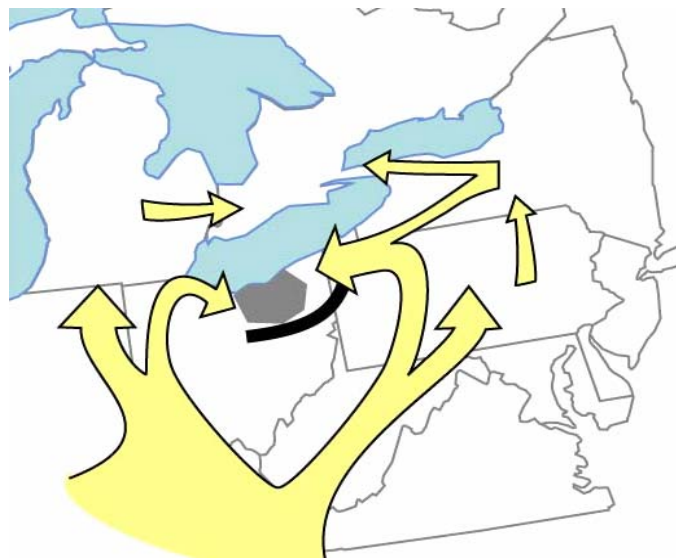
Figure IV.5 — Power Flows at 16:05:58, After the Sammis-Star Trip

Soon after the Sammis-Star trip, four of the five 48 MW Handsome Lake combustion turbines in western Pennsylvania tripped off-line. These units are connected to the 345-kV system by the Homer City-Wayne 345-kV line, and were operating that day as synchronous condensers to participate in PJM's spinning reserve market (not to provide voltage support). When Sammis-Star tripped and increased loadings on the local transmission system, the Handsome Lake units were close enough electrically to sense the impact and tripped off-line at 16:07:00 on under-voltage relay protection.

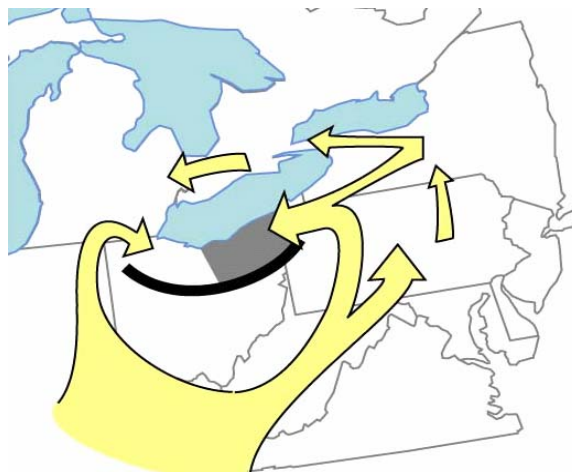
Figure IV.8 — Power Flows at 16:09:25

The tripping of the Galion-Ohio Central-Muskingum and East Lima-Fostoria Central transmission lines removed the transmission paths from southern and western Ohio into northern Ohio and eastern Michigan. Northern Ohio was connected to eastern Michigan by only three 345-kV transmission lines near the southwestern bend of Lake Erie. Thus, the combined northern Ohio and eastern Michigan load centers were left connected to the rest of the grid only by: (1) transmission lines eastward from northeastern Ohio to northwestern Pennsylvania along the southern shore of Lake Erie, and (2) westward by lines west and northwest of Detroit, Michigan, and from Michigan into Ontario (Figure IV.8).

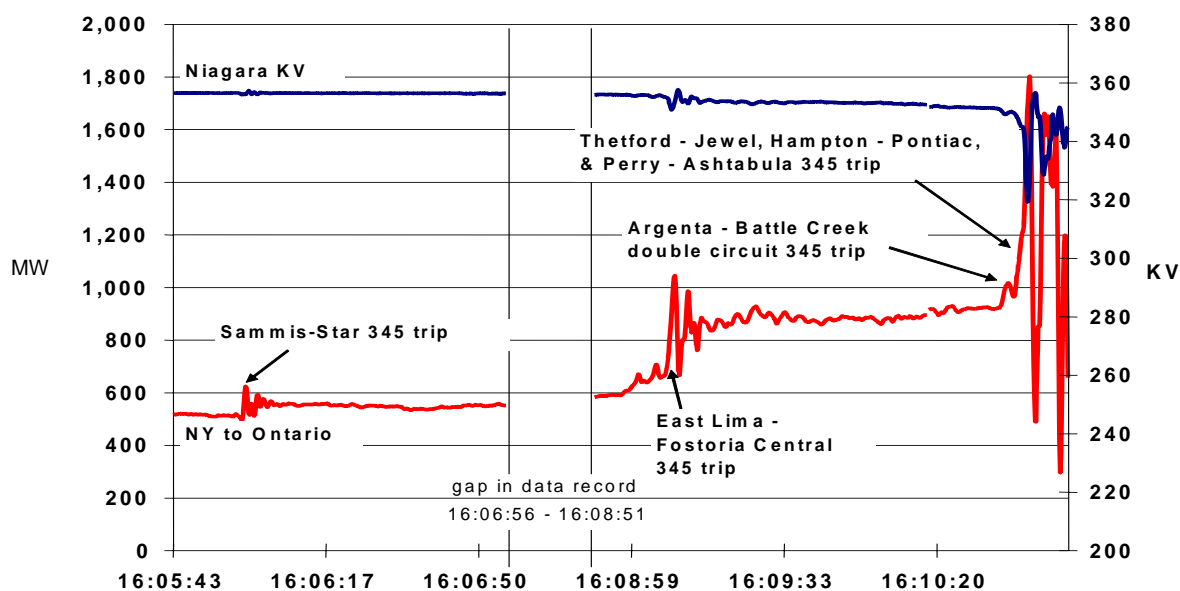
Figure IV.9 — New York-Ontario Line Flows at Niagara

Figure IV.9 shows voltage levels recorded in the Niagara area. It shows that voltage levels remained stable until about 16:10:30, despite significant power fluctuations. In the cascade that followed, the voltage instability was a companion to, not a driver of, the angular instability that tripped generators and lines. A high-speed recording of 345-kV flows at Niagara Falls taken by the Hydro One recorders (shown as the lower plot in Figure IV.9), shows the impact of the East Lima-Fostoria Central and the New York-to-Ontario power swing, which continued to oscillate for more than ten seconds. Looking at the MW flow plot, it is clear that when Sammis-Star tripped, the system experienced oscillations that quickly damped out and rebalanced. But East Lima-Fostoria triggered significantly greater oscillations that worsened in magnitude for several cycles, and then dampened more slowly but continued to oscillate until the Argenta-Battle Creek trip 90 seconds later. Voltages also began to decline at that time.

The far right side of Figure IV.9 shows the fluctuations in flows and voltages at the New York-Ontario Niagara border triggered by the trips of the Argenta-Battle Creek, Argenta-Tompkins, Hampton-Pontiac, and Thetford-Jewell 345-kV lines in Michigan, and the Erie West-Ashtabula-Perry 345-kV line linking the Cleveland area to Pennsylvania. Farther south, the very low voltages on the northern Ohio transmission system made it difficult for the generation in the Cleveland and Lake Erie area to remain synchronous with southeast Michigan. Over the next two minutes, generators in this area shut down after reaching a point of no recovery as the stress level across the remaining ties became excessive.

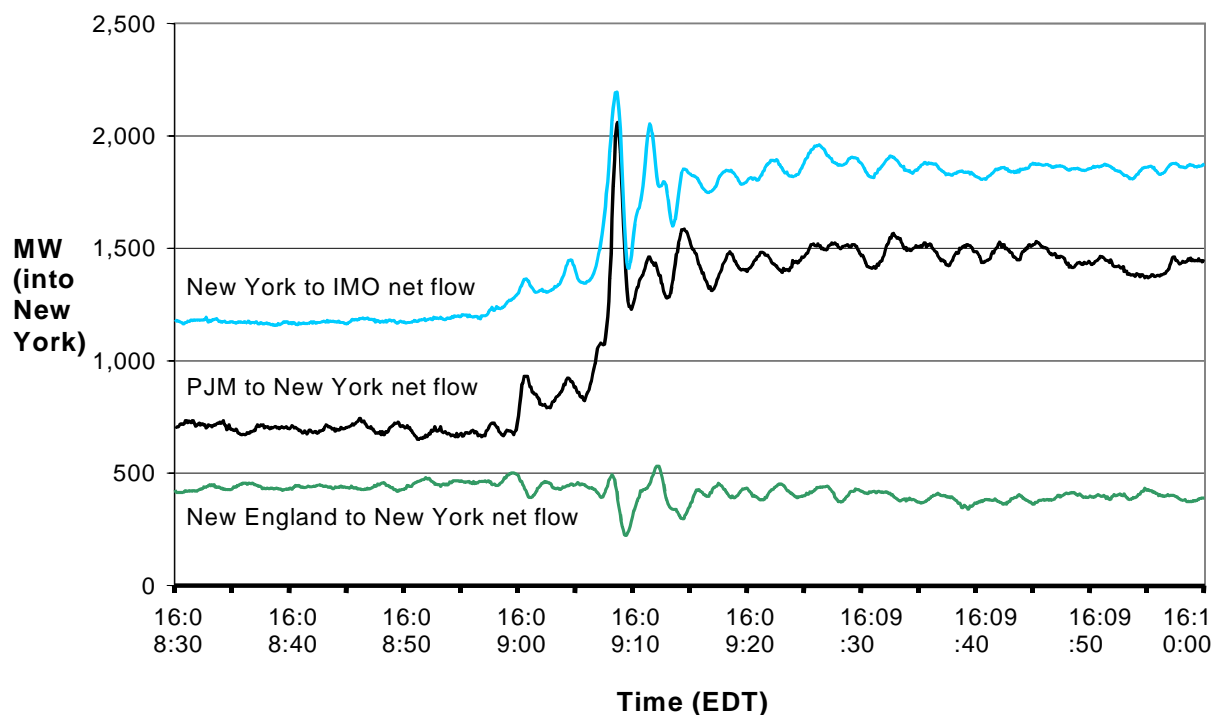
Figure IV.10 — First Power Swing has Varying Impacts on New York Interfaces

Figure IV.10, showing metered power flows along the New York interfaces, documents how the flows heading north and west toward Detroit and Cleveland varied at three different New York interfaces. Beginning at 16:09:05, power flows jumped simultaneously across all three interfaces; but when the first power surge peaked at 16:09:09, the change in flow was highest on the PJM interface and lowest on the New England interface. Power flows increased significantly on the PJM-New York and New York-Ontario interfaces because of the redistribution of flow around Lake Erie to serve the loads in northern Ohio and eastern Michigan. The New England and Maritimes systems maintained the same generation-to-load balance and did not carry the redistributed flows because they were not in the direct path of the flows. Therefore, the New England-New York interface flows showed little response.

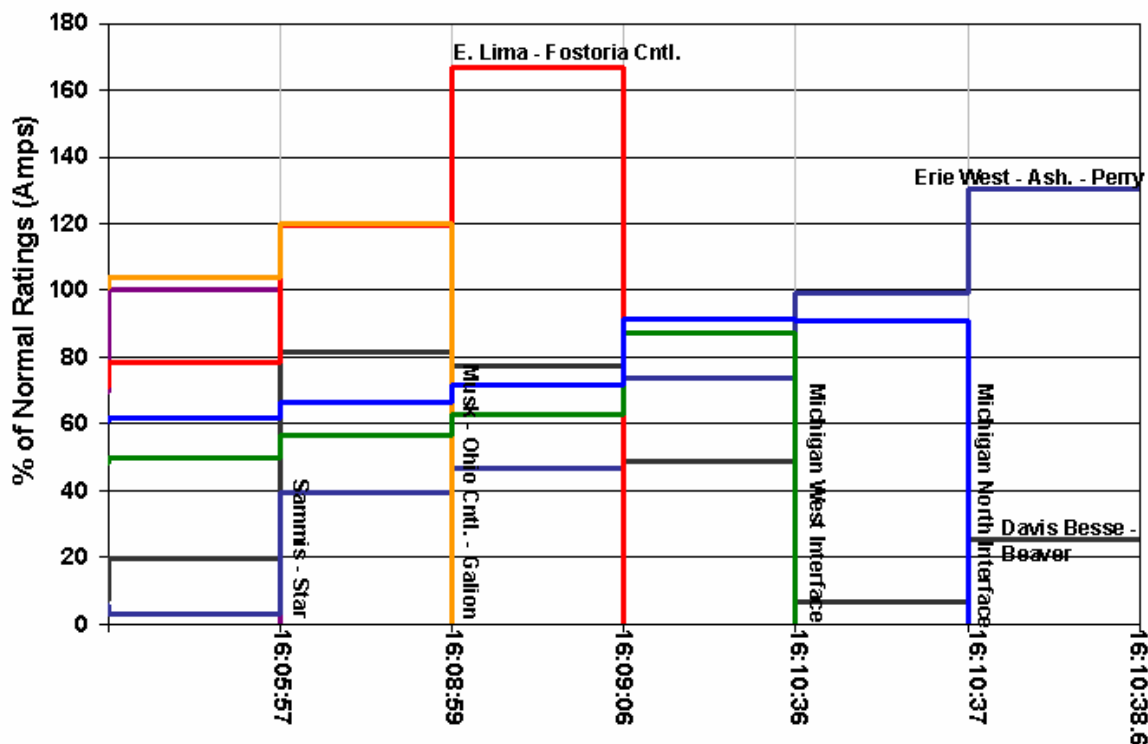
Figure IV.15a — Simulated 345-kV Line Loadings From 16:05:57 Through 16:10:38.6

Figure IV.15a shows the results of modeling of line loadings on the Ohio, Michigan, and other regional interfaces for the period between 16:05:57 until the Thetford-Jewell trip; this helps to illustrate how power flows shifted during this period. Evolving system conditions were modeled for August 14, based on the 16:05:50 power flow case developed by the MAAC-ECAR-NPCC Operations Studies Working Group. Each horizontal line in the graph indicates a single or set of 345-kV lines and their loading as a function of normal ratings over time as first one, then another, set of circuits tripped out of service. In general, each subsequent line trip causes the remaining line loadings to rise. Note that Muskingum and East Lima-Fostoria Central were overloaded before they tripped, but the Michigan west and north interfaces were not overloaded before they tripped. Erie West-Ashtabula-Perry was loaded to 130 percent after the Hampton-Pontiac and Thetford-Jewell trips.

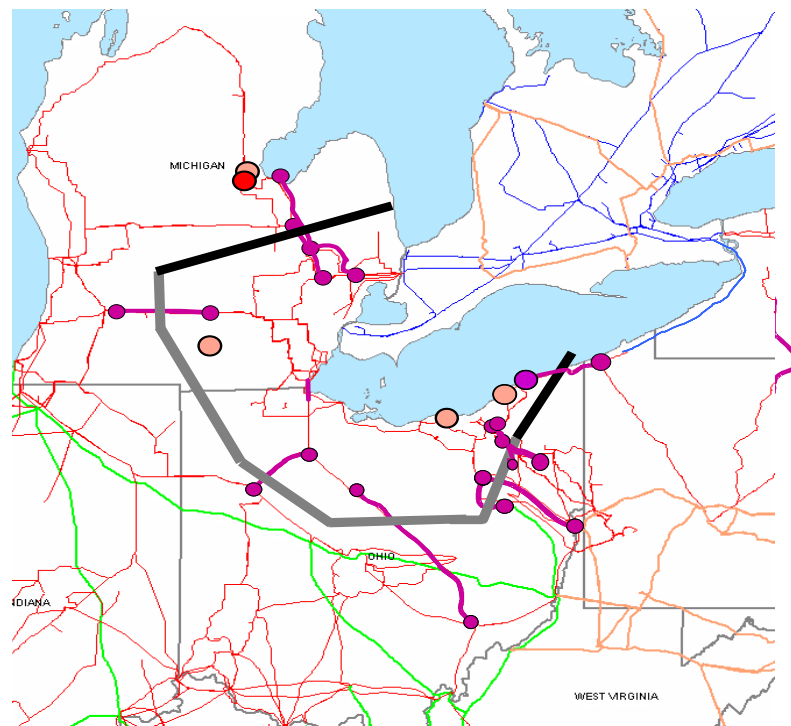
Figure IV.16 — Michigan Lines Trip and Ohio Separates From Pennsylvania, 16:10:36 to 16:10:38.6

Perry-Ashtabula was the last 345-kV line connecting northern Ohio to the east along the southern shore of Lake Erie. This line tripped at the Perry substation on a zone 3 relay operation and separated the northern Ohio 345-kV transmission system from Pennsylvania and all 345-kV connections. After this trip, the load centers in eastern Michigan and northern Ohio (Detroit, Cleveland, and Akron) remained connected to the rest of the Eastern Interconnection only to the north of Lake Erie at the interface between the Michigan and Ontario systems (Figure IV.16). Eastern Michigan and northern Ohio now had little internal generation left and voltage was declining. The frequency in the Cleveland area dropped rapidly, and between 16:10:39 and 16:10:50, underfrequency load shedding in the Cleveland area interrupted about 1,750 MW of load. However, the load shedding was not enough to reach a balance with local generation and arrest the frequency decline. The still-heavy loads in Detroit and Cleveland drew power over the only major transmission path remaining: the lines from eastern Michigan east into Ontario.

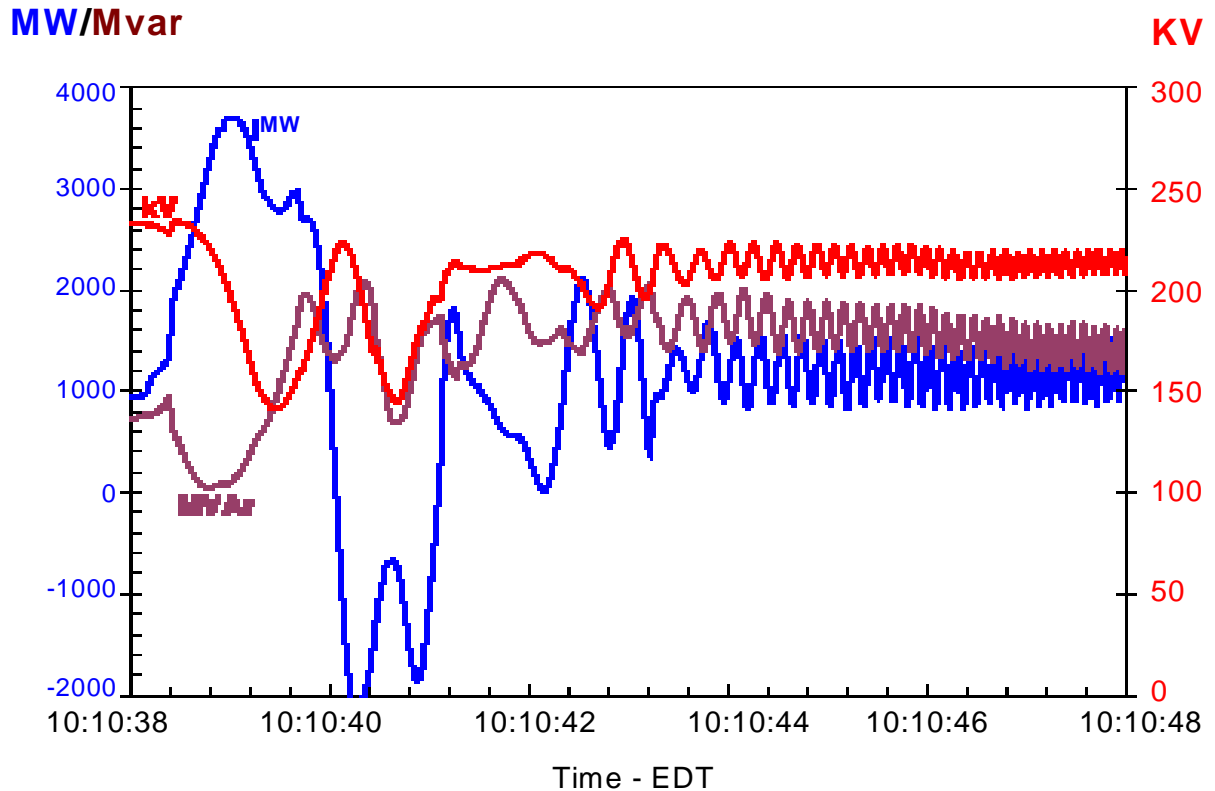
Figure IV.17 — Real and Reactive Power and Voltage From Ontario Into Michigan

At 16:10:38.6, after the 345-kV transmission paths in Michigan and Ohio tripped, the power that had been flowing at modest levels into Michigan from Ontario suddenly jumped in magnitude. While flows from Ontario into Michigan had been in the 250 to 350 MW range since 16:10:09.06, with this new surge the

flows peaked at 3,700 MW at 16:10:39 (Figure IV.17). Electricity moved along a giant loop from the rest of the Eastern Interconnection through Pennsylvania and into New York and Ontario, and then into Michigan via the remaining transmission path to serve the combined loads of Cleveland, Toledo, and Detroit (Figure IV.18). This sudden large change in power flows lowered voltages and increased current levels on the transmission lines along the Pennsylvania-New York transmission interface.

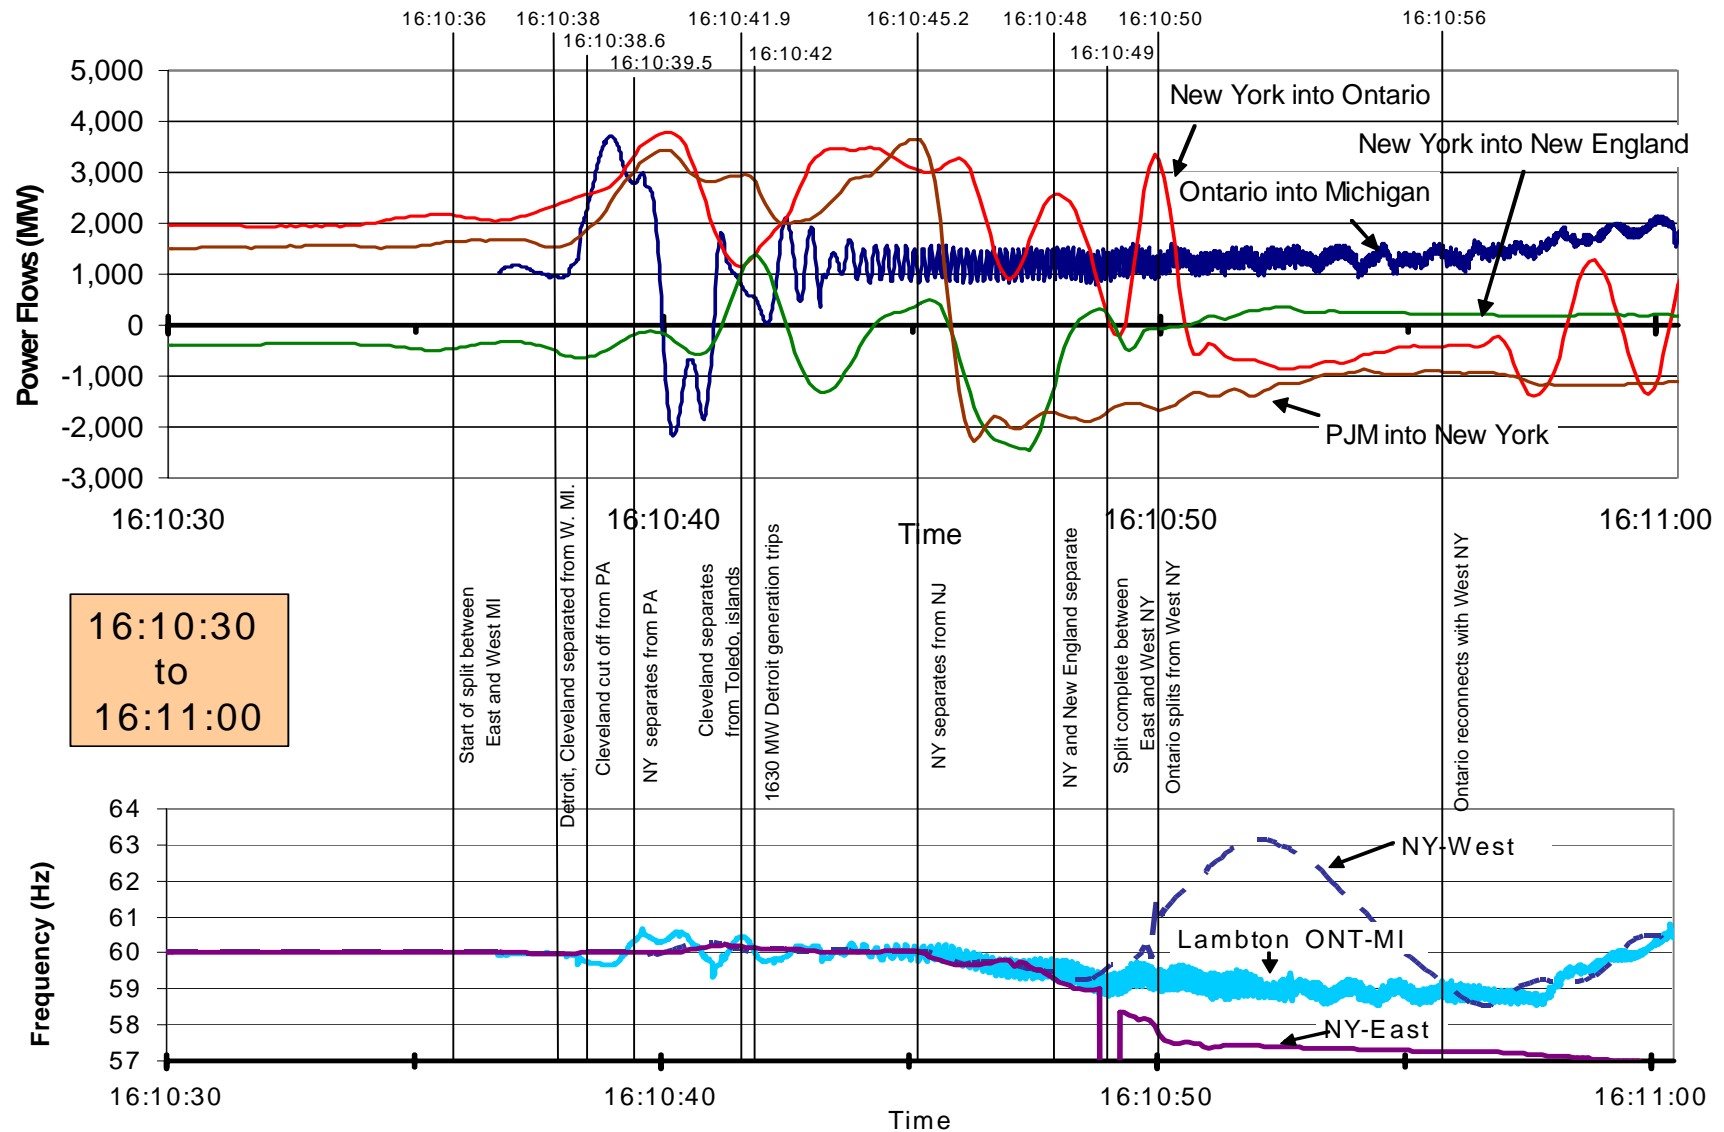
Figure IV.19 — Measured Power Flows and Frequency Across Regional Interfaces, 16:10:30 to 16:11:00, With Key Events in the Cascade

Because the demand for power in Michigan, Ohio, and Ontario was drawing on lines through New York and Pennsylvania, heavy power flows were moving northward from New Jersey over the New York tie lines to meet those power demands, exacerbating the power swing. Figure IV.19 shows actual net line flows summed across the interfaces between the main regions affected by these swings: Ontario into Michigan, New York into Ontario, New York into New England, and PJM into New York. This shows that the power swings did not move in unison across every interface at every moment, but varied in magnitude and direction. This occurred for two reasons. First, the availability of lines across each interface varied over time, as did the amount of load that drew upon each interface, so net flows across each interface were not facing consistent demand with consistent capability as the cascade progressed. Second, the speed and magnitude of the swing was moderated by the inertia, reactive power capabilities, loading conditions, and locations of the generators across the entire region.

After Cleveland was cut off from Pennsylvania and eastern power sources, Figure IV.19 also shows the start of the dynamic power swing at 16:10:38.6. Because the loads of Cleveland, Toledo, and Detroit (less the load already blacked out) were now served through Michigan and Ontario, this forced a large shift in power flows to meet that demand. As noted above, flows from Ontario into Michigan increased from 1,000 MW to a peak of 3,700 MW shortly after the start of the swing, while flows from PJM into New York were close behind (Figure IV.20). But within one second after the peak of the swing, at 16:10:40, flows reversed and flowed back from Michigan into Ontario at the same time that frequency at the interface dropped (Figure IV.21). The large load and imports into northern Ohio were losing synchronism with southeastern Michigan. Flows that had been westbound across the Ontario-Michigan interface by more than 3,700 MW at 16:10:38.8 reversed to 2,100 MW eastbound by 16:10:40, and then returned westbound starting at 16:10:40.5.

Re-examination of Figure IV.19 shows the power swing from the northeast through Ontario into Michigan and northern Ohio that began at 16:10:37, and how it reverses and swings back around Lake Erie at 16:10:39. That return was caused by the combination of natural oscillation accelerated by major load losses, as the northern Ohio system disconnected from Michigan. It caused a power flow change of 5,800 MW, from 3,700 MW westbound to 2,100 eastbound across the Ontario-to-Michigan border between 16:10:39.5 and 16:10:40. Since the system was now fully dynamic, this large oscillation eastbound would lead naturally to a rebound, which began at 16:10:40 with an inflection point reflecting generation shifts between Michigan and Ontario and additional line losses in Michigan.

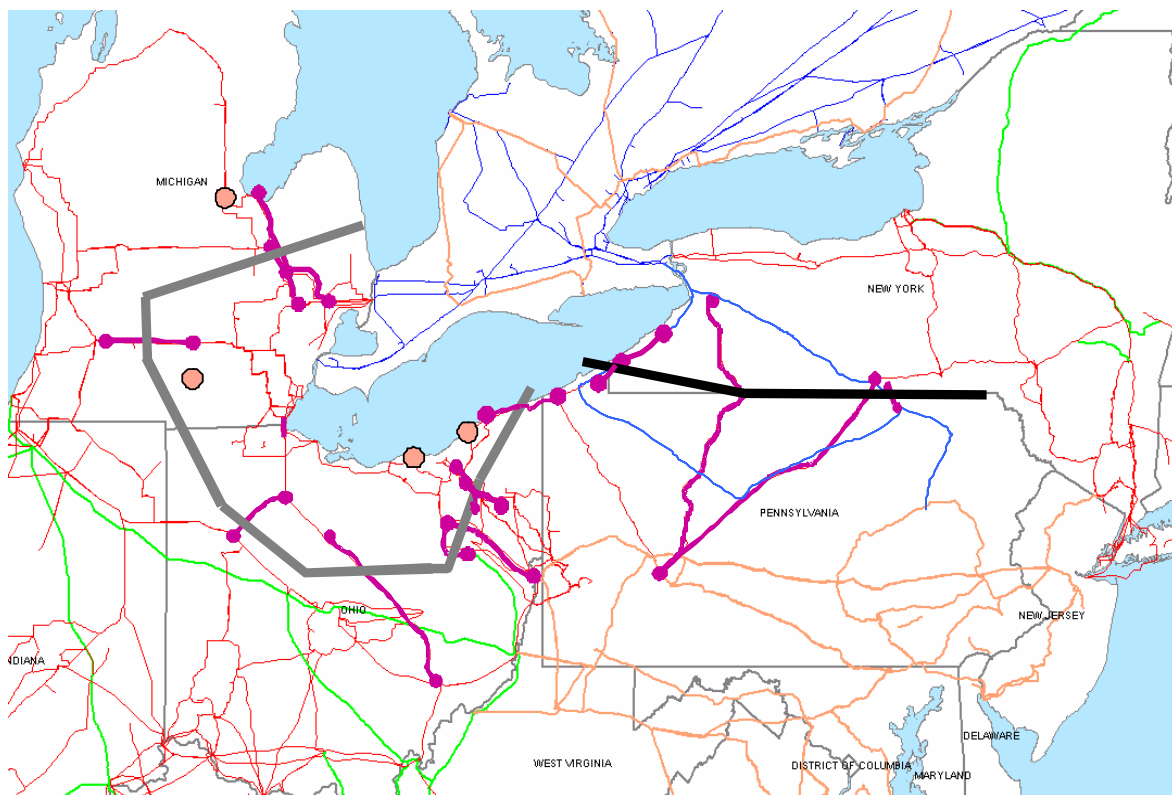
**Figure IV.24 — Western Pennsylvania Separates From New York,
16:10:39 to 16:10:44**

Watercure (177 miles) and Homer City-Stolle Road (207 miles) are relatively long lines with high impedances. Zone 1 relays do not have timers, and therefore operate nearly instantly when a power swing enters the relay target circle. For normal length lines, zone 1 relays have smaller target circles because the relay is measuring less than the full length of the line, but for a long line the greater impedance enlarges the relay target circle and makes it more likely to be hit by the power swing. The Homer City-Watercure and Homer City-Stolle Road lines do not have zone 3 relays.

Given the length and impedance of these lines, it was highly likely that they would trip and separate in the face of such large power swings. Most of the other interfaces between regions have shorter ties. For instance, the ties between New York and Ontario and Ontario to Michigan are only about two miles long, so they are electrically very short and thus have much lower impedance and trip less easily than these long lines. A zone 1 relay target on a short line covers a small distance so a power swing is less likely to enter the relay target circle at all, averting a zone 1 trip.

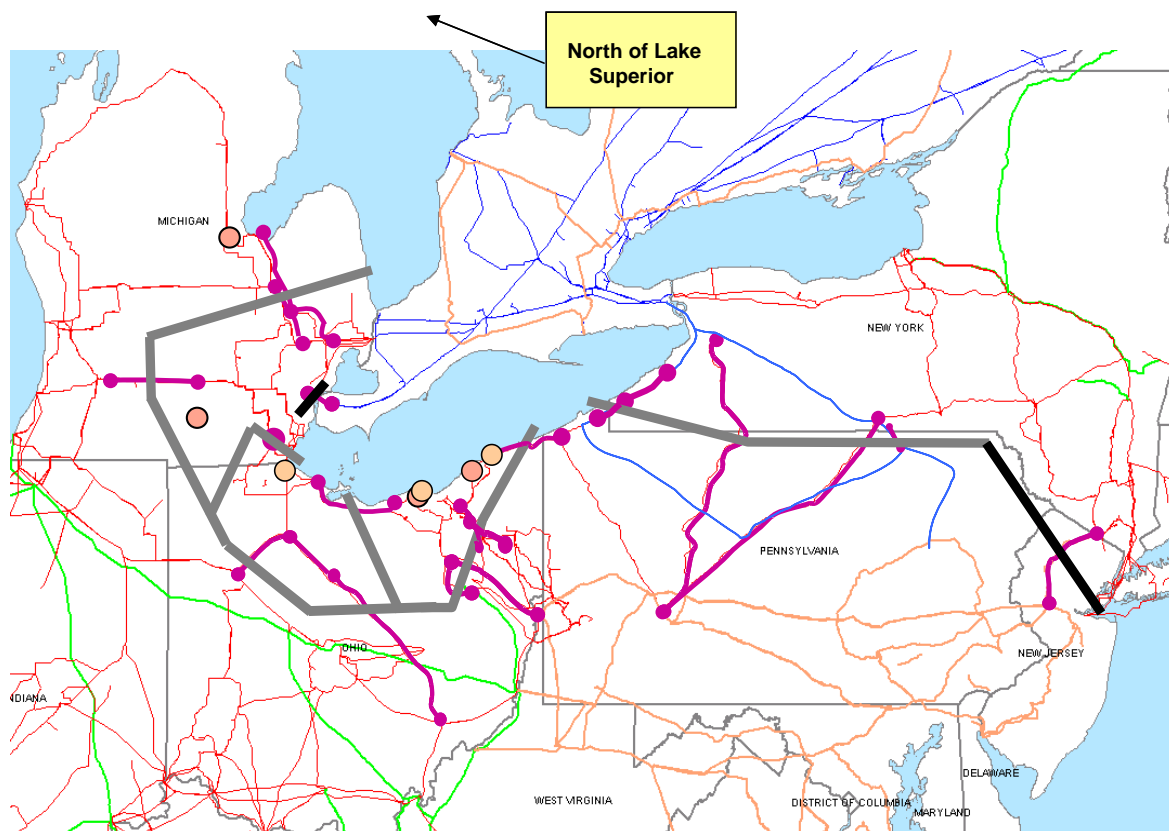
Figure IV.26 — Northeast Separates From Eastern Interconnection, 16:10:45

At 16:10:45, northwest Ontario separated from the rest of Ontario when the Wawa-Marathon 230-kV lines (168 km long) disconnected along the northern shore of Lake Superior, tripped by zone 1 distance relays at both ends. This separation left the loads in the far northwest portion of Ontario connected to the Manitoba and Minnesota systems, and protected them from the blackout (Figure IV.26).

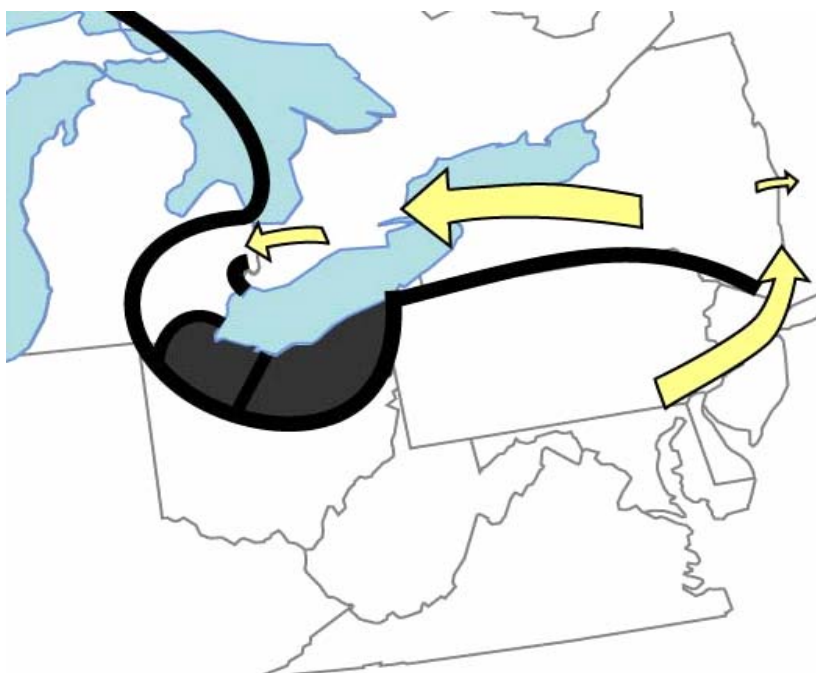
Figure IV.27 — Power Flows at 16:10:45

As shown in Figure IV.27, the 69-mile long Branchburg-Ramapo line and Ramapo transformer between New Jersey and New York was the last major transmission path remaining between the Eastern Interconnection and the area ultimately affected by the blackout. Figure IV.28 shows how that line disconnected at 16:10:45, along with other underlying 230 and 138-kV lines in northeastern New Jersey. Branchburg-Ramapo was carrying over 3,000 MVA and 4,500 amps with voltage at 79 percent before it tripped, either on a high-speed swing into zone 1 or on a direct transfer trip. The investigation team is still examining why the higher impedance 230-kV overhead lines tripped while the underground Hudson-Farragut 230-kV cables did not; the available data suggest that the lower impedance of underground cables made these less vulnerable to the electrical strain placed on the system.
